INITIAL HAZARD POTENTIAL CLASSIFICATION ASSESSMENT

Bremo Power Station CCR Surface Impoundment:
East Ash Pond

Submitted By: Golder Associates Inc.
2108 W. Laburnum Avenue, Suite 200
Richmond, VA 23227

April 2018

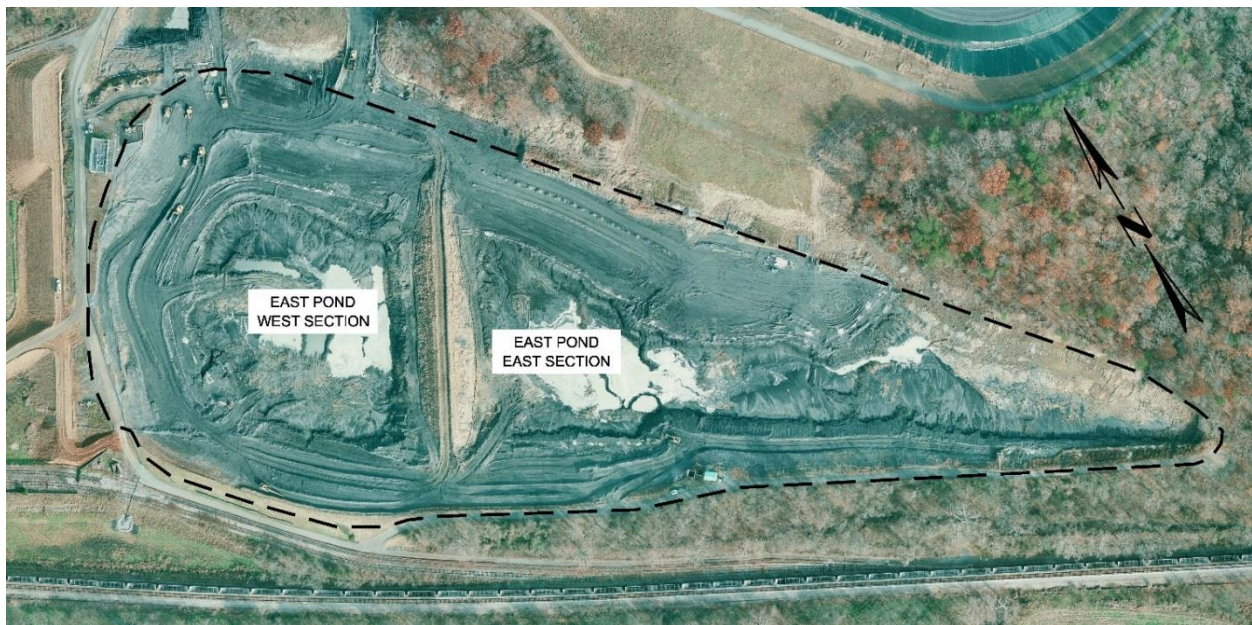
Figure 1 - December 2017 East Ash Pond Aerial Photo

The 26.5-acre impoundment is located east of the Bremo Power Station and is bounded on the south side by a railroad embankment and the James River, on the north side by the North Ash Pond, and on the east by low-lying undeveloped areas. The EAP was constructed partially by excavation on the north side and embankment construction on the south side. After a series of lateral and vertical expansions over its approximately 50-year operational life, the EAP was mostly closed with a soil cap, with the exception of the easternmost section, which was left as open water. The upstream sideslopes are 4 horizontal to 1 vertical (4H:1V) and the downstream sideslopes vary from 3H:1V to 1.5H:1V around the western and southern areas of the pond. The northern and eastern sides are excavated into natural terrain. The effective embankment height is up to 32 feet.

The existing spillway structure is a square concrete intake tower located in the southeast corner of the pond. The tower structure is approximately 5'-6" in width and has a weir opening at an elevation of approximately 229.0 feet. The outlet pipe is a 24-inch diameter reinforced concrete pipe with an inlet invert elevation of 206.9 feet. The outlet pipe has been temporarily plugged to prevent discharges. Stormwater that enters the pond is pumped to the on-site treatment system.

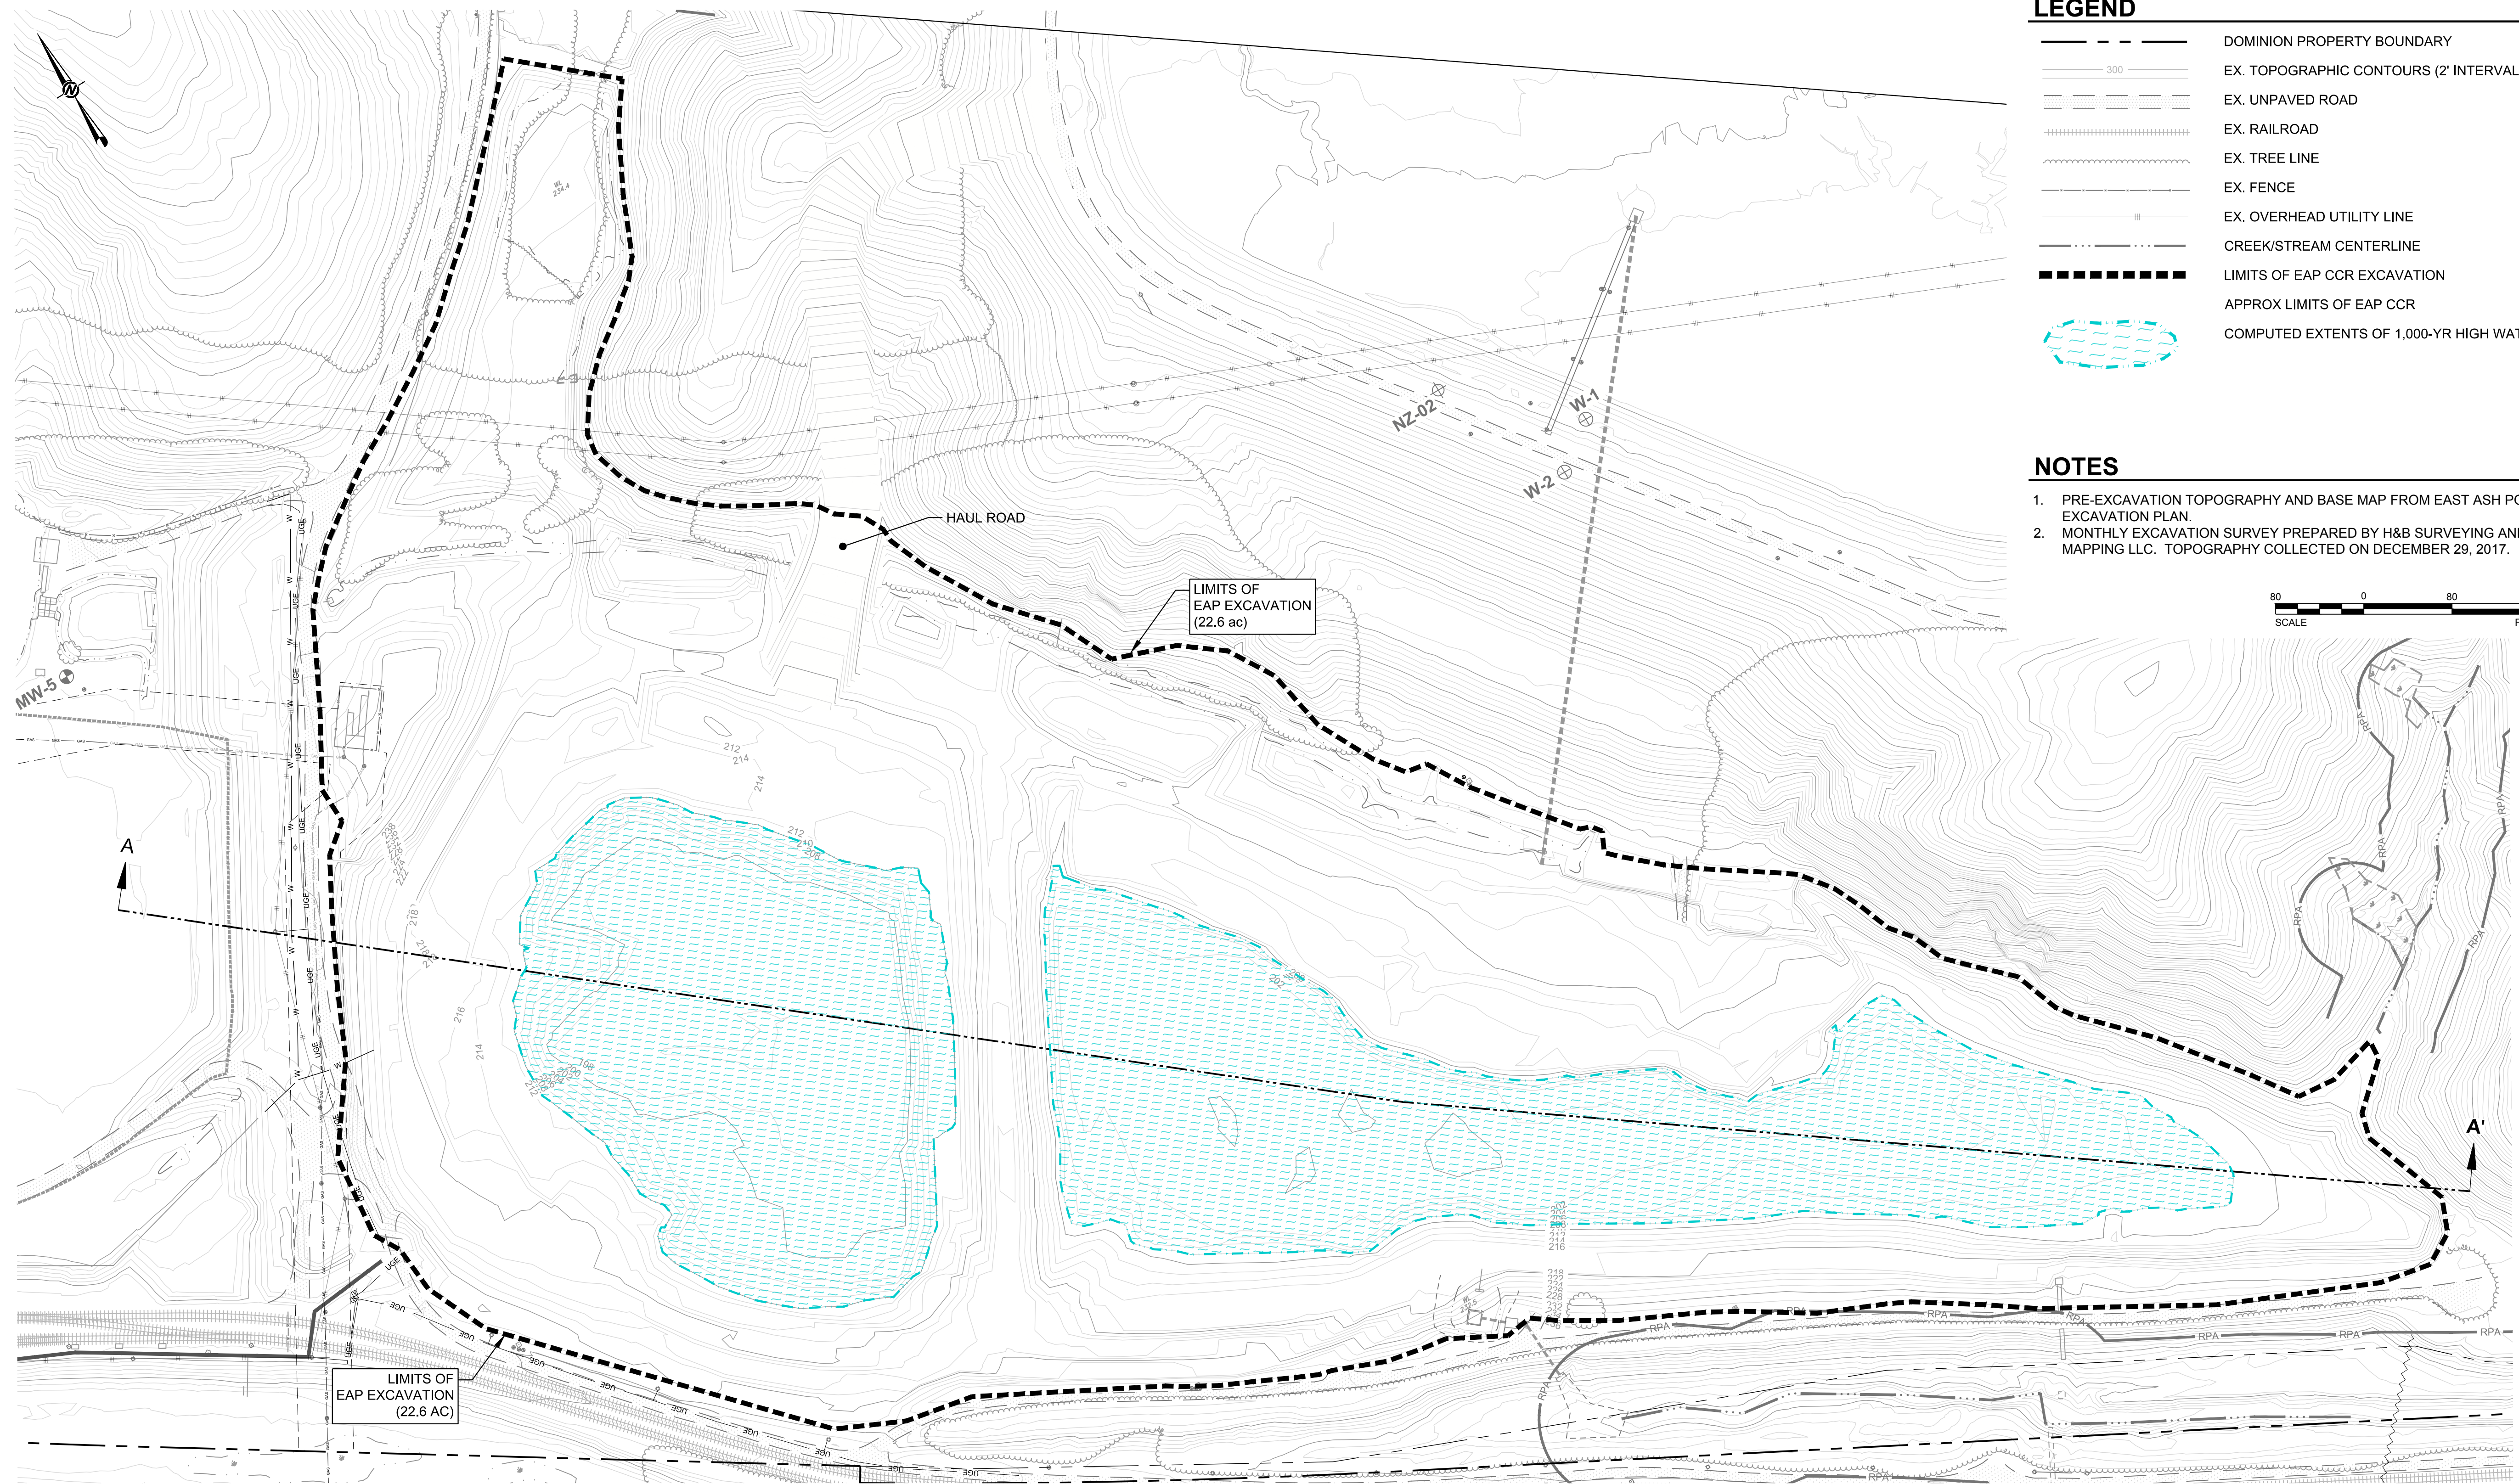
Figure 2 – East Ash Pond 1,000-Yr Event High Water Elevations

Modeling the existing EAP for the 1,000-year event during a non-breach scenario shows the calculated high water elevations for the east and west pond sections to be 207.3 feet and 210.7 feet, respectively, which indicates the flows do not overtop the embankment. Due to the ongoing excavation, these high

water elevations are below the elevation of the outside toe of the embankment, with the exception of a small portion of the man-made ravine near the plugged outlet riser. A breach of the embankment in the western section would have an uphill gradient to escape the pond; therefore, a breach and release from the west section is considered highly improbable and therefore was not modeled.

A breach and water release of the east section of the pond could only occur on the southern embankment, near the riser structure, as all other directions are uphill. The outside toe forms part of a narrow man-made ravine between the pond and the railroad embankment. This narrow ravine receives stormwater flow from approximately 306 acres of undeveloped land to the east, which results in a water level higher in the ravine than the EAP during the 1,000-year event. A breach of the east section would have an uphill hydraulic gradient to escape, and this scenario is also considered highly improbable and therefore was not modeled.

If a structural embankment failure does not occur, the existing pond sections are capable of receiving and storing the runoff volume from the 1,000-year event without overtopping the embankment and without a discharge. The east and west sections of the pond would have 22.7 and 19.3 feet of freeboard, respectively.

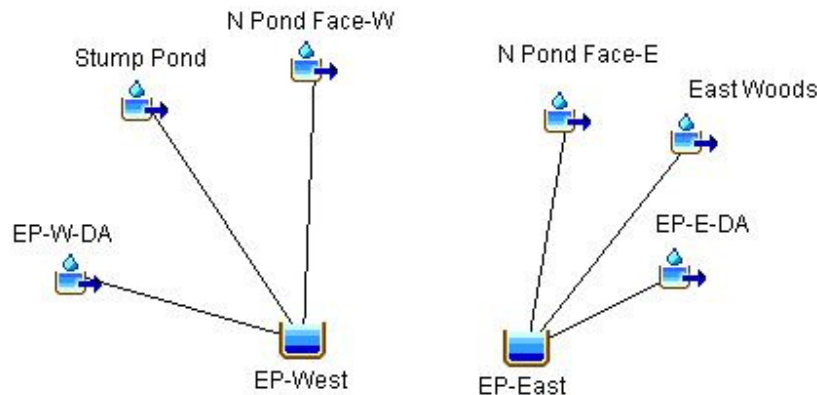
Figure 1 – East Ash Pond HEC-HMS Model

Figure 1 illustrates the connectivity of the stormwater elements and the data inputs as modeled in HEC-HMS. The predominant soil types in the area are Hydrologic Soil Group (HSG) ‘B’ soils. The acreage, curve number (CN) and lag time for each sub-drainage area are in the attached worksheet.
