DOMINION ENERGY

PERIODIC STRUCTURAL STABILITY ASSESSMENT

BREMO STATION INACTIVE CCR SURFACE
IMPOUNDMENT: EAST POND

APRIL 2023

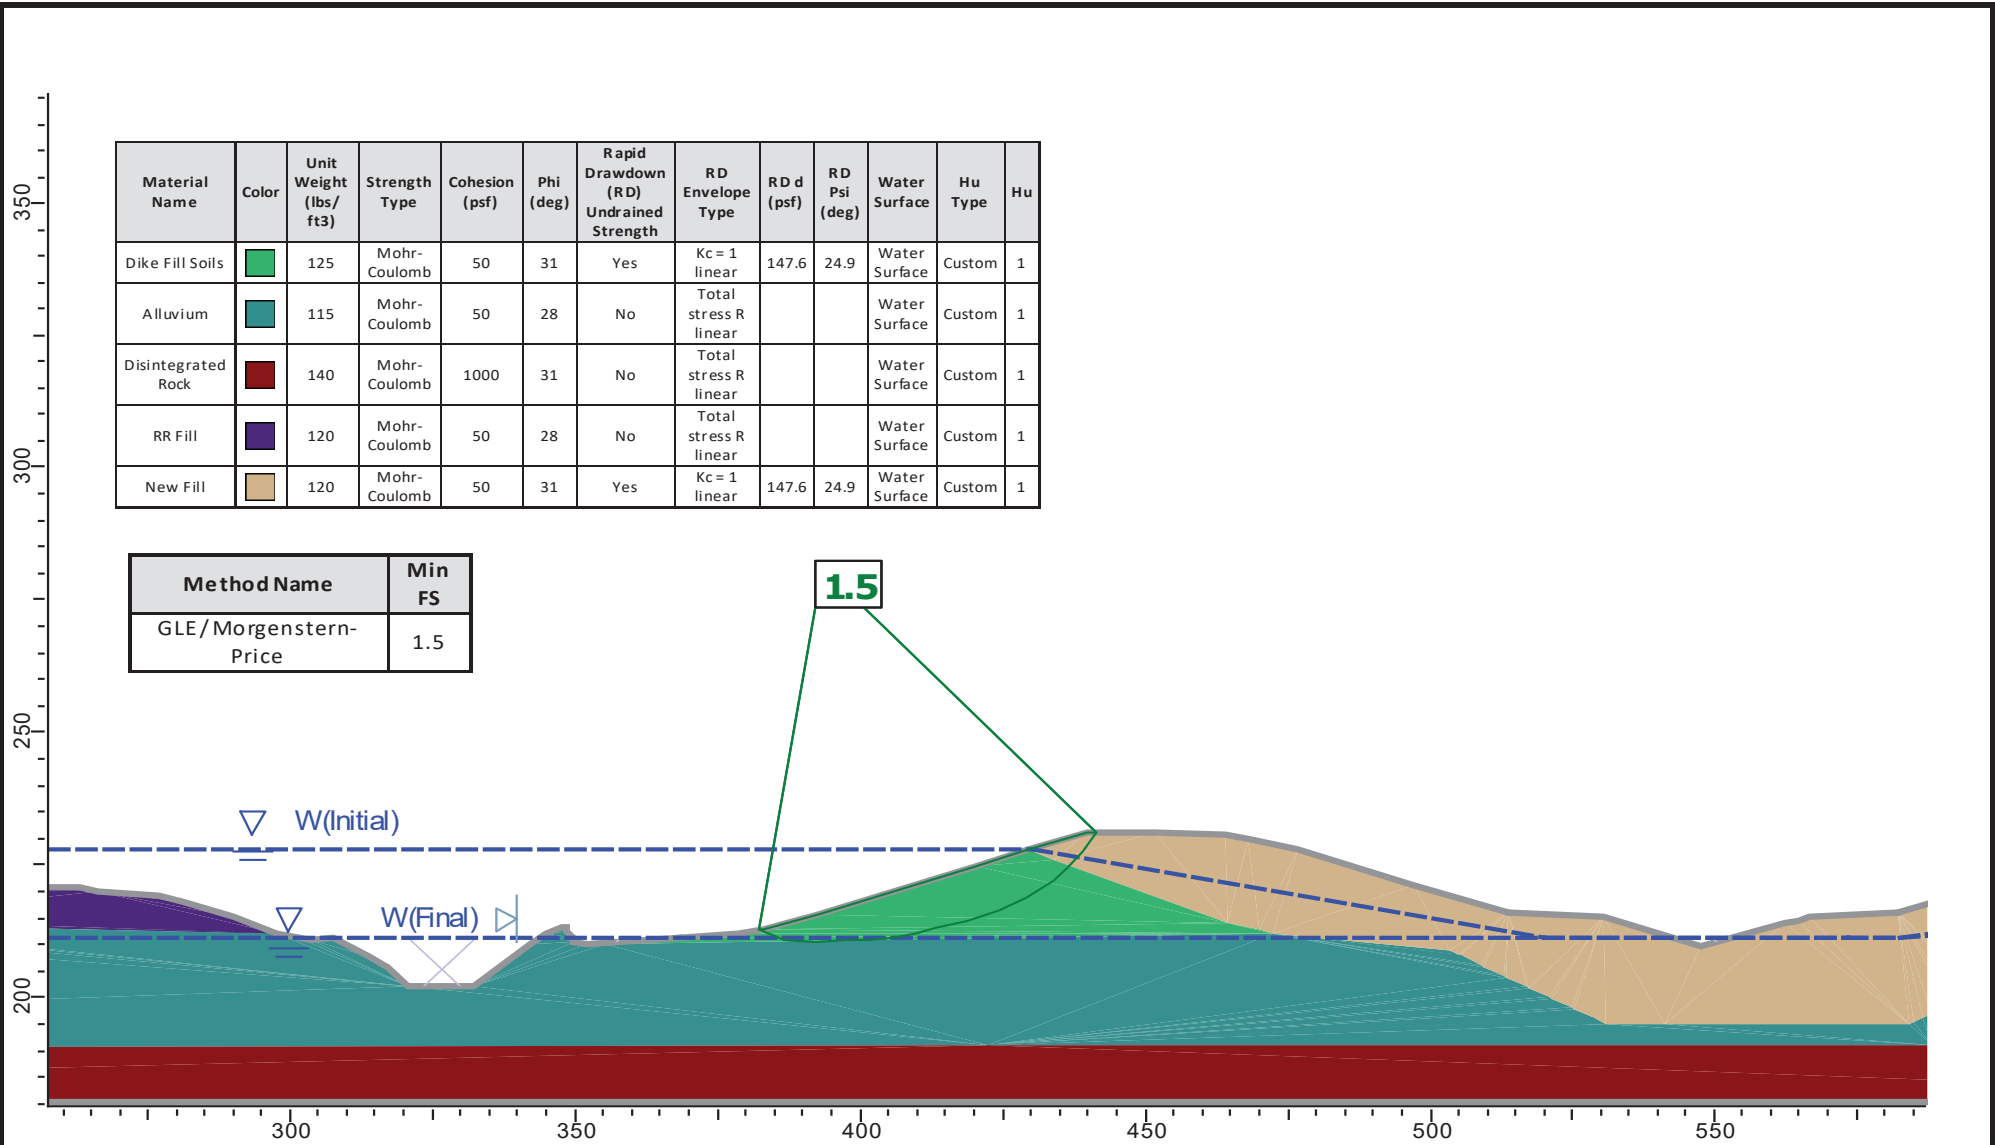
SCALE	AS SHOWN	PROJECT	Bremo East Pond - 2023 Safety Factor Assessment	
	DATE	April 2023	TITLE	Section A-A Rapid Drawdown	
	MADE BY	WJF			
	CAD	-			
FILE	STABILITY	CHECK	SSS	CLIENT	Dominion Energy
PROJECT No.	GL21466315	REVIEW	GLH	FIGURE

Cross-Sections	Factor of Safety
A-A'	1.5
B-B'	1.7
C-C'	1.4
D-D'	1.5

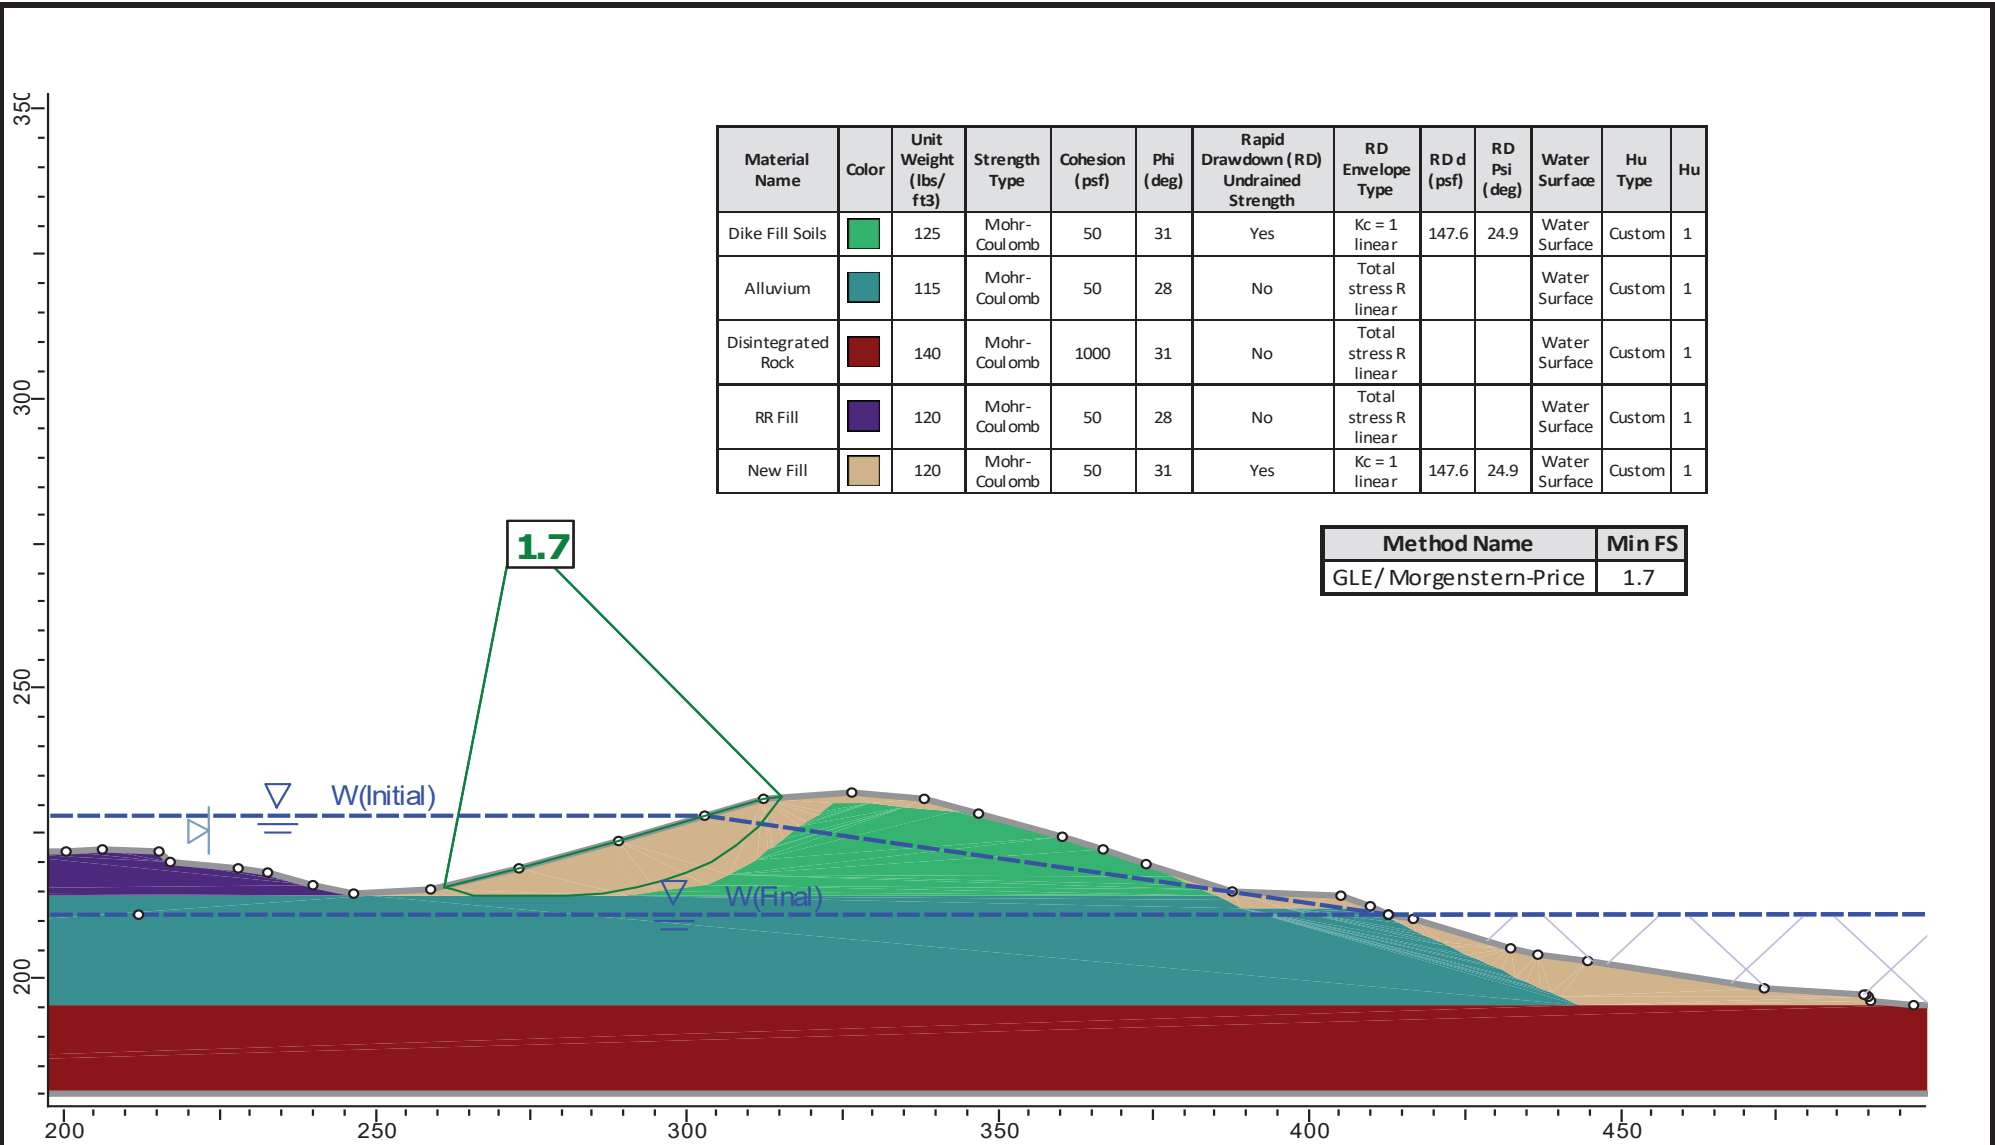
SCALE	AS SHOWN	PROJECT	Bremo East Pond - 2023 Safety Factor Assessment		
	DATE	April 2023	TITLE	Section B-B Rapid Drawdown		
	MADE BY	WJF				
	CAD	-				
FILE	STABILITY	CHECK	SSS	CLIENT	Dominion Energy	
PROJECT No.	GL21466315	REV.	0	REVIEW		GLH
					FIGURE	3(d)

Method Name	Min FS
GLE/Morgenstern-Price	1.7

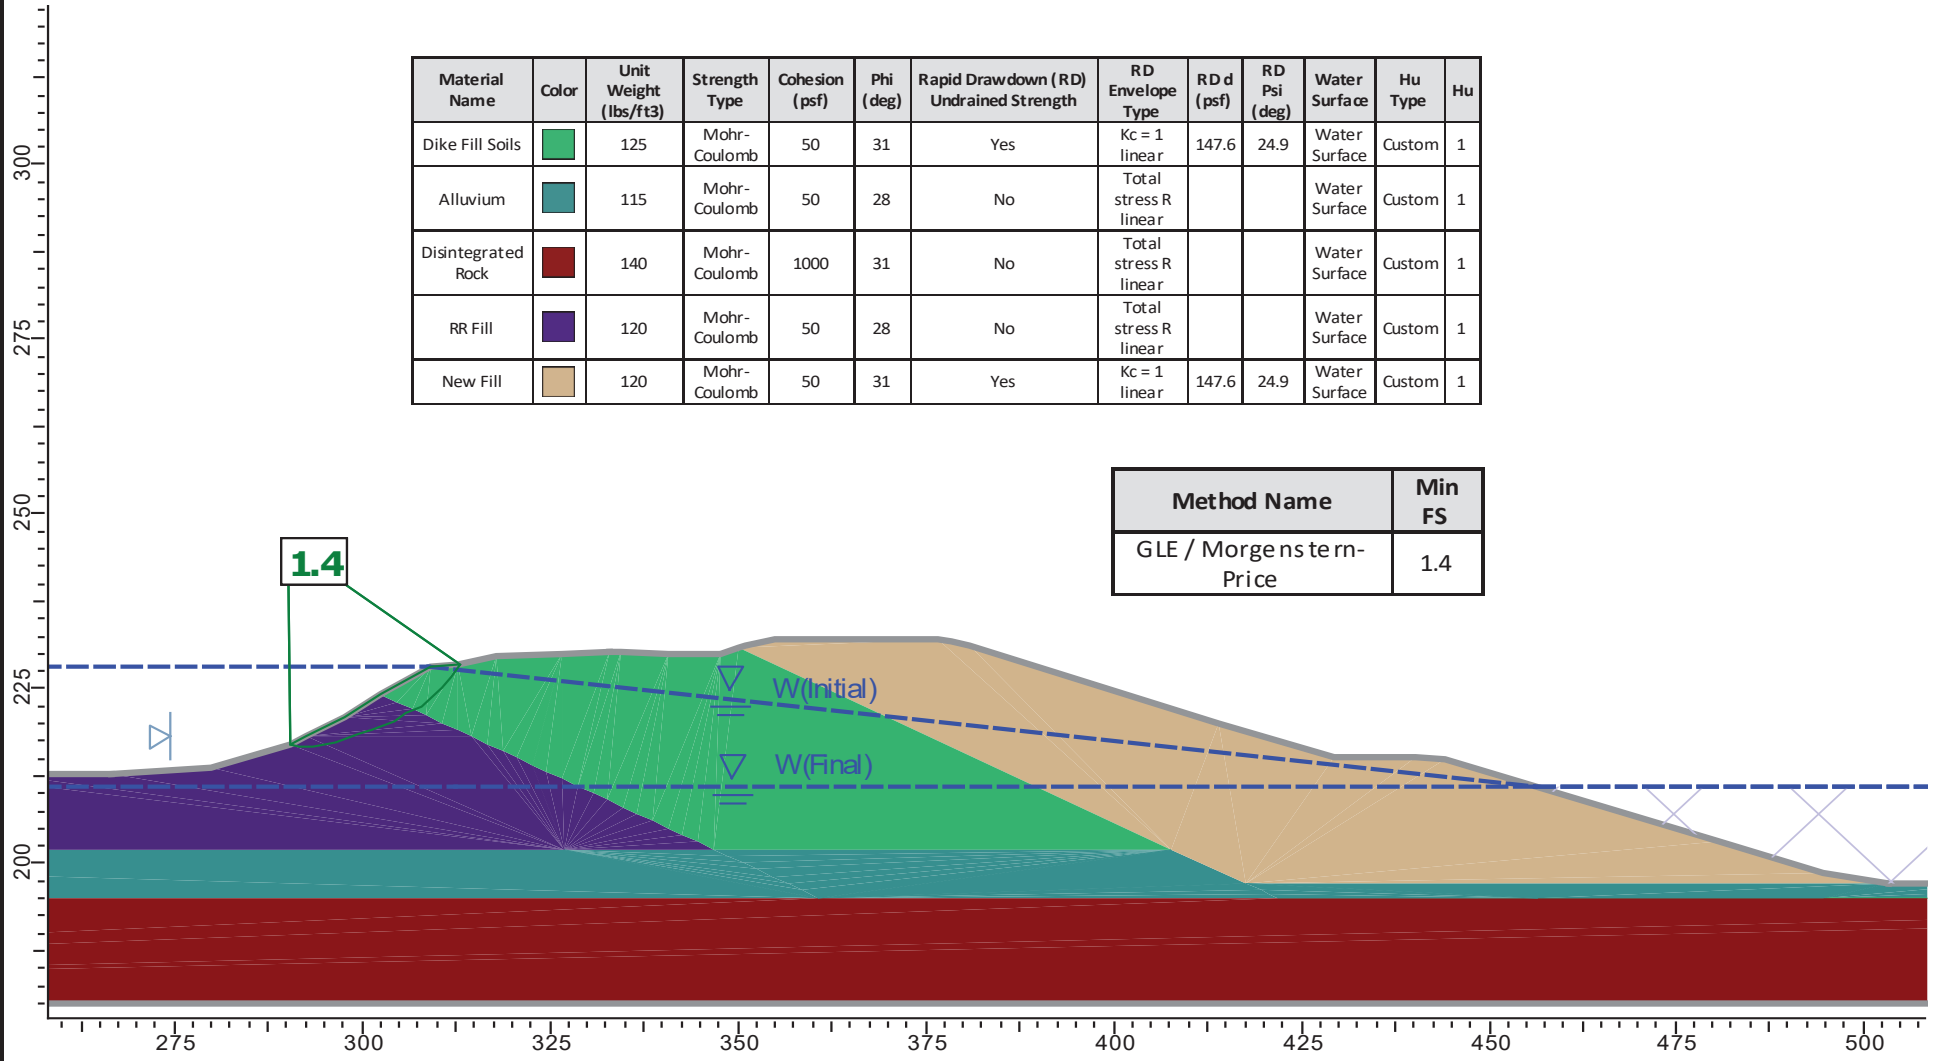
SCALE	AS SHOWN	PROJECT	Bremo East Pond - 2023 Safety Factor Assessment		
DATE	April 2023	TITLE	Section C-C Rapid Drawdown		
MADE BY	WJF				
CAD	-				
FILE	STABILITY	CHECK	SSS	CLIENT	
PROJECT No.	GL21466315	REV.	0	Dominion Energy	FIGURE
		REVIEW	GLH		4(d)

Method Name	Min FS
GLE / Morgenstern-Price	1.4
