INITIAL STRUCTURAL STABILITY ASSESSMENT

Bremo Power Station CCR Surface Impoundment:
East Ash Pond

April 2018

Project No. 15-20347

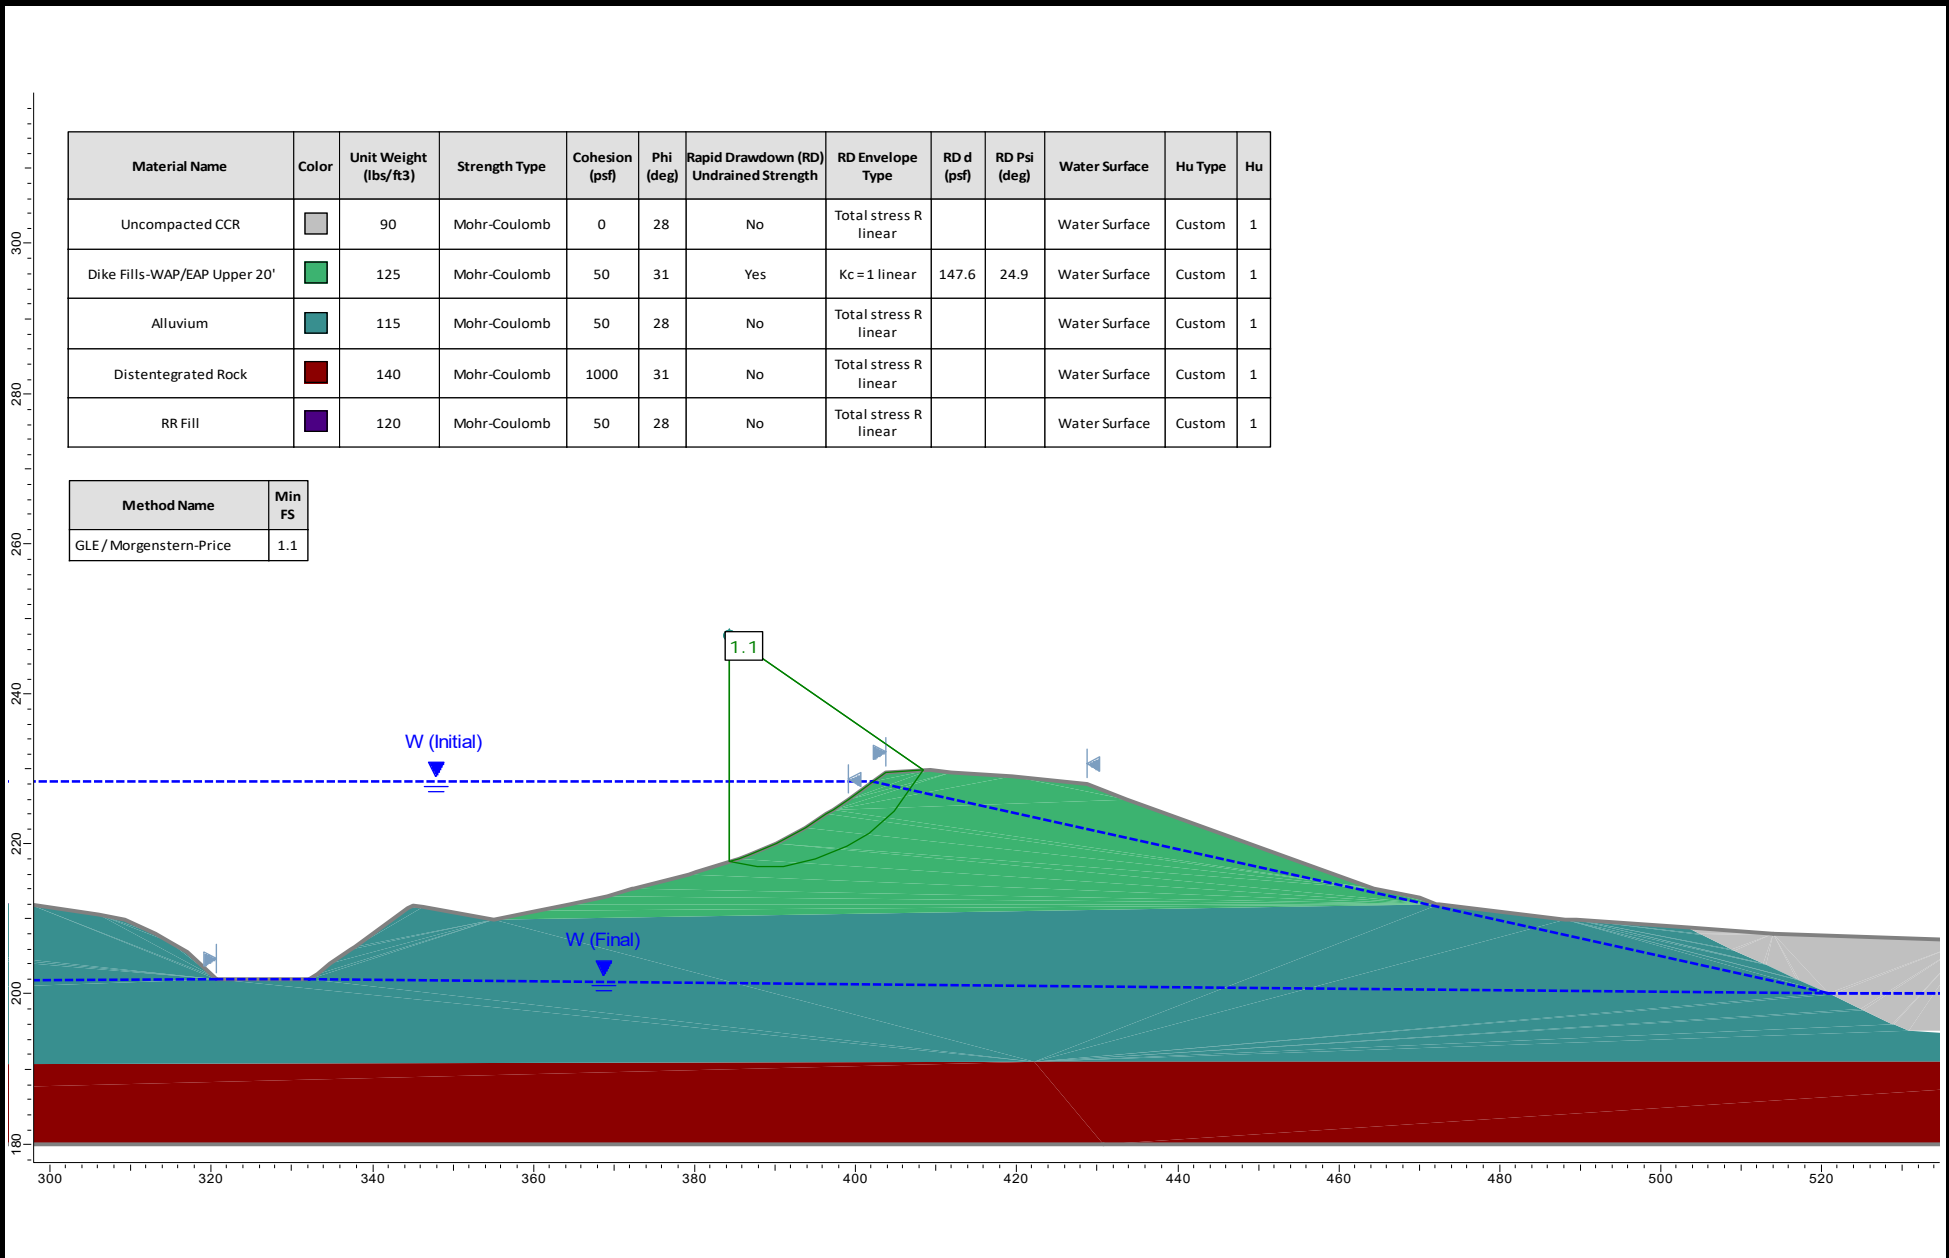
SCALE	AS SHOWN	PROJECT	Bremo East Pond - Inactive Pond Demonstration	
	DATE	Mar 2018	TITLE	Section A-A Rapid Drawdown	
	MADE BY	LJ			
	CAD	-			
FILE	STABILITY	CHECK	JGM	CLIENT	Dominion Energy
PROJECT No.	1520347	REVIEW	GLH	FIGURE

Cross-Sections	Factor of Safety
A-A	1.1
B-B	1.0
C-C	1.4
D-D	1.8

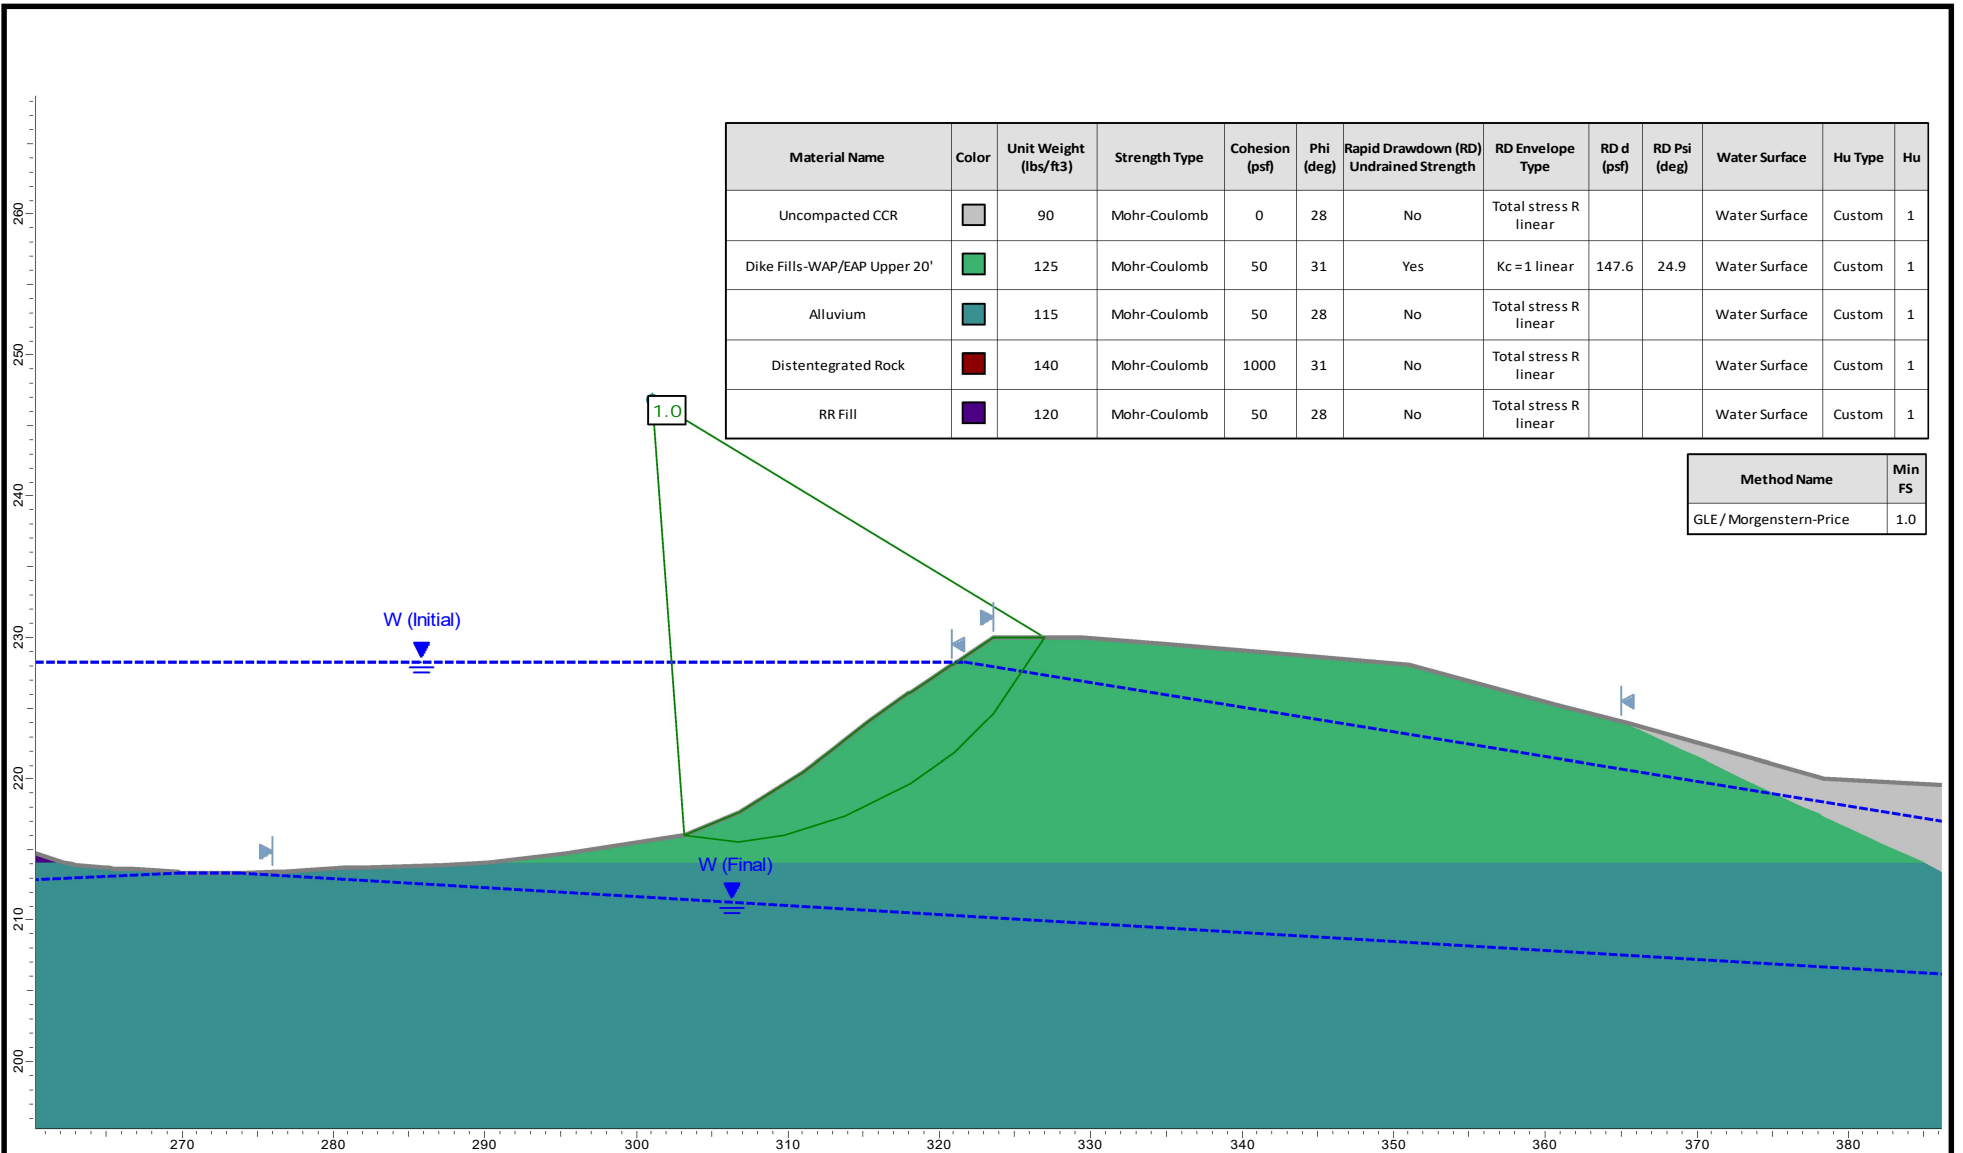
PROJECT **Bremo East Pond - Inactive Pond Demonstration**
 TITLE **Section B-B
 Rapid Drawdown**
 CLIENT **Dominion Energy**
 FIGURE **3(d)**

inundation of the southern exterior slopes of the EAP can be expected. Golder's evaluation of slope stability under rapid drawdown conditions after a 100-year flood event shows the embankments exhibit satisfactory factors of safety, with the exception of Section B-B. For more details on the rapid drawdown analysis, please refer to the Rapid Drawdown Methodology Package (Appendix A).

In recognition of Section B-B not meeting the target factor of safety, routine weekly inspections are conducted to observe any changes in the embankment. Water is removed through diversion and pumping and not impounded behind the EAP embankment, and monitoring will continue until the pond achieves final closure through removal of CCR and reduction in the embankment height.

Based upon a review of available information and the additional analyses performed for this and other assessments, areas of the EAP dikes, similar to Section B-B, require regrading to ensure global stability. The EAP will be closed by removal of CCR materials. Following the removal of CCR, the area will be repurposed and the existing perimeter dikes will have the trees removed and be regraded to a 3H:1V slope to improve stability.
