# STRUCTURAL STABILITY ASSESSMENT

Bremo Power Station CCR Surface Impoundment:  
North Ash Pond

October 2016

Project No. 15-20347

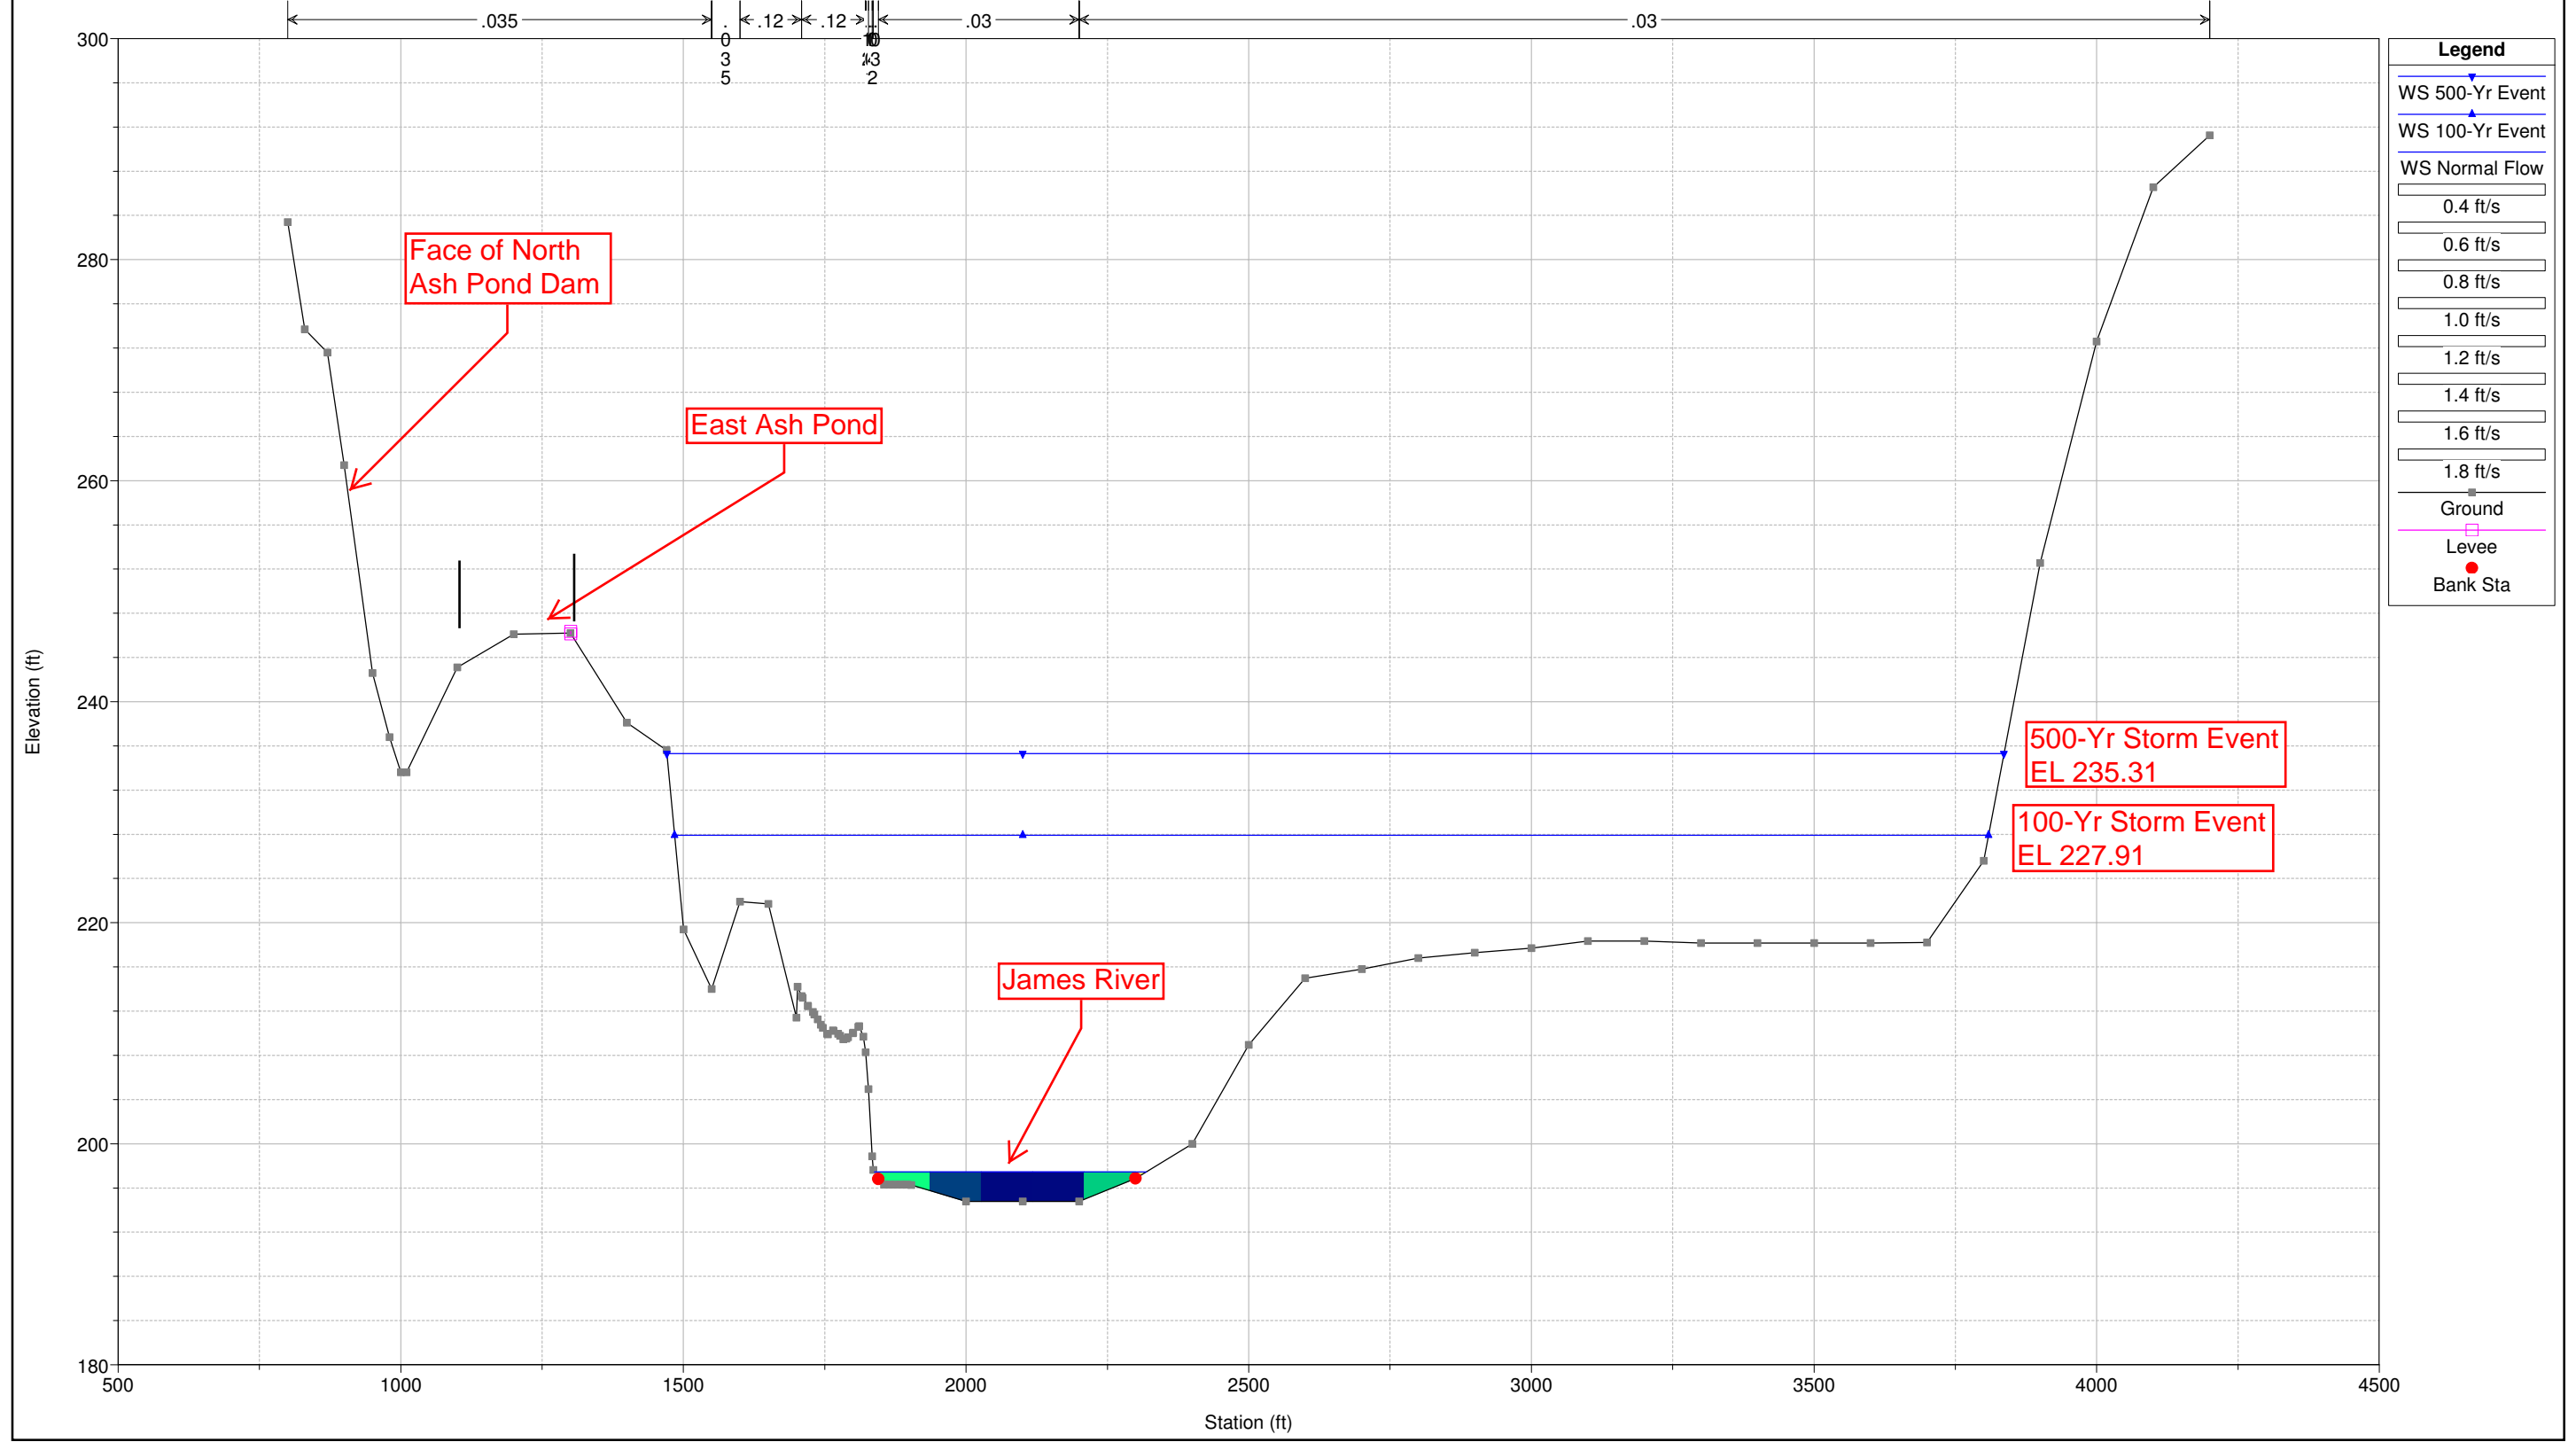
### **North Ash Pond Inundation Cross-Section**

The NAP dam is located approximately 900 feet from the James River. The toe of the dam abuts the East Ash Pond (EAP) embankment at an approximate elevation of 234 feet above mean sea level (ft amsl). The 100-year and 500-year storm events were considered. The water surface elevations of the James River resulting from the 100-year and 500-year storm events are 227.91 ft amsl and 235.31 ft amsl, respectively. The resulting temporary inundation from the 500-year storm event (1.31 feet) is considered to have a negligible impact to the structural stability of the NAP embankment. A cross-section through the NAP dam and the James River is provided in Appendix A.
