INITIAL HAZARD POTENTIAL CLASSIFICATION ASSESSMENT

Chesapeake Energy Center CCR Surface
Impoundment: Bottom Ash Pond

April 2018

Project No. 13-00193

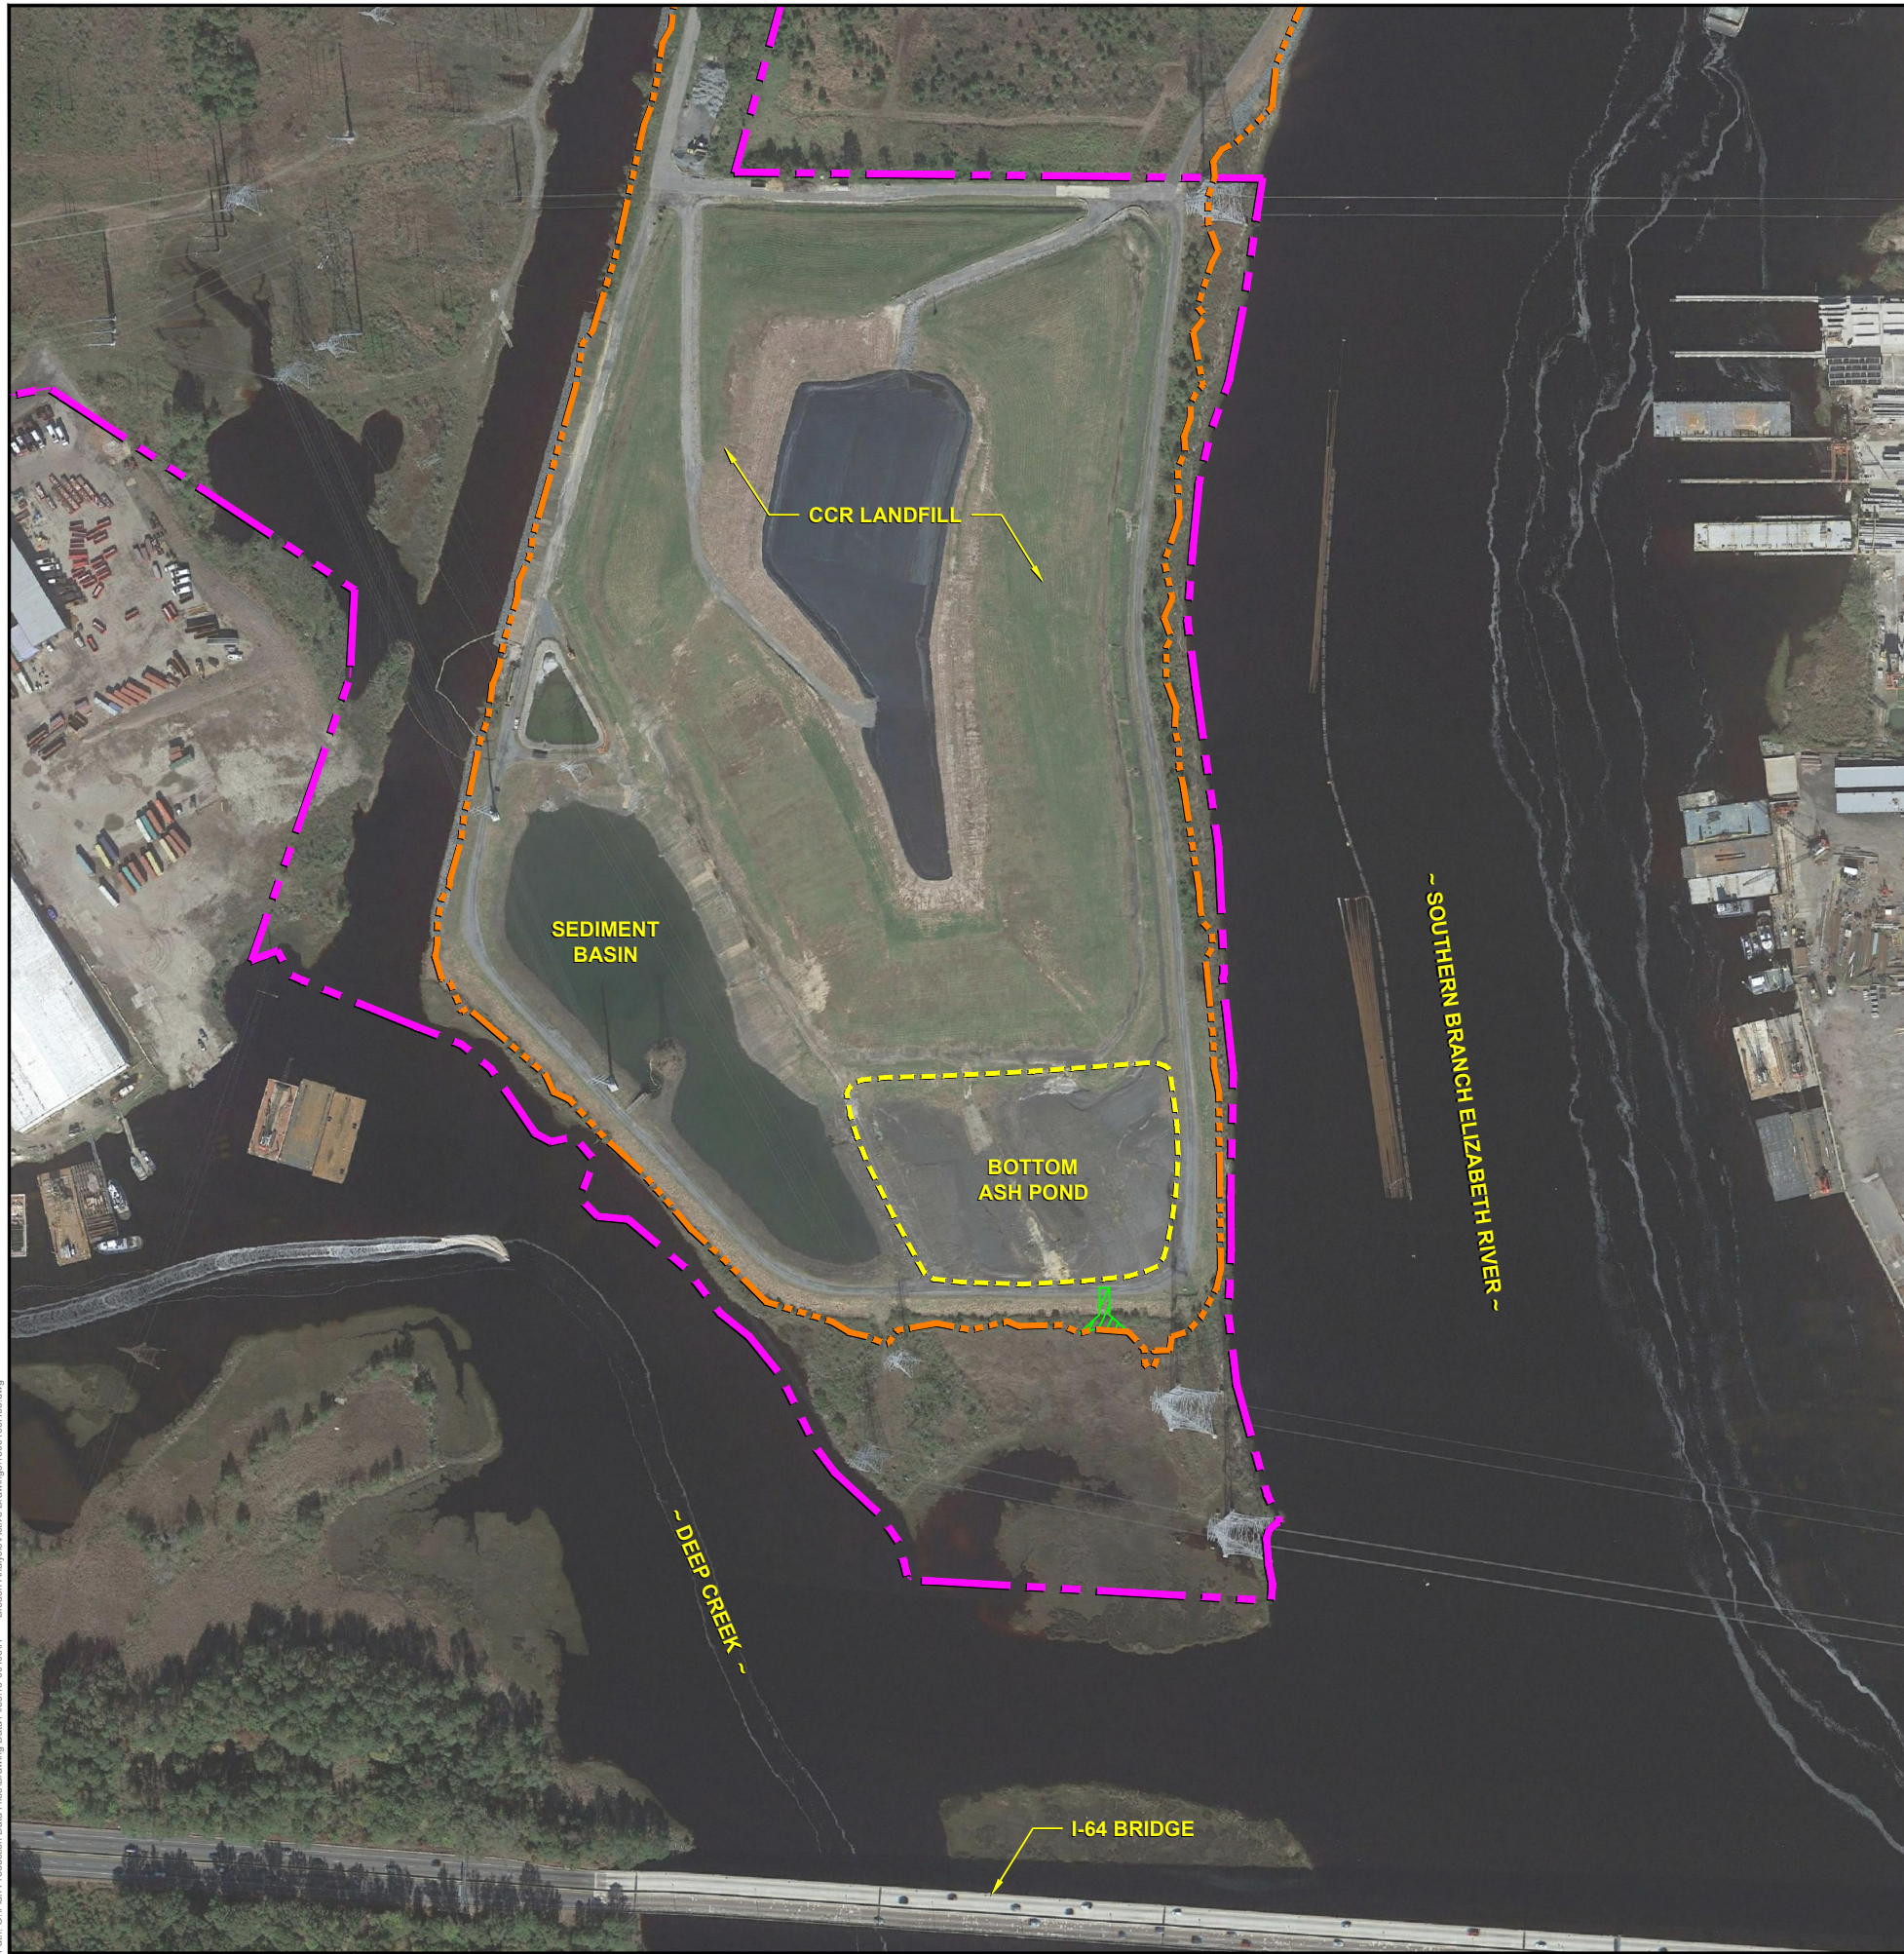
FIGURE
1

Due to the simplicity of the downstream geometry, numerical modeling of the breach outflow was not performed. Instead, a general discharge map was generated. Due to the basin’s proximity to the Elizabeth River, the entire area downstream of the bottom ash pond (west, south and east directions) is subject to flooding from the 1% annual chance event (100-Yr event) and is classified as Zone AE on the Flood Insurance Rate Map (FIRM) (reference 6). The elevation given on the FIRM in the area of the basin (8.5 feet AMSL) indicate floodwater levels in the Elizabeth River and Deep Creek would overtop the low-lying wetland areas; however, the basin would not be overtopped (El 20). This is important to note since the storm event used in this analysis is much larger in magnitude than the 1% annual chance event that would cause flooding in the water bodies adjacent to the BAP. The FIRM is included as Figure 2 of this report. A breach of the BAP is not anticipated to impact the CEC or any other developed areas.

The modeled embankment failure scenarios may cause erosion damage to the downstream side of the embankment leading to wetland areas/Deep Creek. The effect of the inflow into the Deep Creek/Elizabeth River confluence is anticipated to be minimal, due to the short duration of the flow event and the relatively small volume of the breach flow in comparison to the normal volume of flow in the river.
