Periodic Structural Stability Assessment

Chesterfield Power Station CCR Surface Impoundment: Lower Ash Pond

Golder Associates Inc.

October 2021

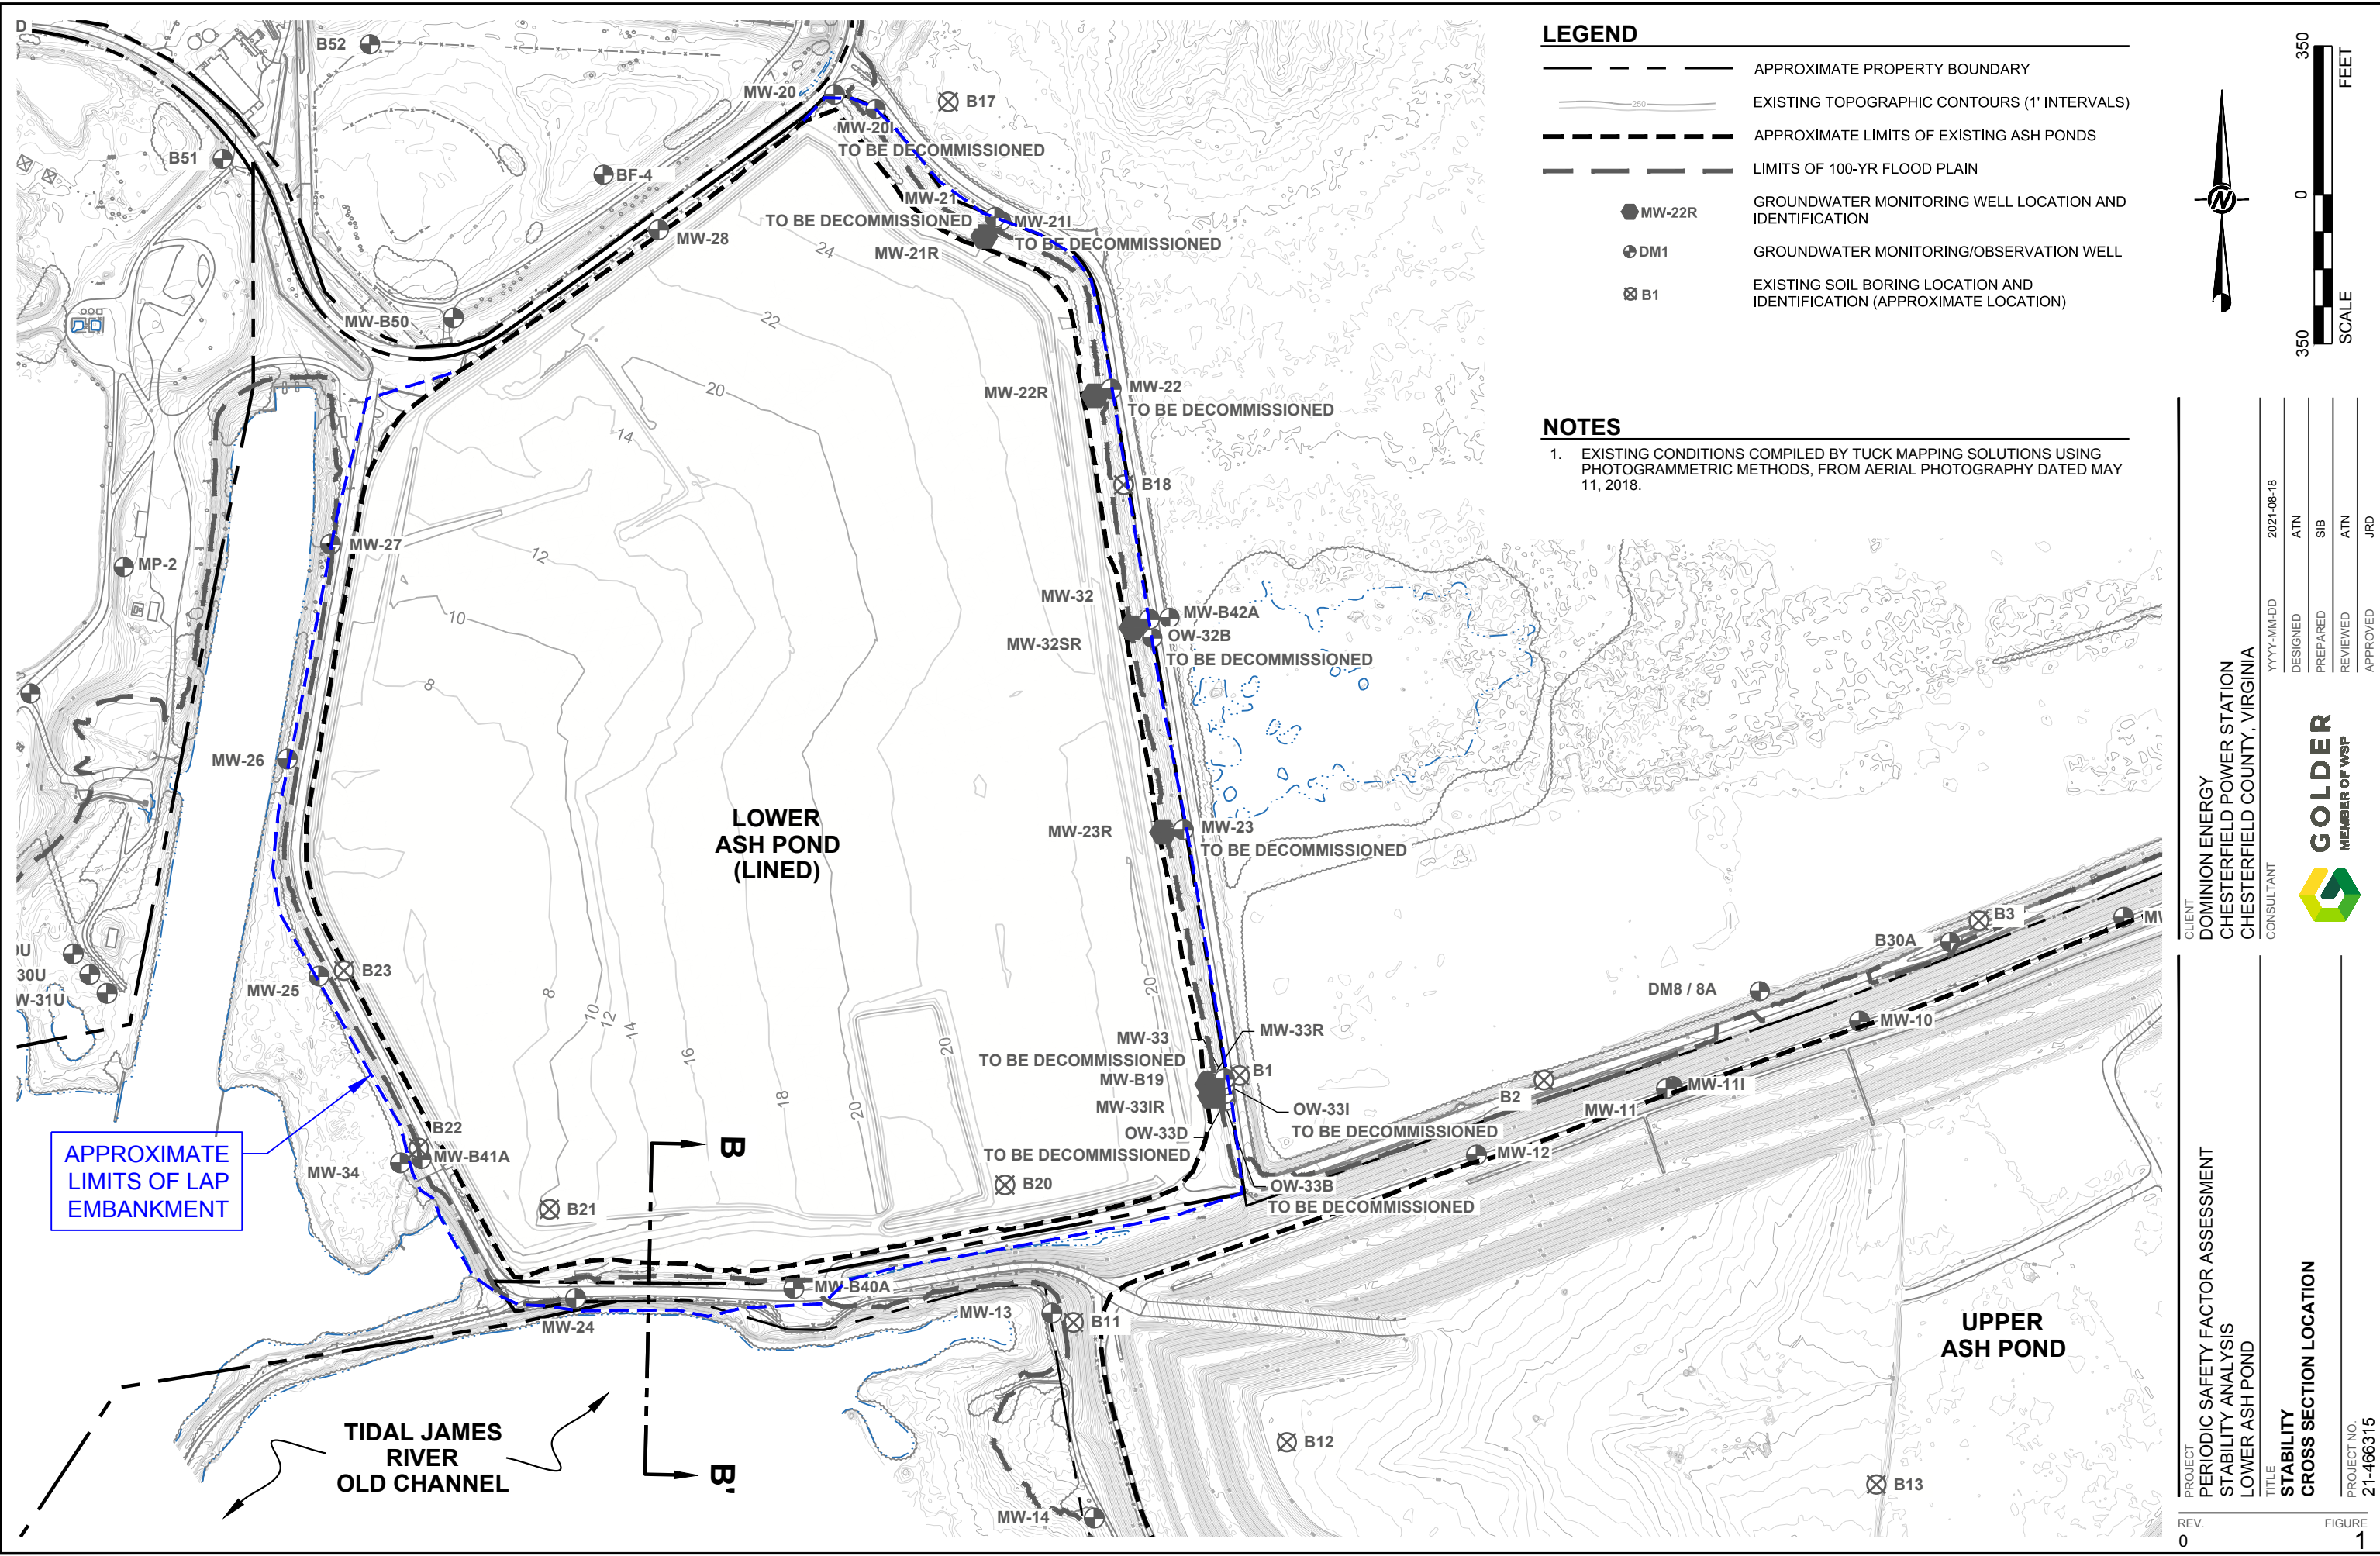
FIGURE NO. 1

The downstream slopes of the embankment on the southwestern side of the LAP border an old channel of the James River called Farrar Gut. The embankment surrounding the LAP is subject to the 100-year flood event as defined by FEMA, with a flood elevation of 16 feet above mean sea level (ft-amsl). A rapid drawdown assessment was performed on Section B shown in Figure 1 using the 100-year flood event as the starting water level and a final water level equal to sea level (see Appendix A). The target factor of safety for a rapid drawdown condition is 1.1 to 1.3 (USACE, 2003). The factor of safety for a rapid drawdown condition is 1.1, which meets the U.S. Army Corps of Engineers (USACE) minimum requirement. The location of the cross section analyzed for rapid drawdown is included in Figure 1, and calculations for the rapid drawdown assessment are included in Appendix A.

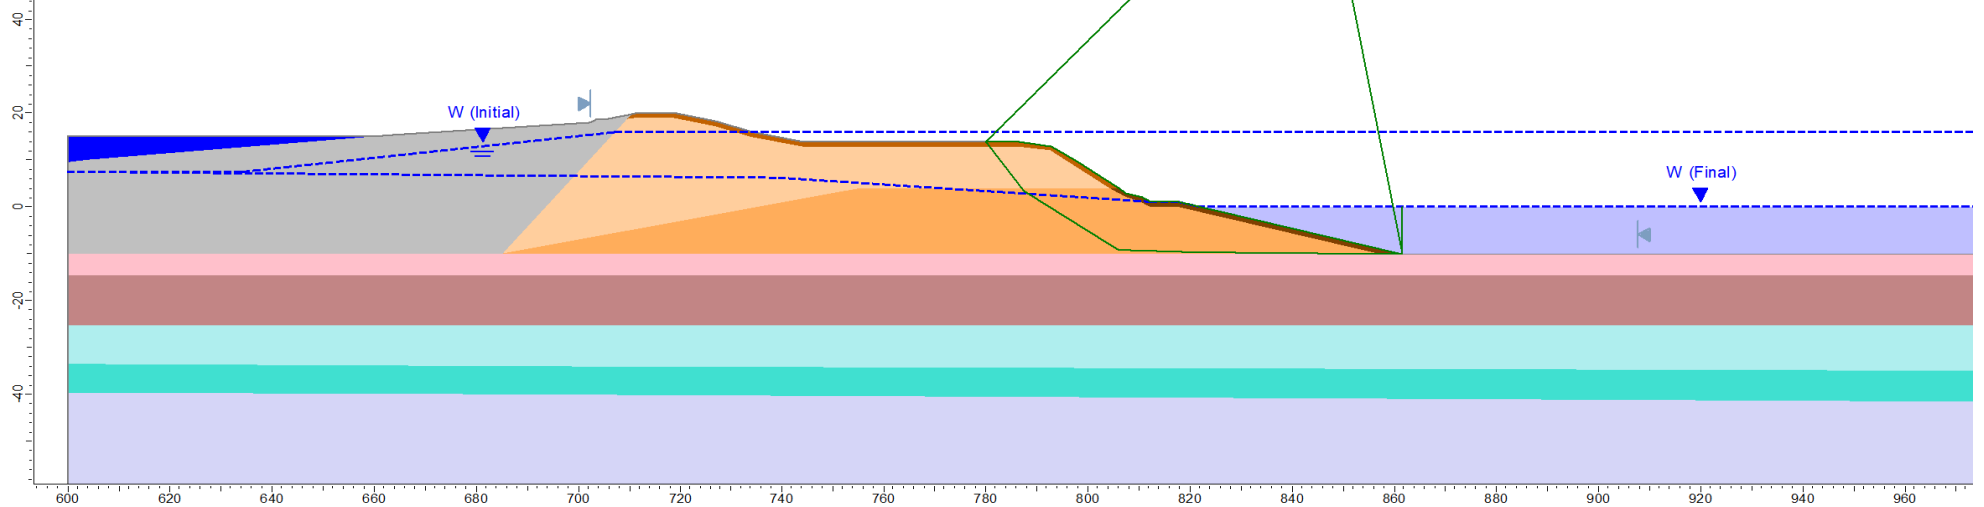
SCALE	AS SHOWN	PROJECT	Chesterfield Power Station			
	DATE	Oct 2021	TITLE	Lower Ash Pond Section B-B' Rapid Drawdown			
	MADE BY	SDRM					
	CAD	-					
FILE	SAFETY FACTOR ASSESSMENT		CHECK	ALB	CLIENT	Dominion Energy	FIGURE 1
PROJECT No.	21466315	REV.	0	REVIEW	ATN

Results of the safety factor assessment referenced in this structural stability assessment indicate that the embankment surrounding the LAP does not meet the minimum requirements as outlined in the CCR rule § 257.73(e)(1). Because factors of safety do not meet the minimum requirements, a more rigorous analysis of the

embankment surrounding the LAP should be performed to determine the severity of the potential failure modes analyzed and the extents of the embankment that may also be susceptible to stability concerns.

Method Name	Min FS
GLE / Morgenstern-Price	1.1

In response to this evaluation, Dominion Energy plans to enhance the strength of the southwest corner of the Lower Ash Pond berm by installing deep soil mixing shear panels (or similar type enhancements). Engineering efforts are ongoing through the end of this year and construction is expected to begin in the first quarter of 2022 with an estimated completion in mid-2022.
