**COAL COMBUSTION RESIDUALS
STRUCTURAL STABILITY ASSESSMENT**

**VIRGINIA ELECTRIC AND POWER COMPANY
CHESTERFIELD POWER STATION
LOWER ASH POND
CHESTERFIELD COUNTY, VIRGINIA**

MV1373
October 2016

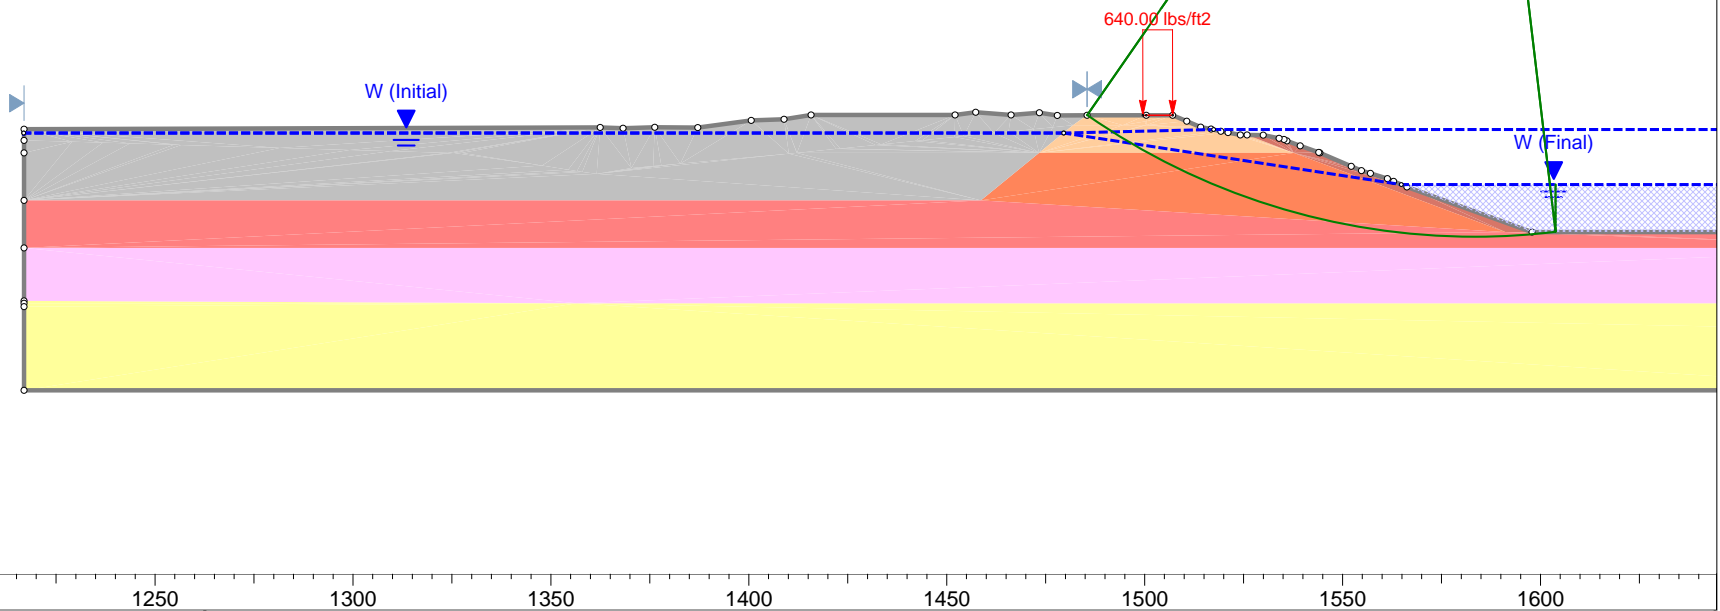
Project				Chesterfield Power Station - Lower Ash Pond			
Analysis Description				Cross Section E - Rapid Drawdown			
Drawn By		CL		Scale		1:582	
Date		09/29/2016		Company		Geosyntec Consultants	
				File Name		Cross Section E - Rapid drawdown.slim

The downstream slopes of the embankment on the southwestern side of the LAP are bordered by an old channel of the James River that is currently a backwater area called Farrar Gut. Rapid drawdown of Farrar Gut is not anticipated during normal conditions; however, rapid drawdown may occur after a flood event. A rapid drawdown stability assessment was conducted on the LAP embankment facing Farrar Gut and the results are included in Appendix A. In order to determine the maximum water surface elevation at which the rapid drawdown would commence a hydraulic model of a 100-year flood event was conducted (Geosyntec, 2016d). The maximum water surface elevation was estimated to be 15.9 feet. The minimum allowable factor of safety for a rapid drawdown condition is 1.2 (USACOE, 2003). With a starting water surface elevation on the outside slope of the embankment of 15.9 feet, the minimum rapid drawdown factor of safety is 1.4 which is greater than the minimum allowable factor of safety.
