# Periodic Structural Stability Assessment

*Chesterfield Power Station CCR Surface Impoundment: Upper Ash Pond*

## **Golder Associates Inc.**

October 2021

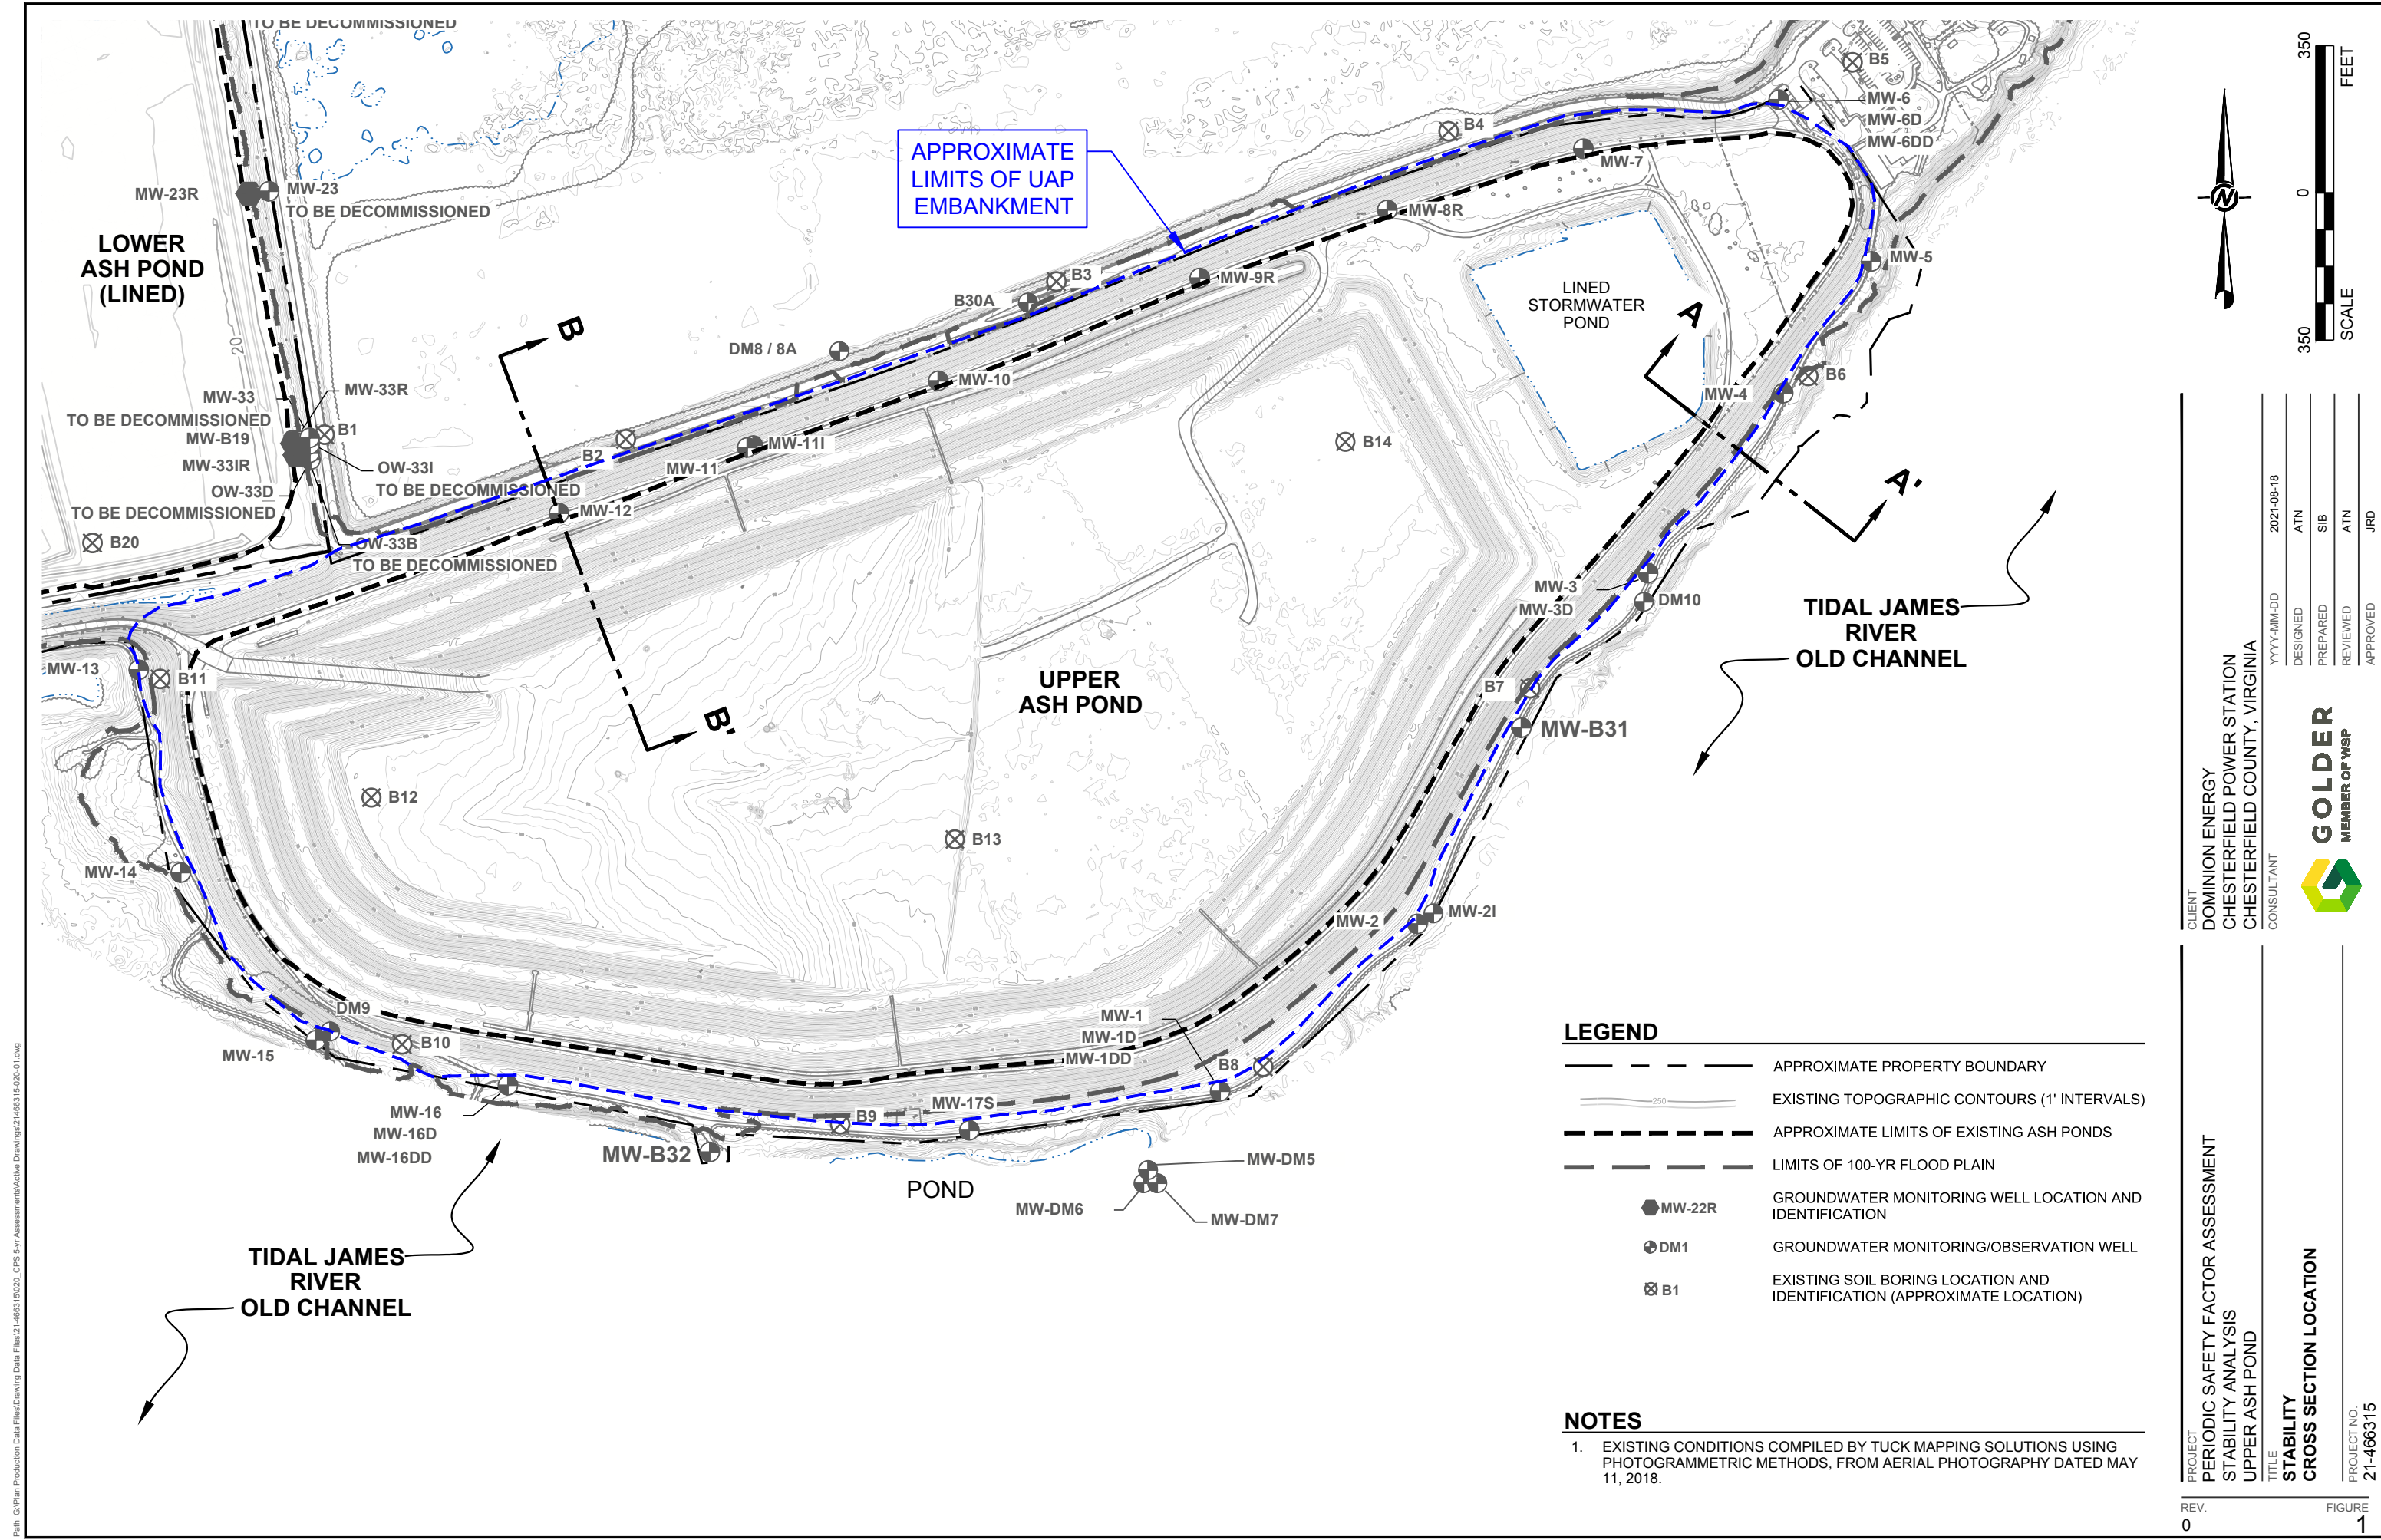
**Figure 1** - Stability Cross Section Location

The UAP sits within an artificial oxbow lake formed by the James River and a manmade channel. The embankment surrounding the UAP is subject to the 100-year flood event as defined by FEMA, with a flood elevation of 16 feet above mean sea level (ft-amsl). Golder states reliance on the accuracy of the rapid drawdown assessment performed by GAI for the 2016 Structural Stability Analysis. Golder performed an additional rapid drawdown assessment on the section outlined in the Safety Factor Assessment (Golder, 2021a). The target factor of safety for a rapid drawdown condition is 1.1 to 1.3 (USACE, 2003). The rapid drawdown factor of safety for cross section A, previously analyzed by GAI, through the stormwater sediment pond is 1.55 (GAI, 2016a), and the rapid drawdown factor of safety for cross section B, analyzed by Golder, through the maximum CCR height is 1.33. Both of these factors of safety exceed the requirement for a rapid drawdown condition. The locations of the cross sections analyzed for rapid drawdown are included in Figure 1, and calculations for the rapid drawdown assessment are included in Appendix A.

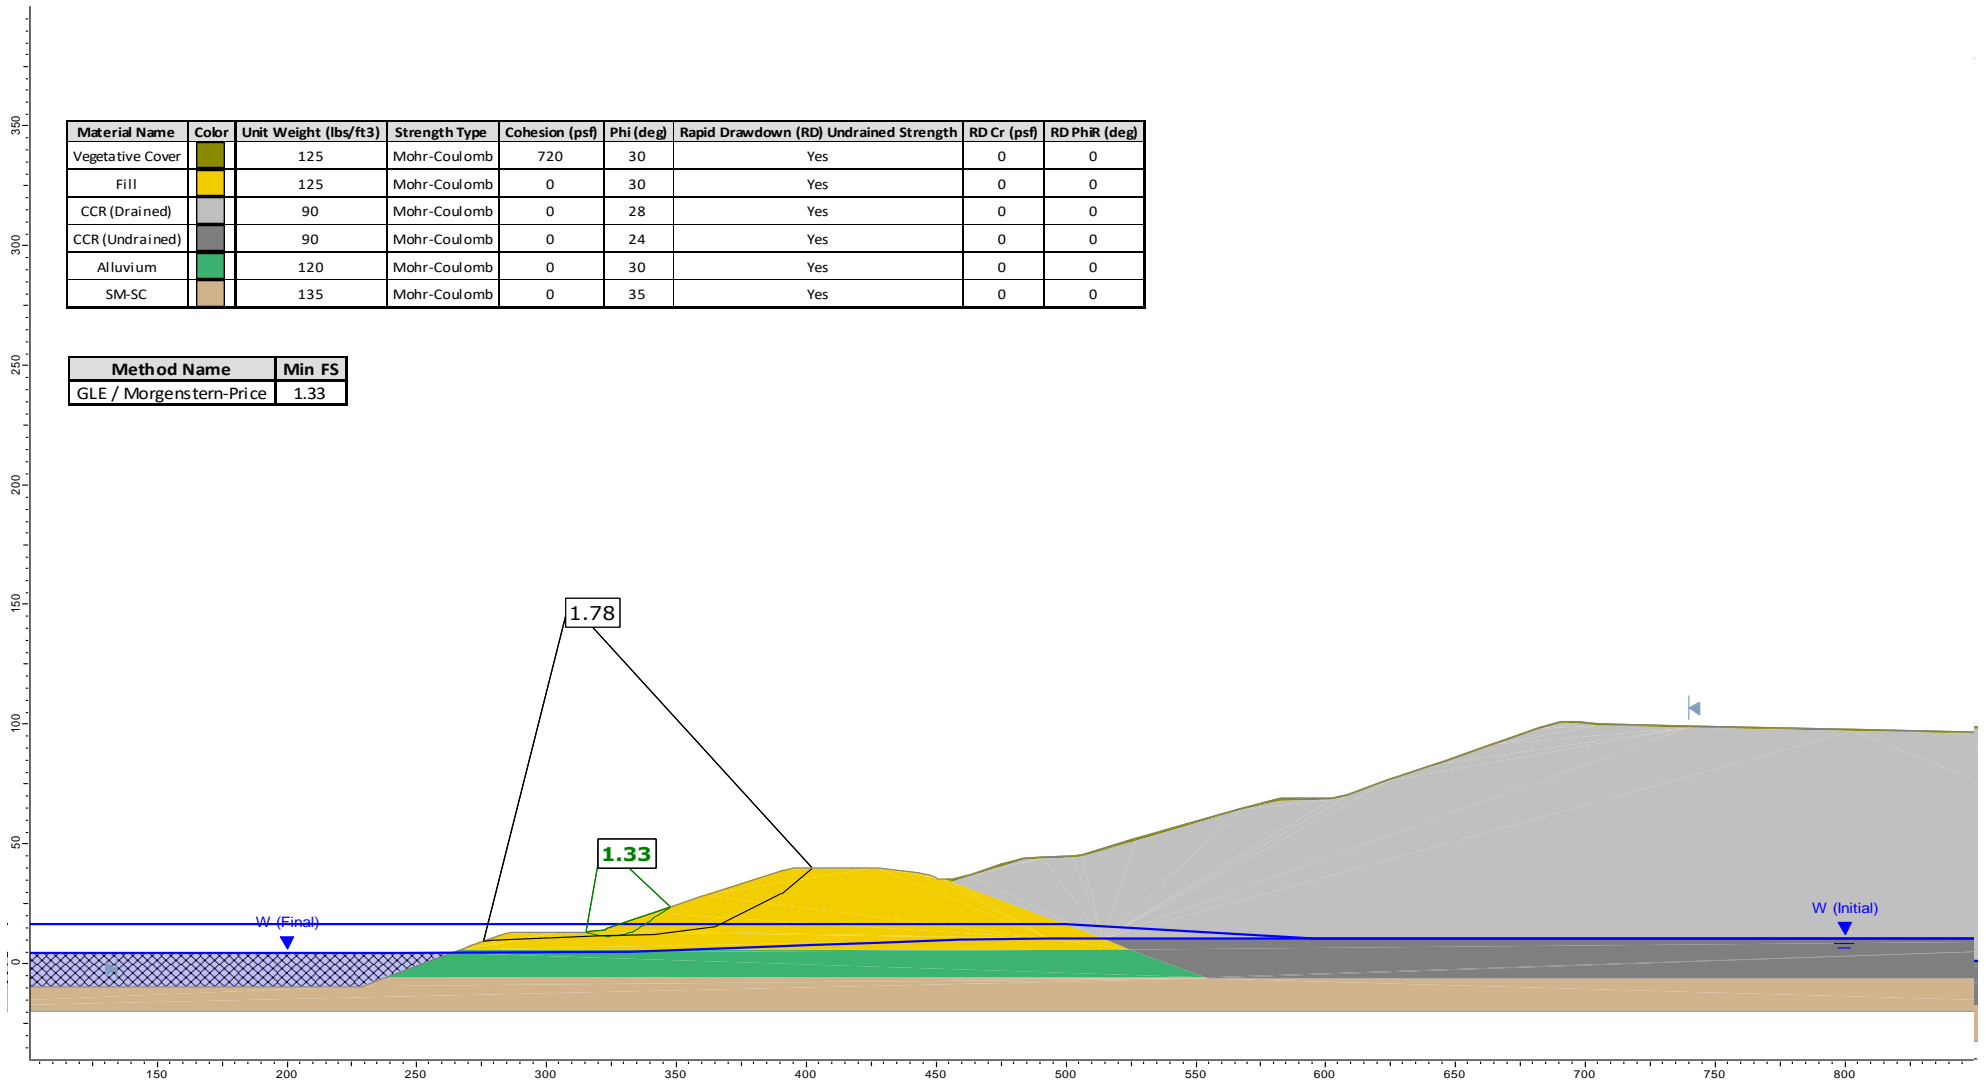
# Cross Section B

Method Name	Min FS
GLE / Morgenstern-Price	1.33
