DOMINION ENERGY

# CORRECTIVE MEASURES REPORT

## POSSUM POINT POWER STATION INACTIVE CCR SURFACE IMPOUNDMENT: PONDS ABC

AUGUST 2024

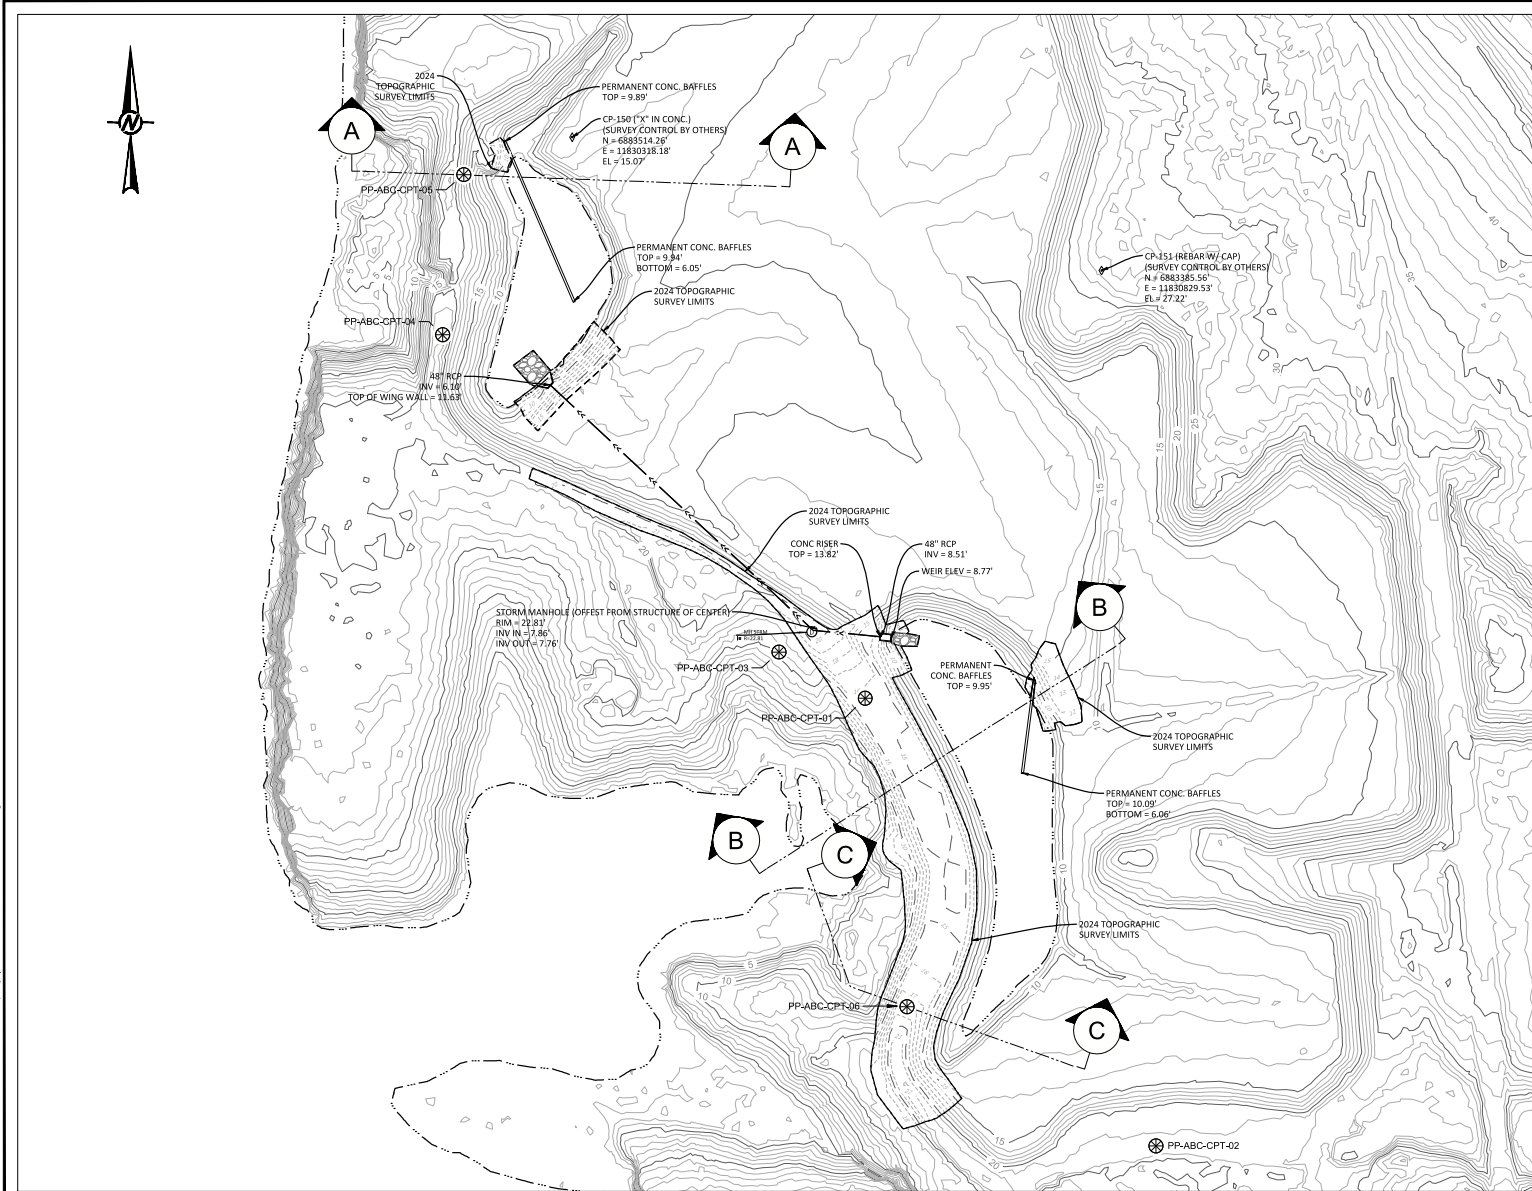
**DOMINION ENERGY - POSSUM POINT**  
**REVISED TOPOGRAPHY JULY 2024**  
**SAFETY FACTOR ASSESSMENT - POND ABC PLAN VIEW**  
**FIGURE 2**

As part of ongoing work associated with the closure of the CCR ponds, a water treatment system is currently being constructed in the Ponds ABC footprint. In conjunction with the Site Plan application and subsequent Land Disturbance Permit obtained from Prince William County for that work, Dominion Energy included the regrading of the southeastern area of the berm as a corrective measure to meet the required safety factors. The specific corrective measure entailed decreasing the height of the berm to produce a more moderate slope on both the interior and exterior of the berm in the Section C-C' area (approximately 2H:1V on the inside slope and 4:1 on the exterior). Figure 2 in Appendix A shows the regraded berm design contours.

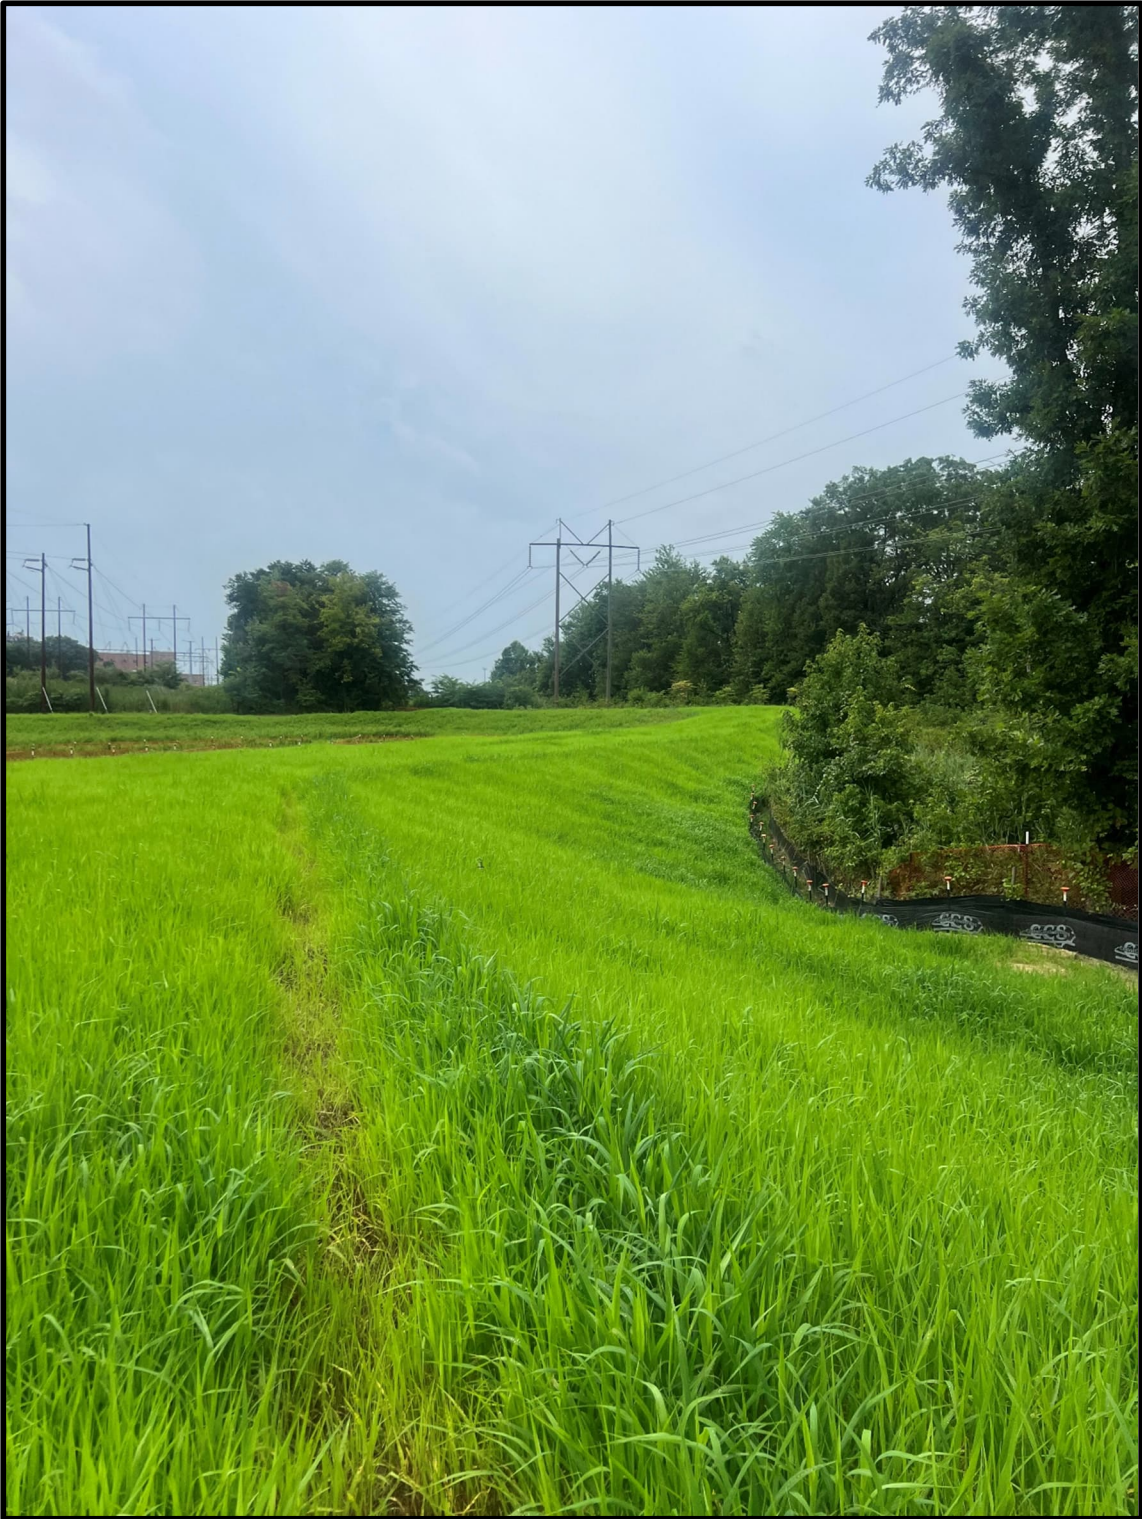
Photo 1 - Ponds ABC Repairs Looking South towards Sections B-B' and C-C'

Dominion Energy retained Glover Construction Co., Inc. (Glover) to implement the corrective measures in the design plan described above. Glover cut down the berm to the design elevations, including reducing the height and increasing the width of the berm in this area resulting in an inside slope of approximately 2:1 and an exterior slope of approximately 4:1. The area was surveyed to produce the topographic plan view shown in Figure 2 (Appendix A) and verify that design grades were achieved. The berm was revegetated during a period of frequent rain, providing substantial grass coverage and therefore good erosion control.

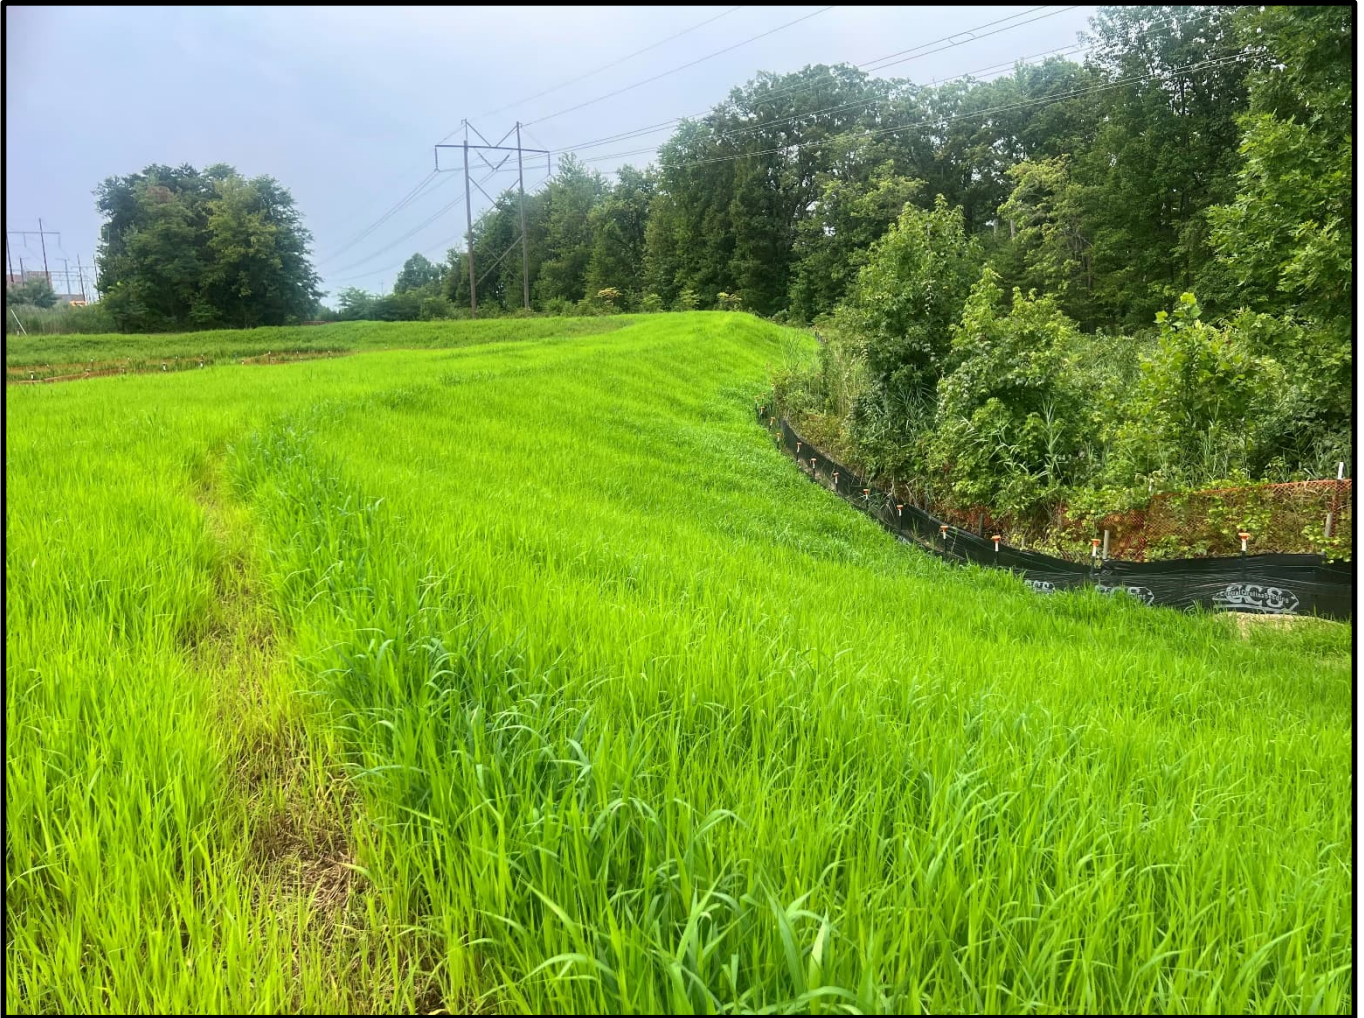
Photo 2 - Ponds ABC Repairs Looking South adjacent to Section C-C'

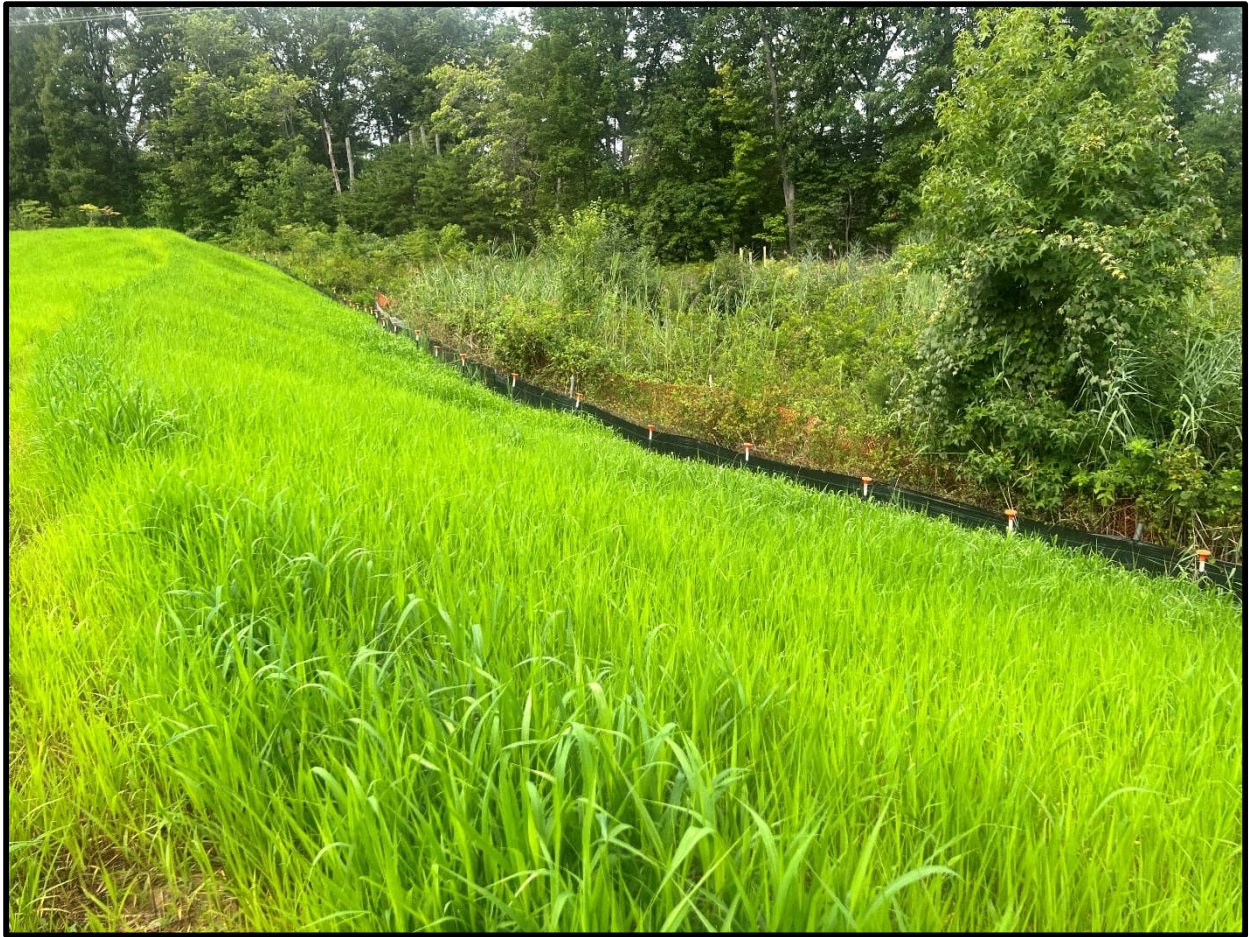
Photo 3 - Ponds ABC Repairs Looking South-Southwest at Section C-C'

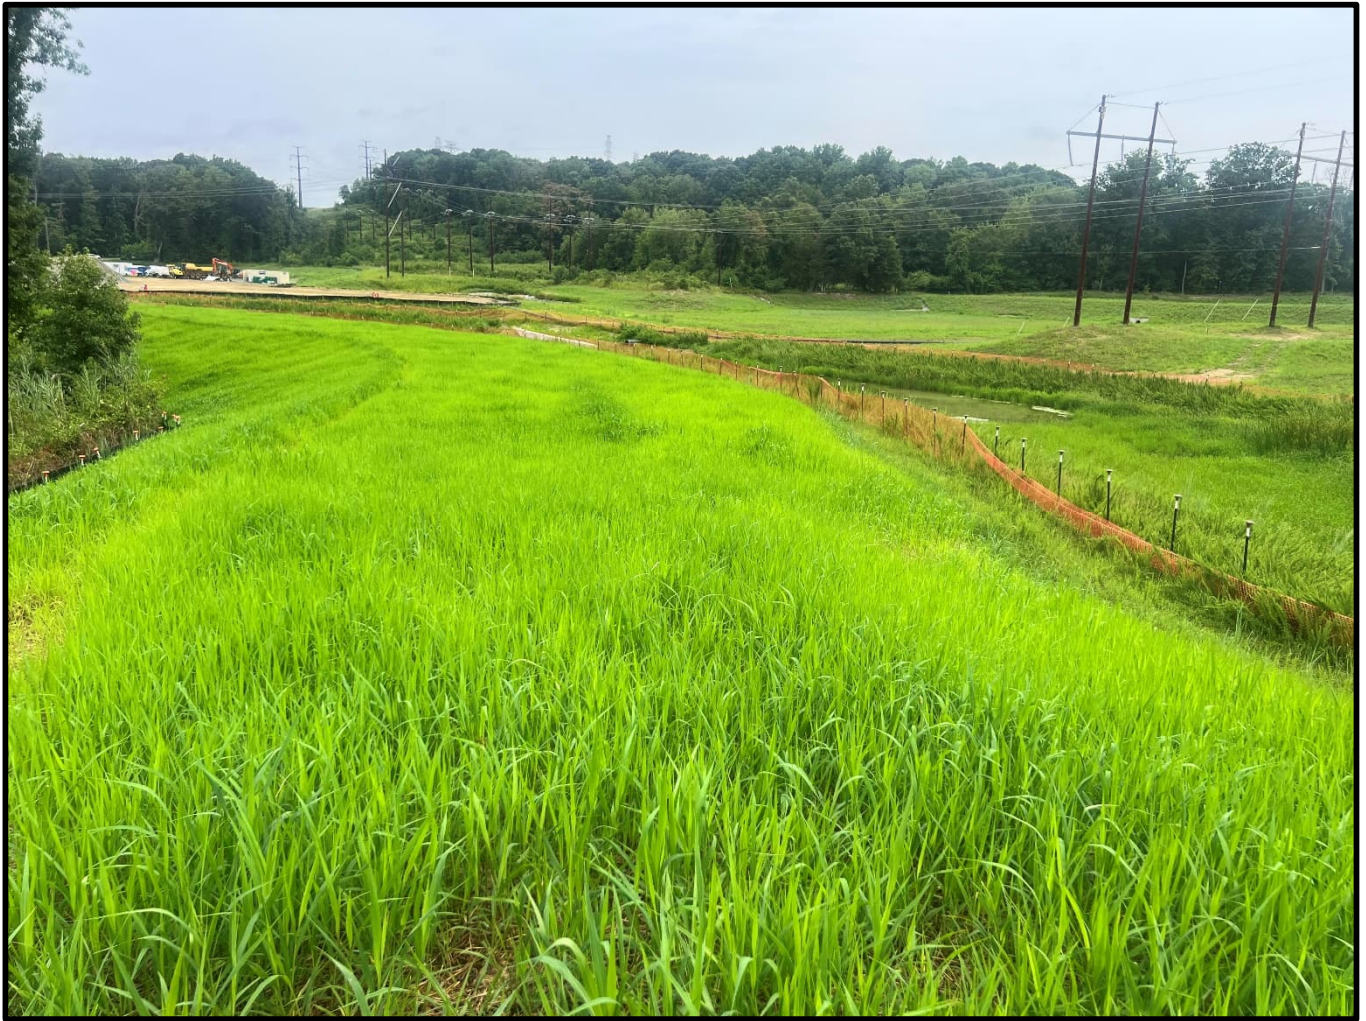
Photo 4 - Ponds ABC Repairs Looking North towards Sections C-C' and B-B'

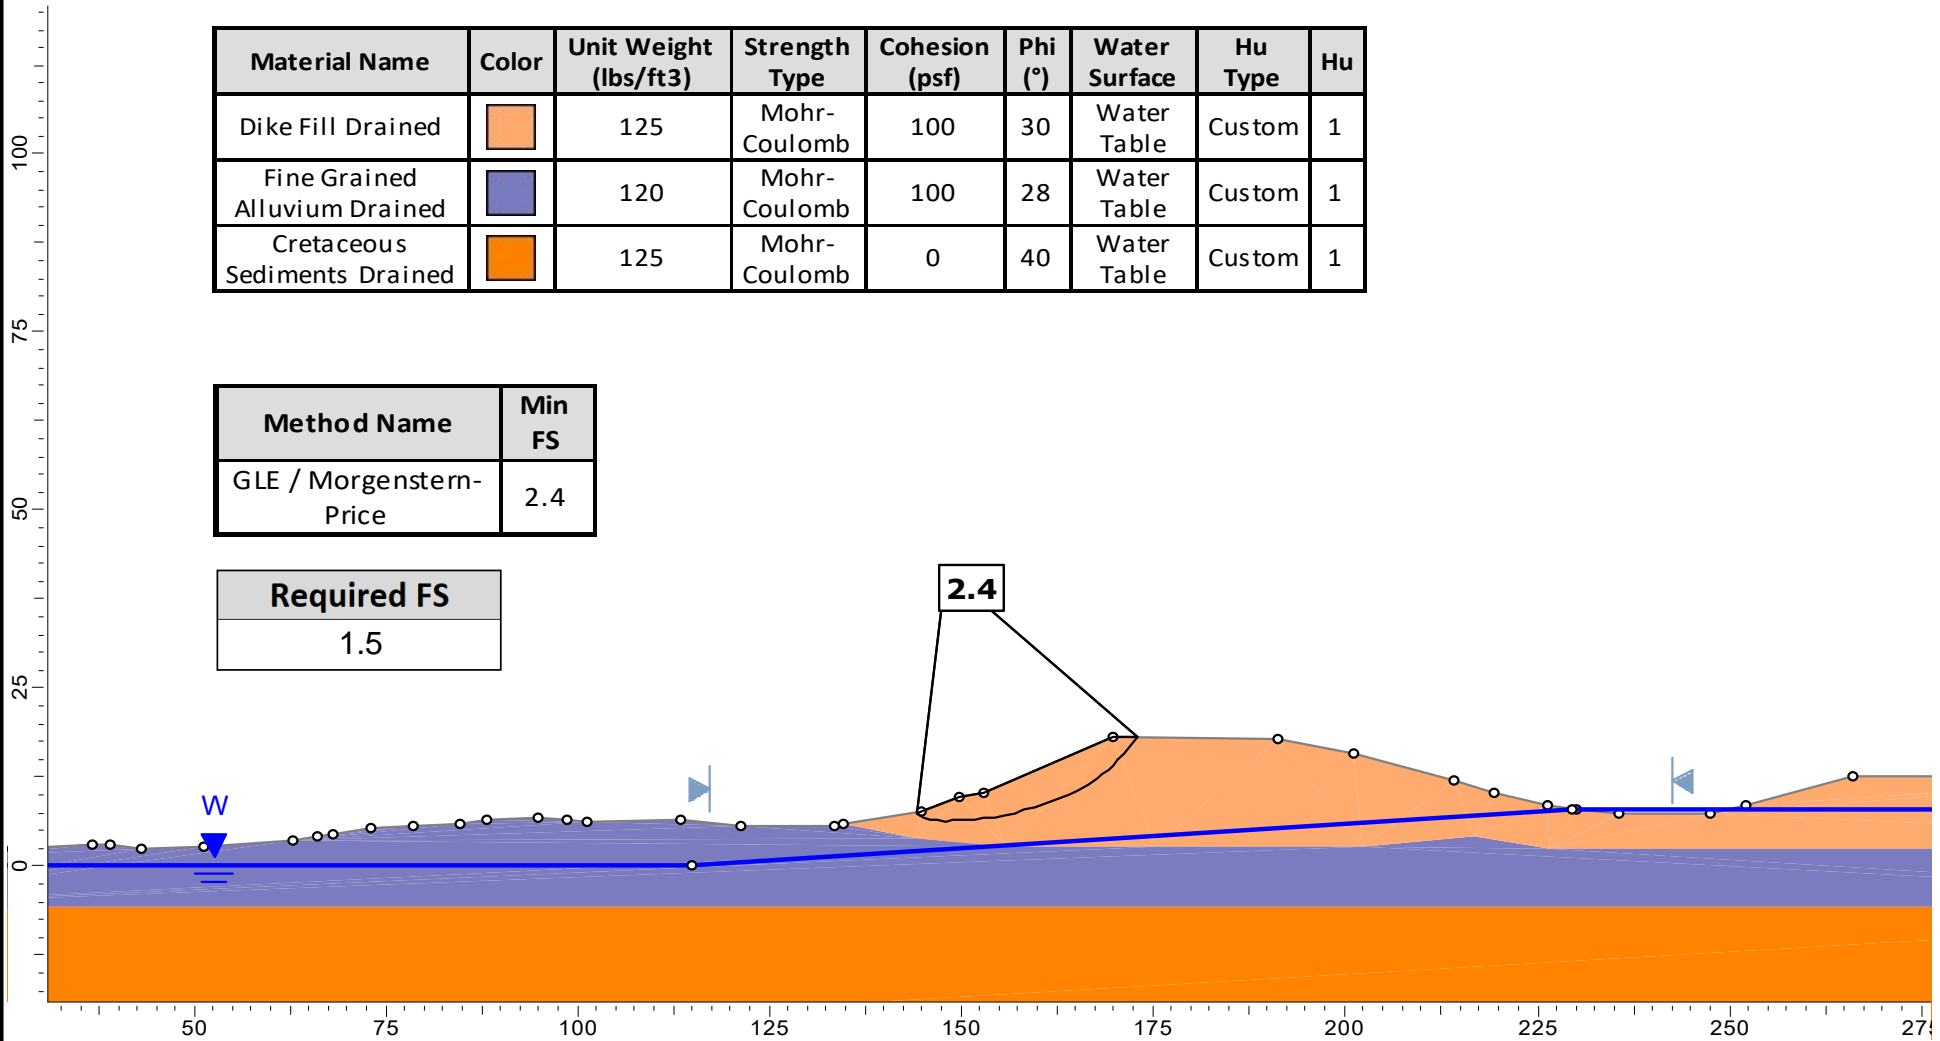
FIGURE **4(a)**

Following the implementation of the corrective measures described in Section 3, the factors of safety for Cross-Section C-C' were recalculated using the same methodology as described in the 2023 Safety Factor Assessment. The revised July 2024 calculated factors of safety are provided in Table 2 and the stability analysis figures are included in Appendix C.

Method Name	Min FS
GLE / Morgenstern-Price	2.4

Required FS
1.5

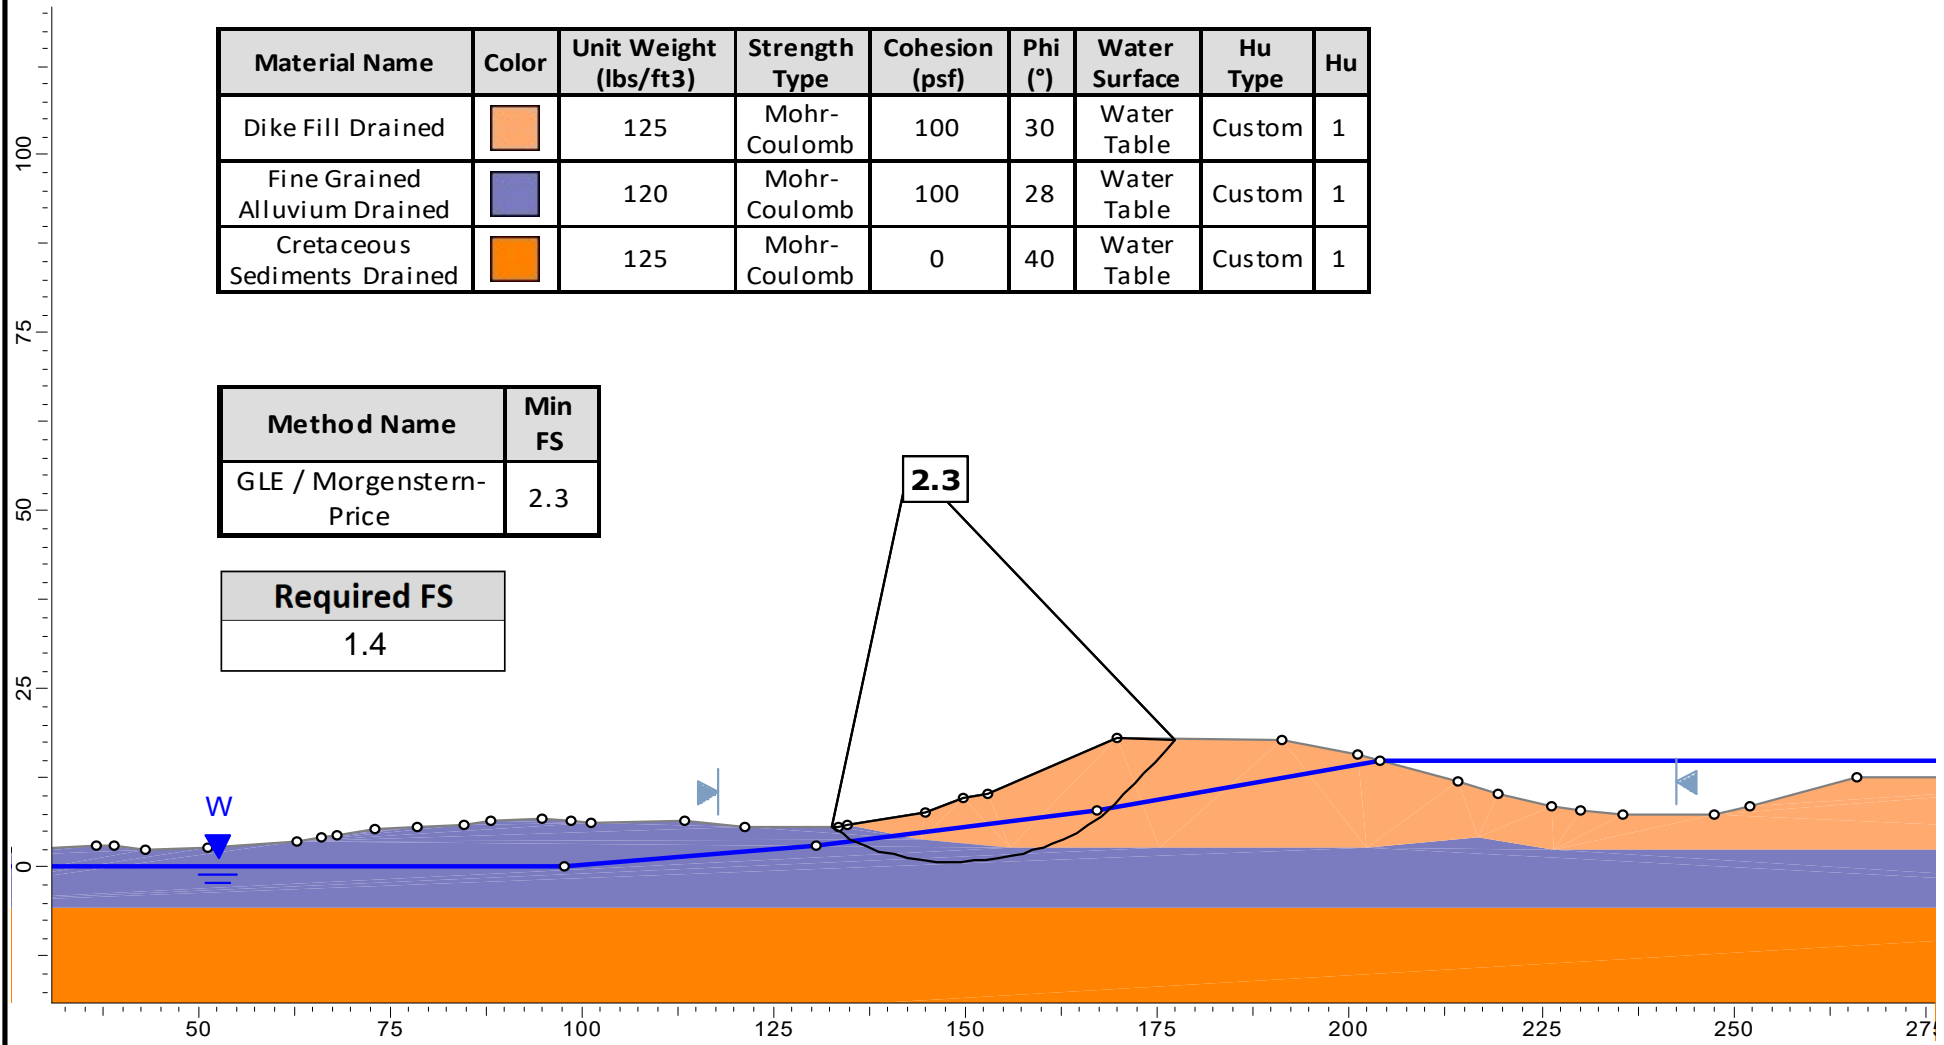
Method Name	Min FS
GLE / Morgenstern-Price	2.3

Required FS
1.4
