*Application of Virginia Electric and Power Company for  
approval and certification of electric transmission facilities:  
Lines #2019 and #2007 Rebuild Project*  
**Case No. PUR-2023-00023**

**Application, Appendix,  
DEQ Supplement, Direct  
Testimony and Exhibits of  
Virginia Electric and Power  
Company**

**Lines #2019 and #2007 Rebuild  
Project**

**Case No. PUR-2023-00023**

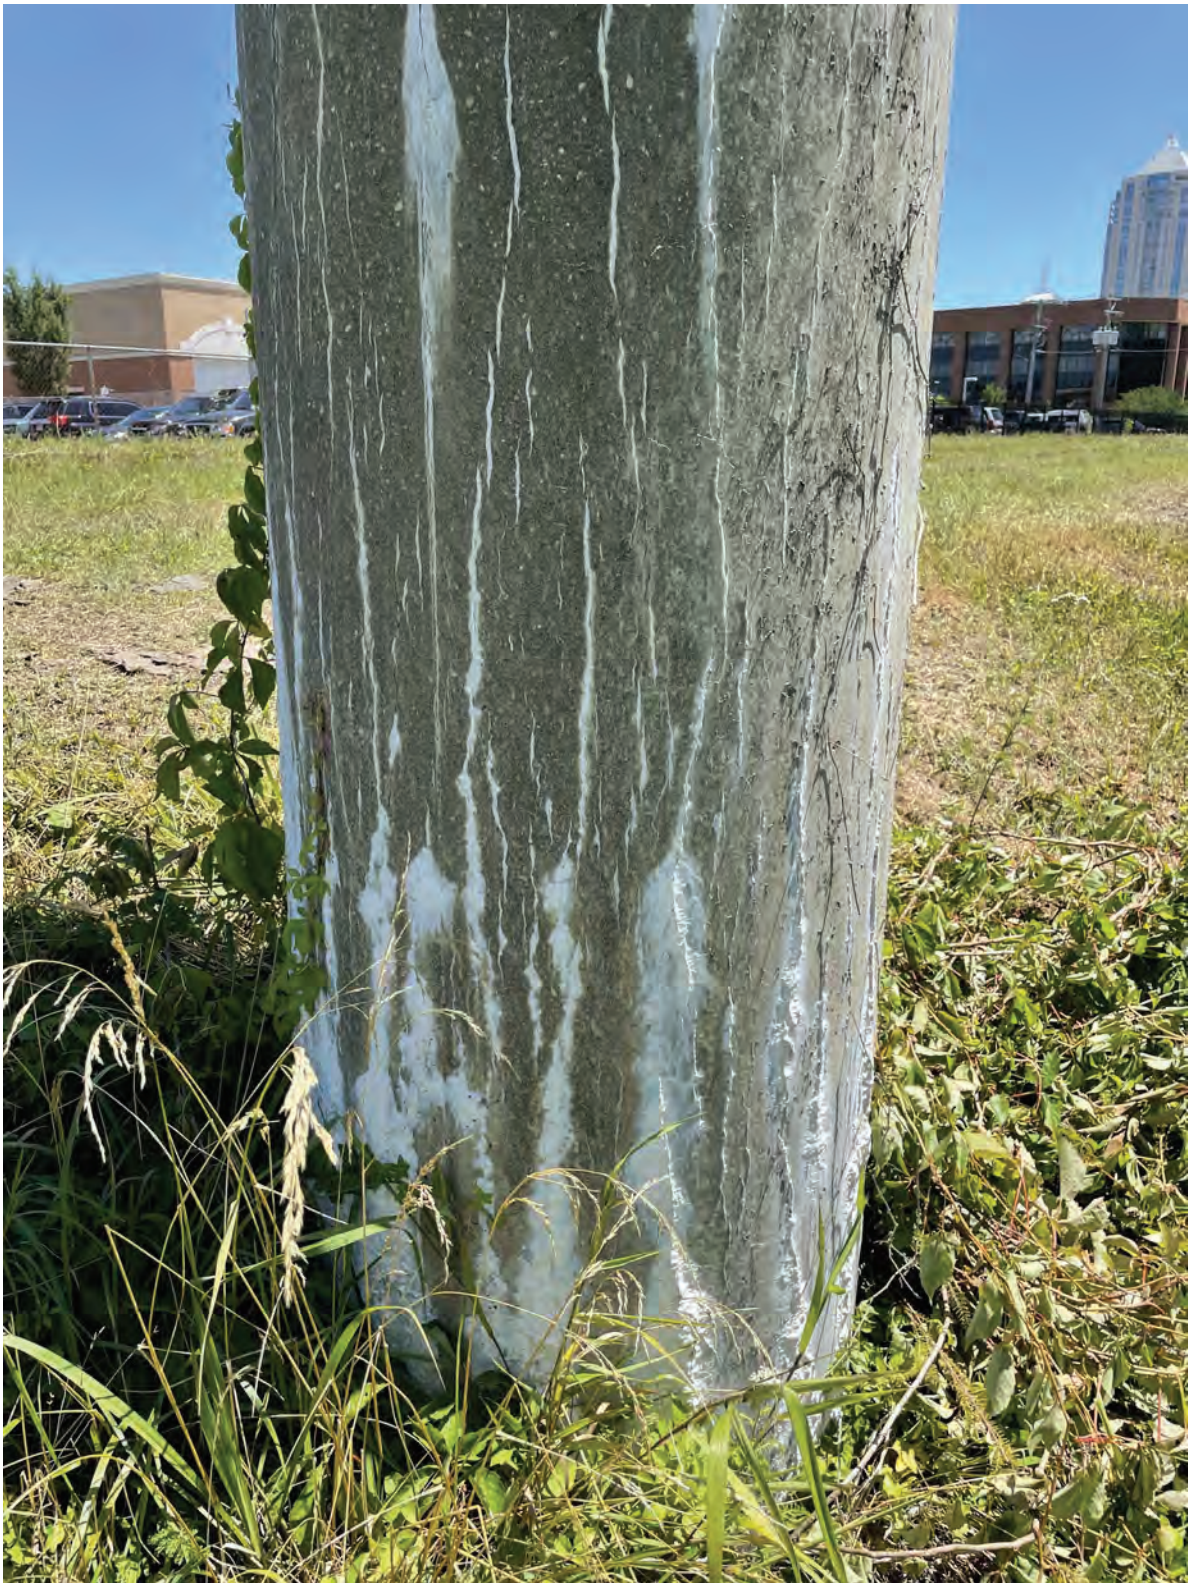
**Structure #2019/32**

Hairline cracking with efflorescence near the base of the pole.  
This is typical of most poles in the corridor.

**Deterioration Type:**  
**Hairline Cracking with Efflorescence**

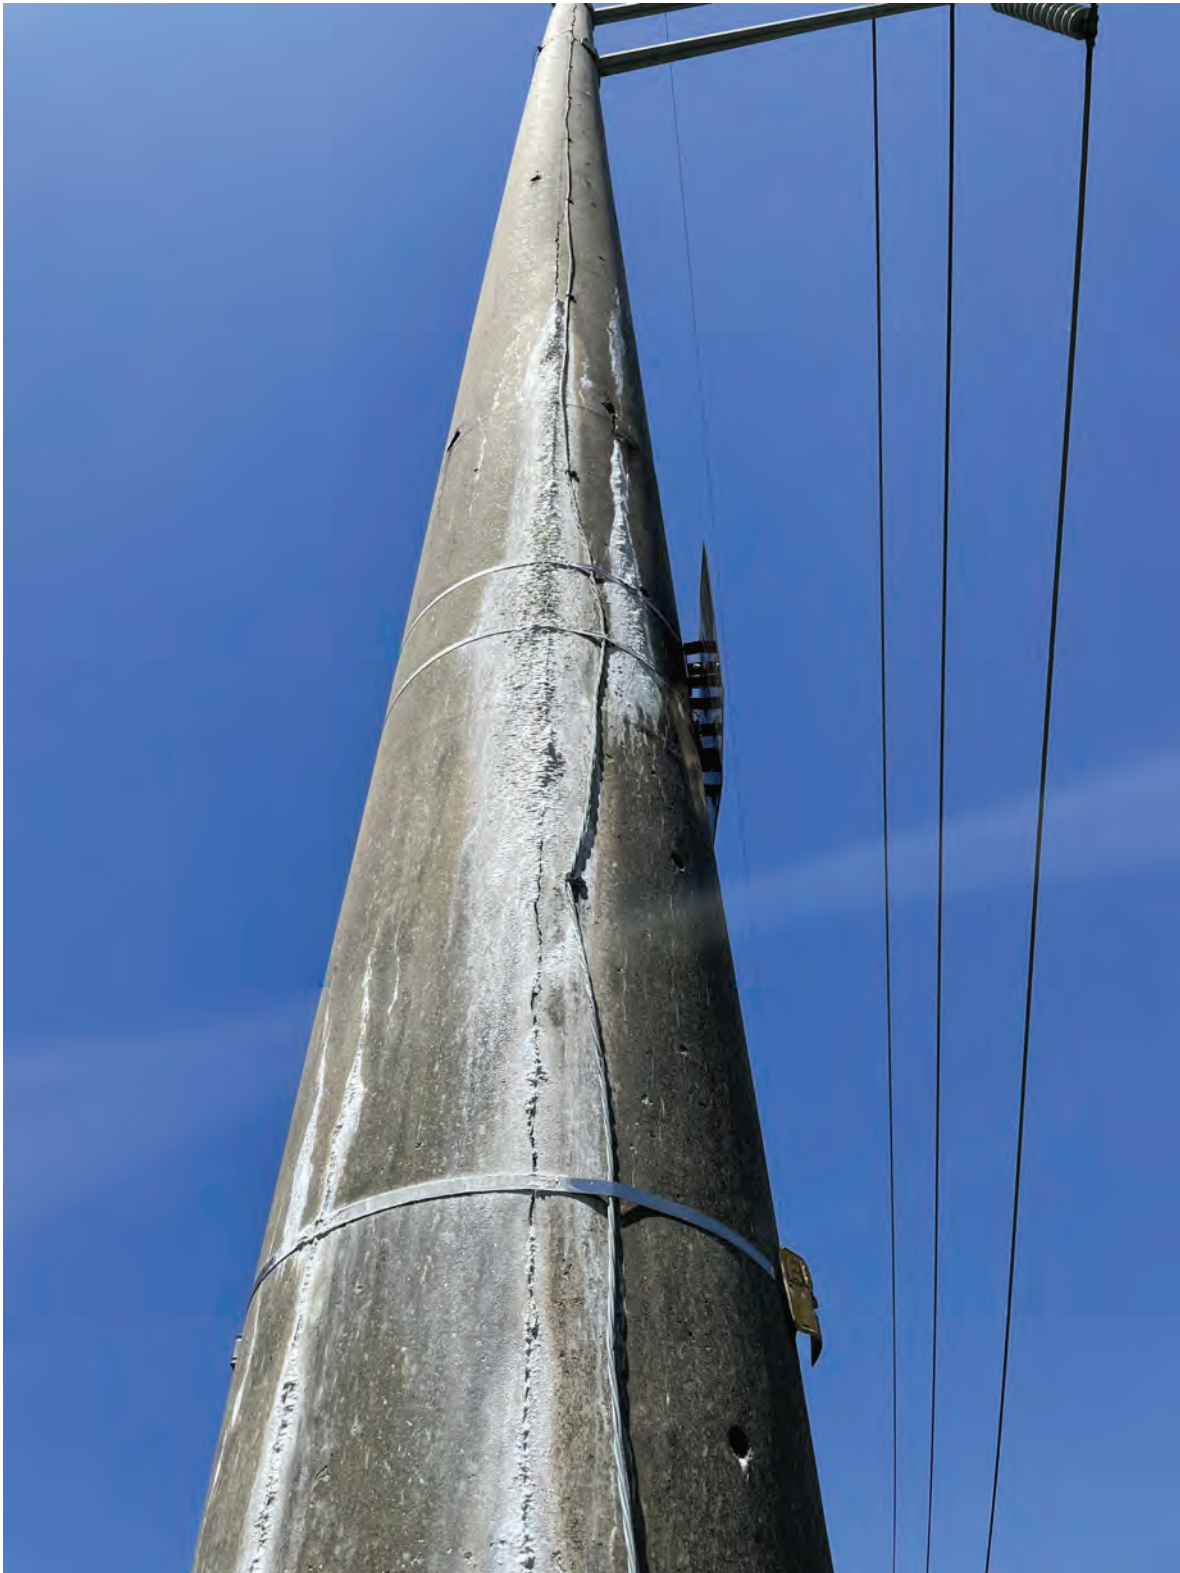
**Structure #2019/34**

Substantial cracking with efflorescence continues approx. 15-20 FT above the base of the pole

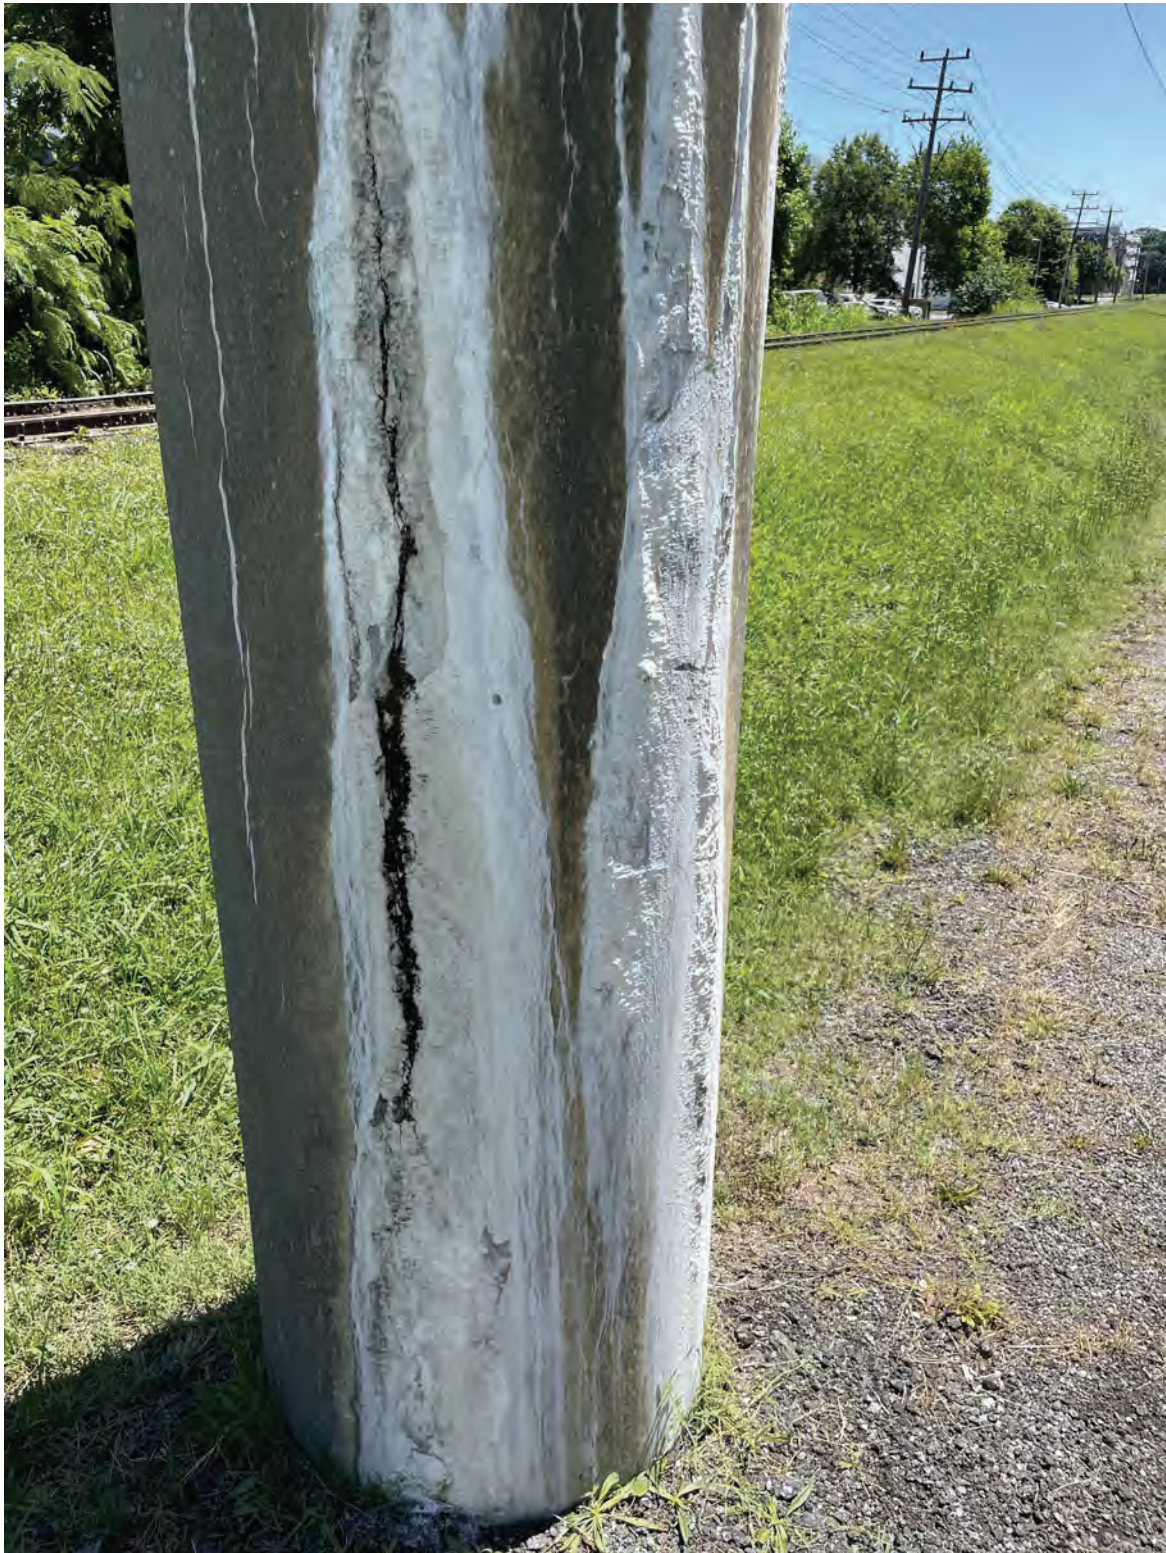
**Structure #2019/35**

Substantial cracking with major efflorescence near the base of the pole

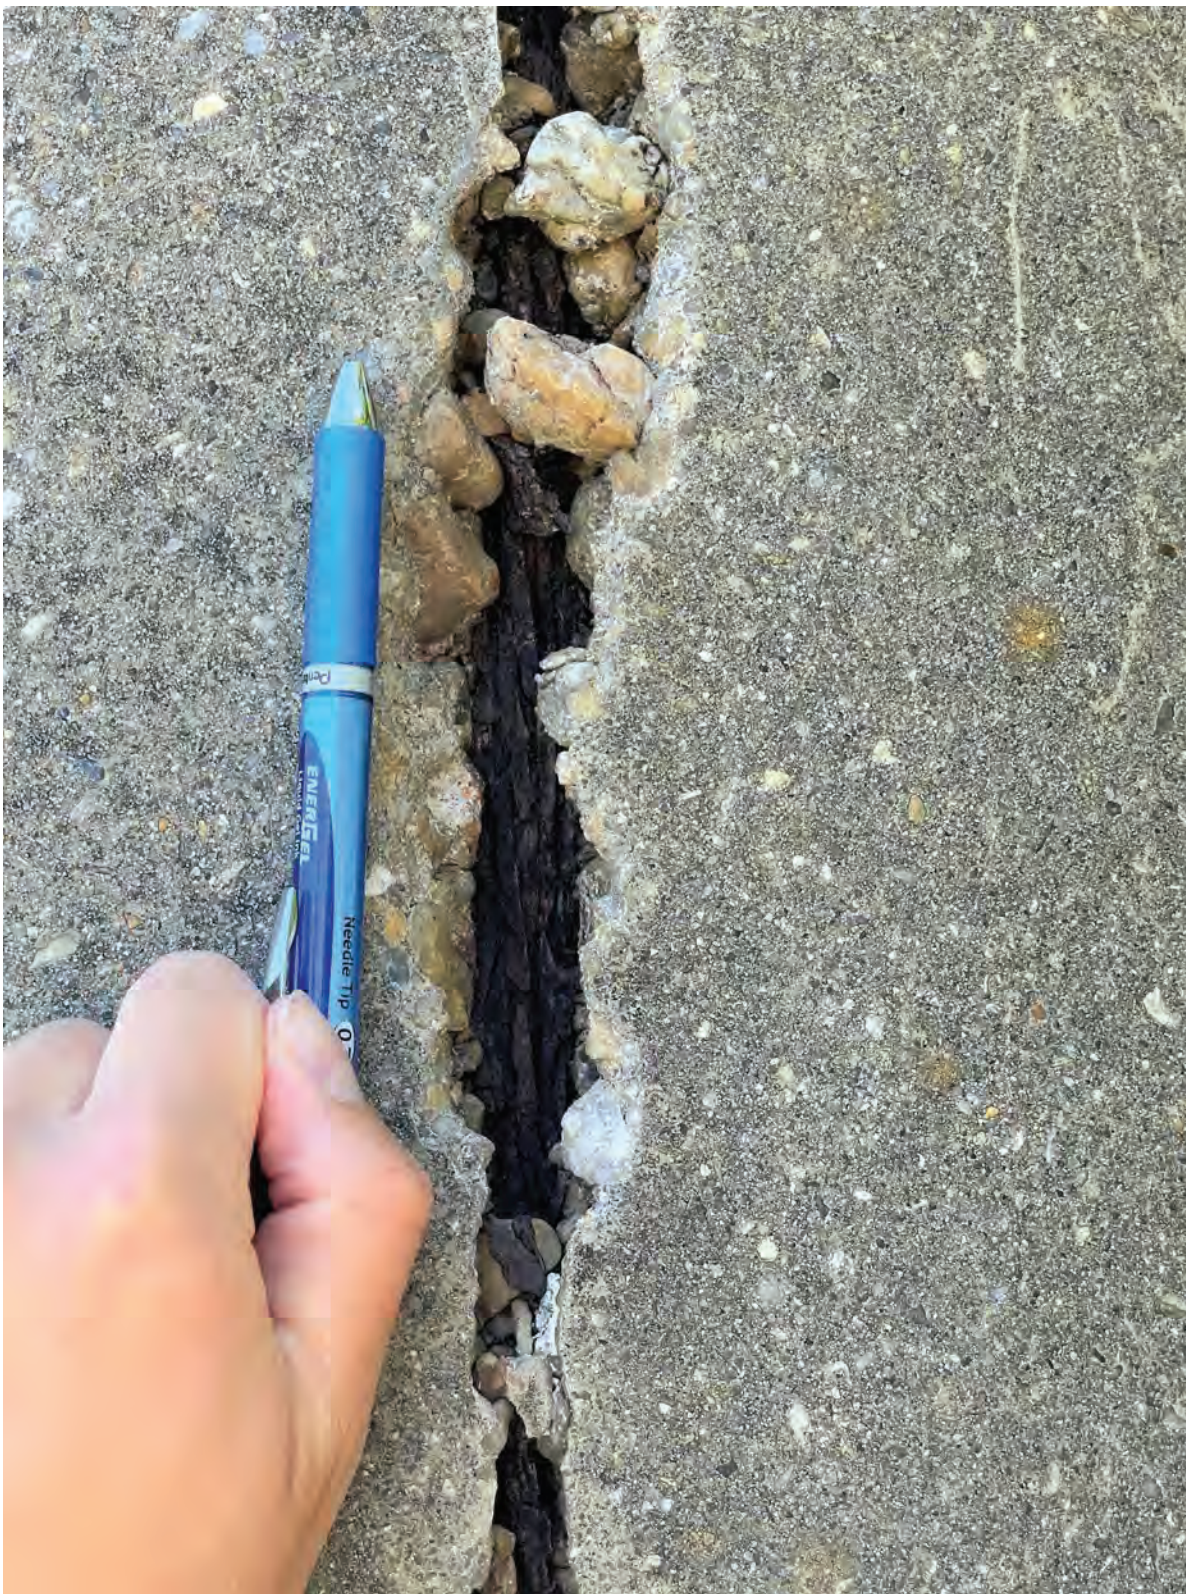
**Structure #2019/38**

Major cracking with exposed rebar near the base of the pole

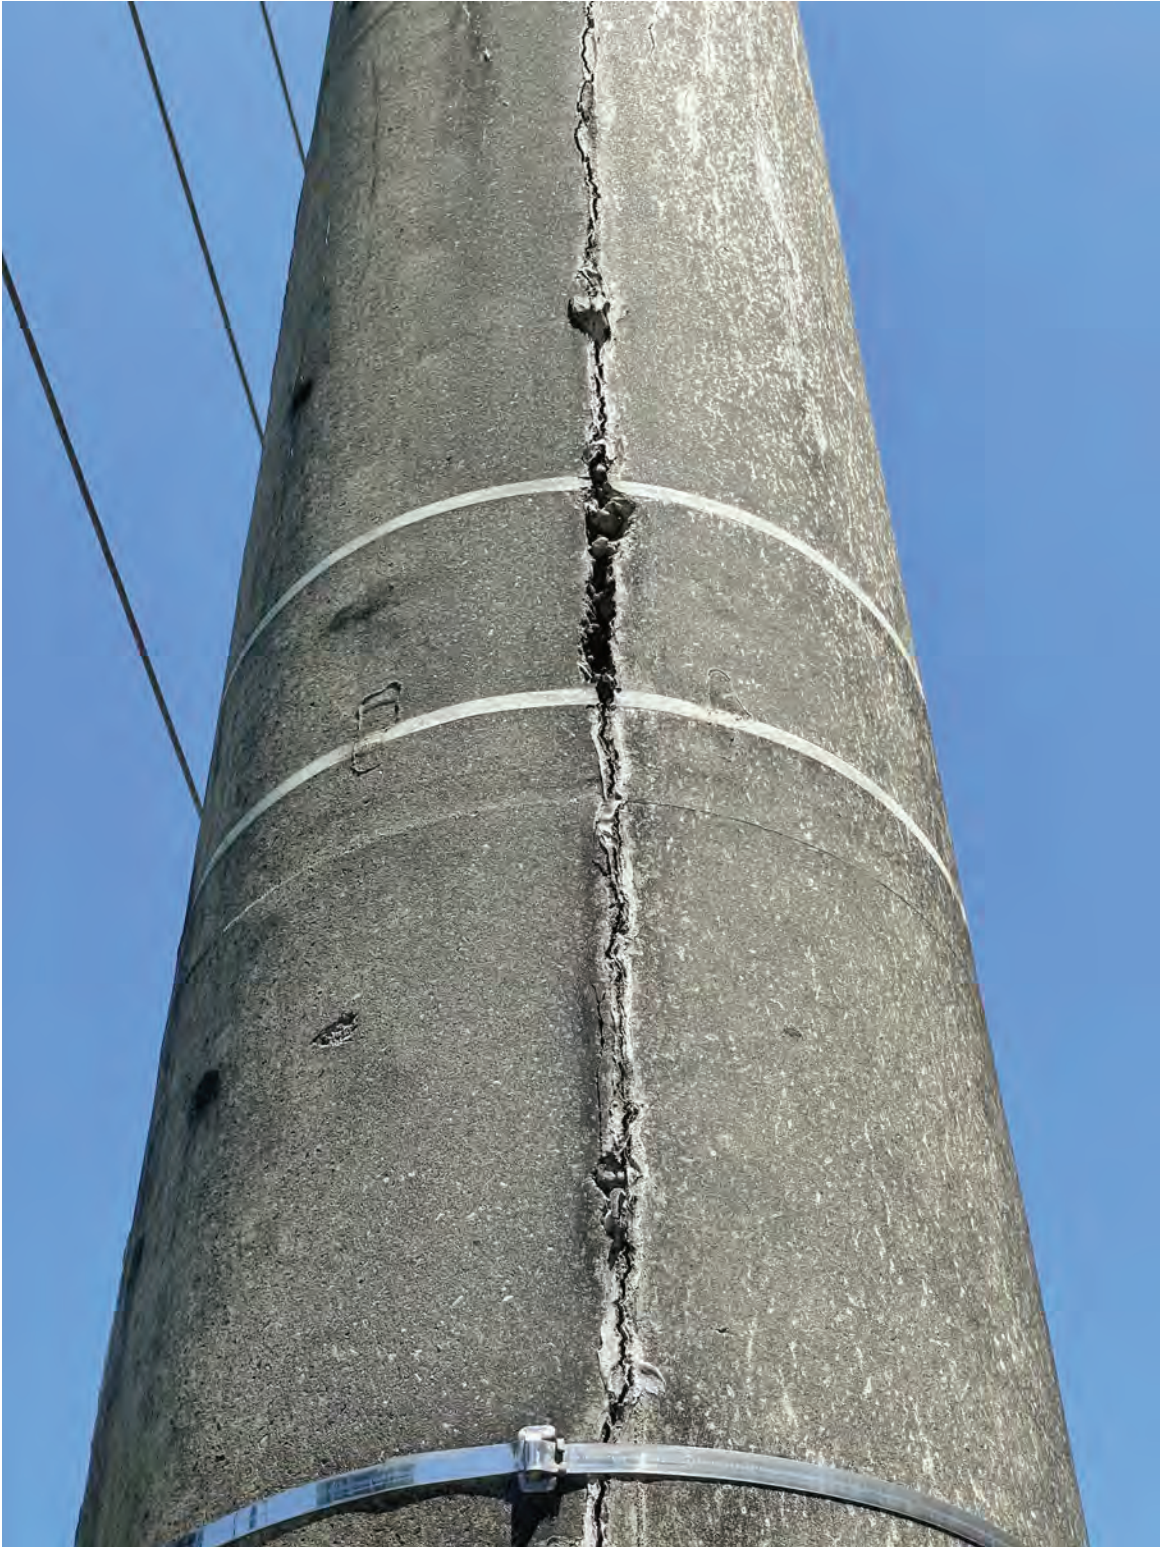
**Structure #2007/56**

Major cracking approx. 10 FT above the base of the pole

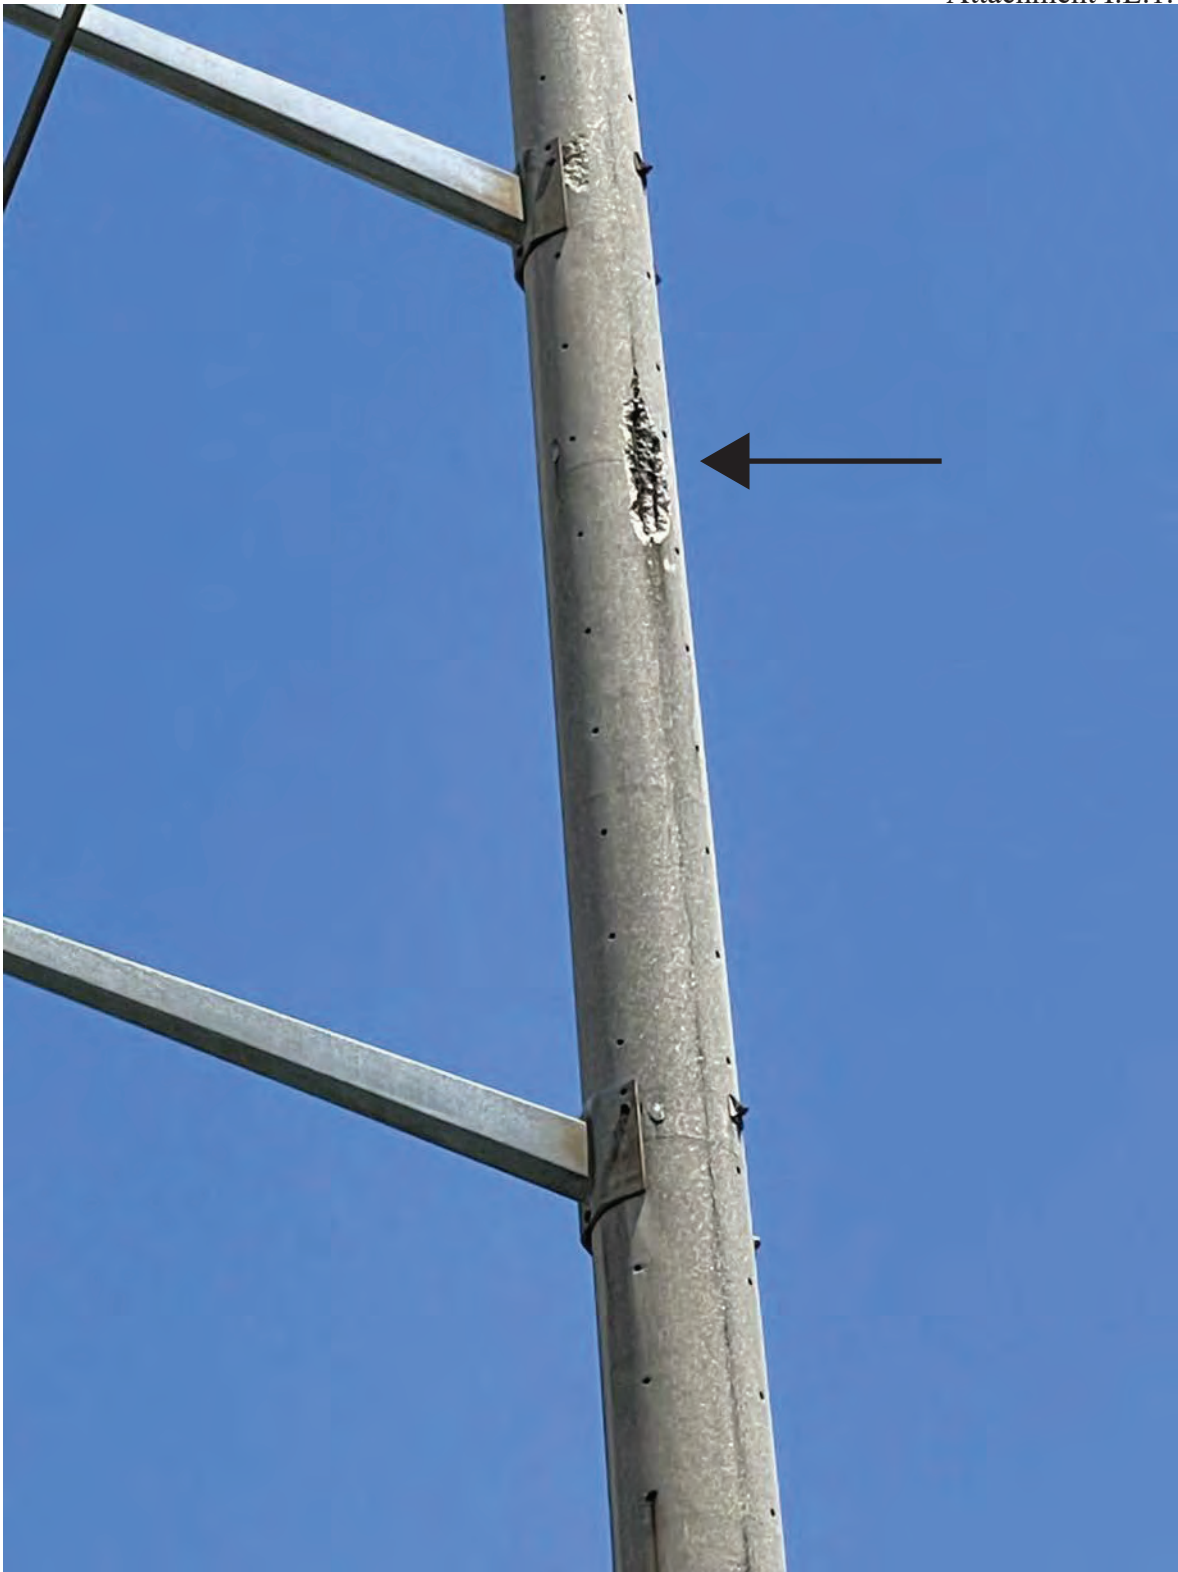
**Structure #2007/86**

Spalling has left rebar exposed and between lower and middle phases
