Application, Appendix, DEQ Supplement, Direct Testimony and Exhibits of Virginia Electric and Power Company

Lanexa-Northern Neck Line #224 230 kV Transmission Line Partial Rebuild Projects

Case No. PUR-2018-00090

Filed: June 18, 2018

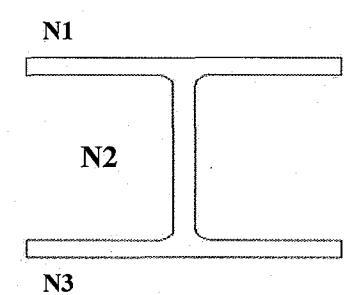
4 A PILE AND C PILE SHOW ONLY MODERATE SCALE.

4 B PILE HAS KNIFE EDGING BEGINNING 21" FROM CAP. 11" LONG AND UP TO 5/8" DEEP INTO THE FLANGE.

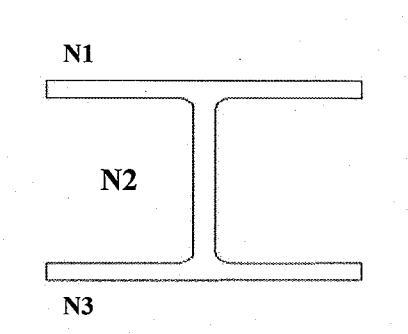
3 A, B AND C PILES SHOW ONLY MODERATE SCALE.

4 A, B AND C PILES SHOW ONLY MODERATE SCALE.
