DOMINION ENERGY

PERIODIC STRUCTURAL STABILITY ASSESSMENT

BREMO STATION INACTIVE CCR SURFACE IMPOUNDMENT: WEST POND

APRIL 2023

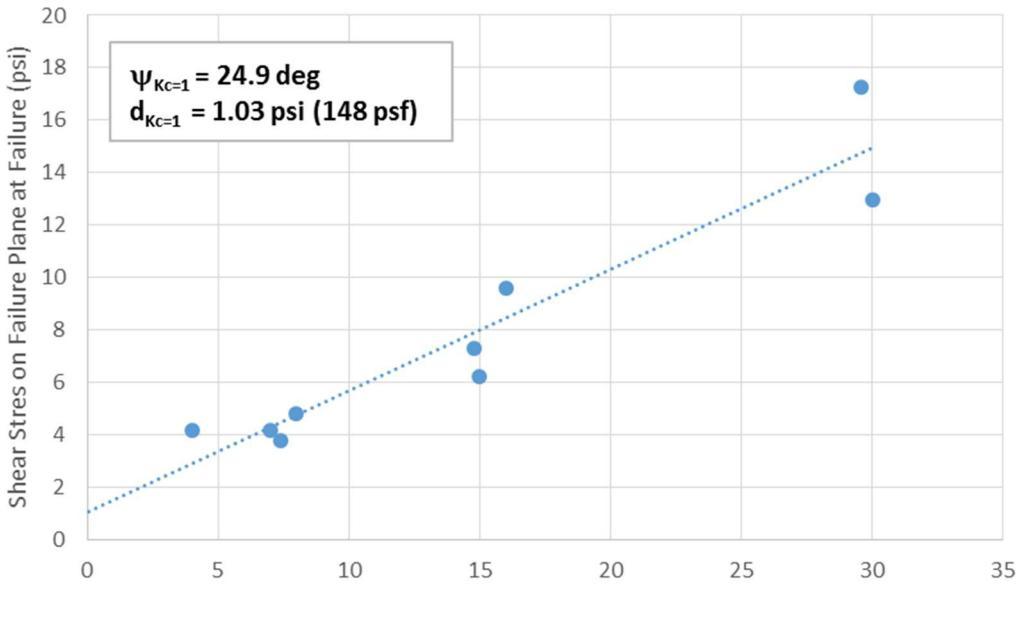
Figure 3. K_c = 1 Shear Strength Envelope for Rapid Drawdown Computations

Strength envelopes were developed for the undrained ($K_c = 1$) condition and the effective strength condition ($K_c = K_f$) by fitting lines to the data as shown in Figure 3 and 4, respectively.

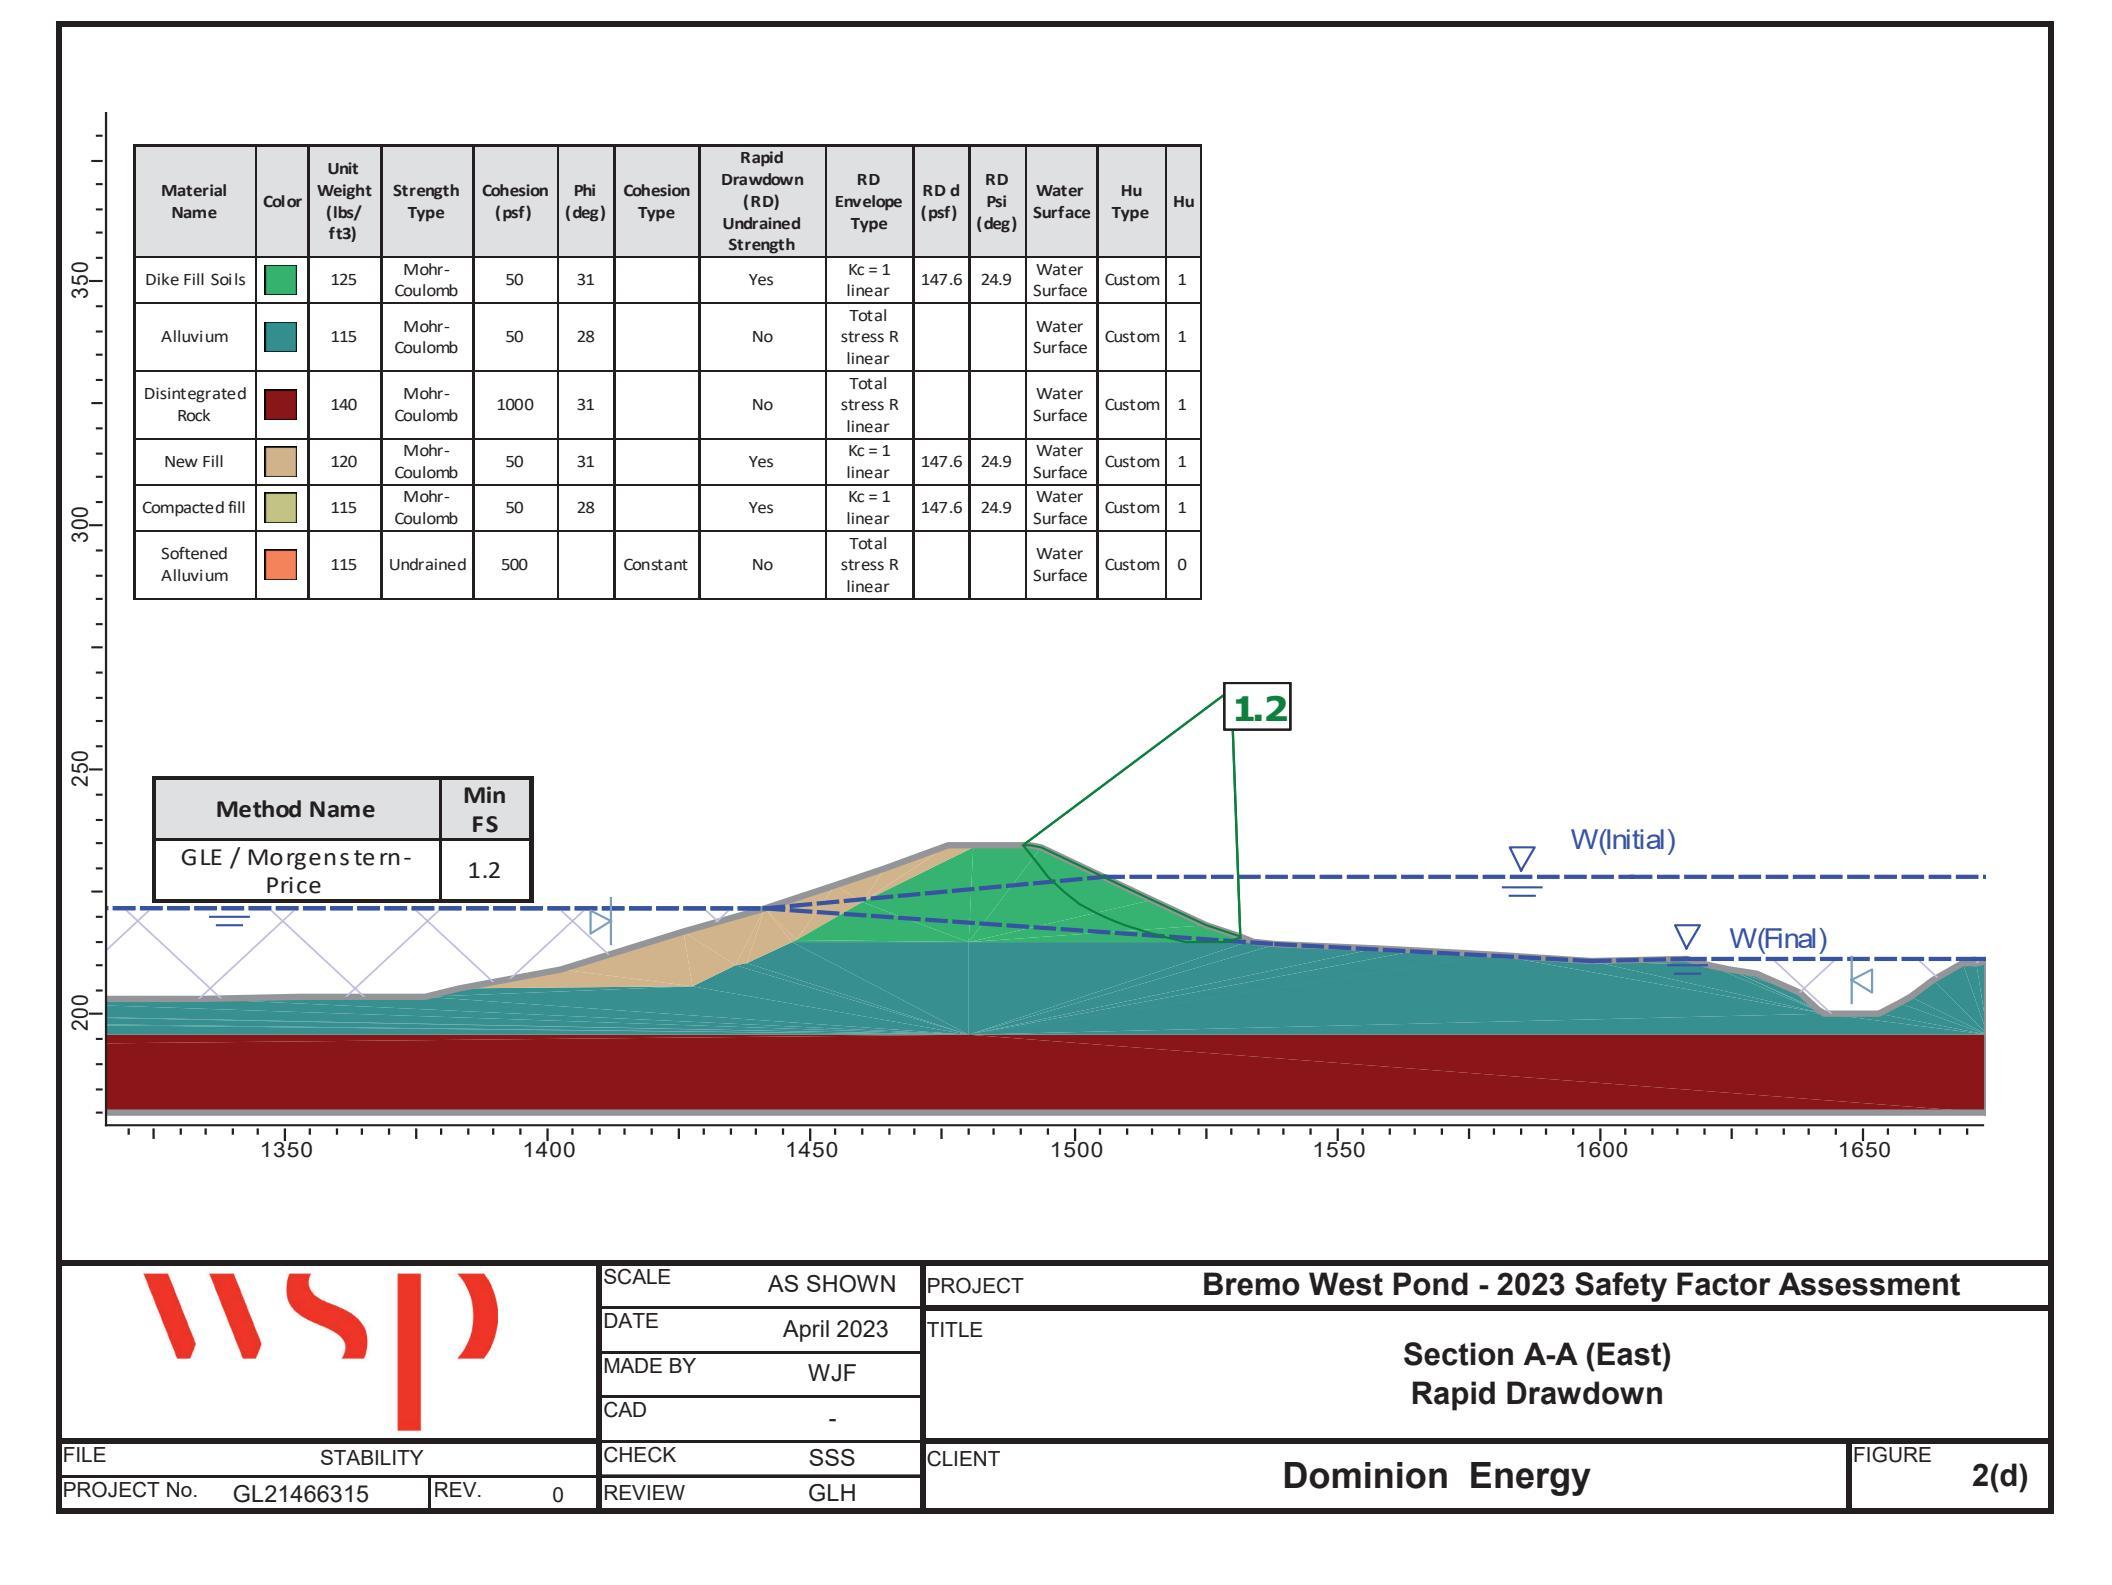
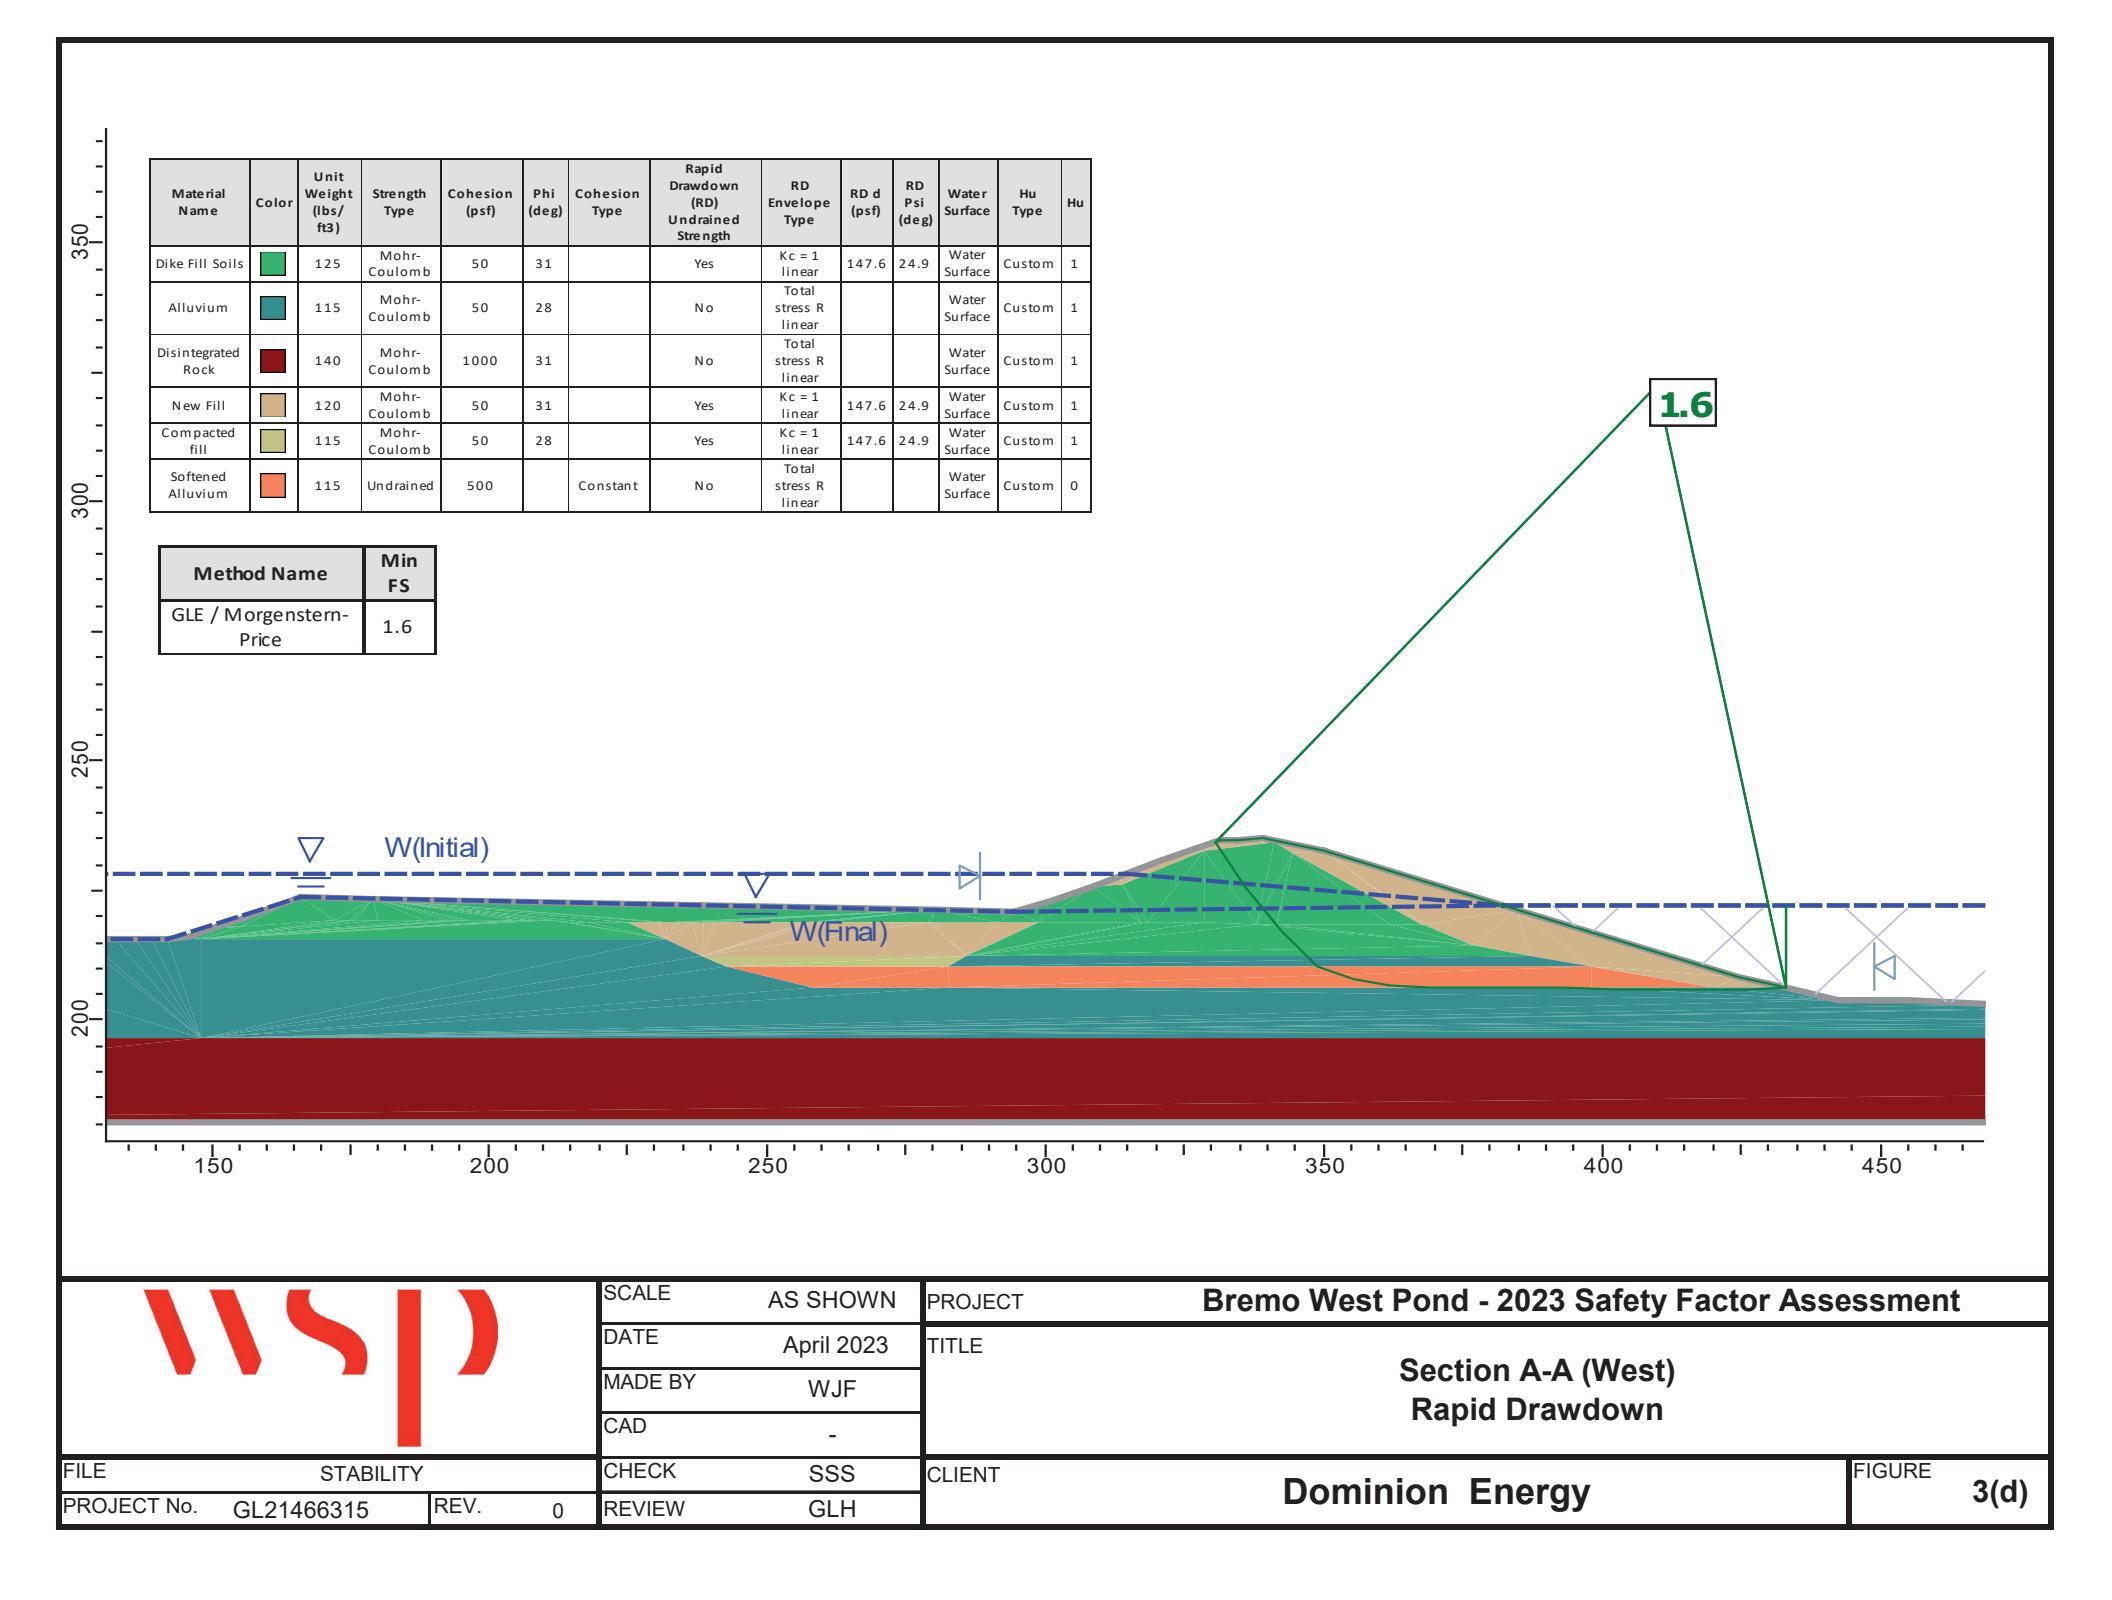
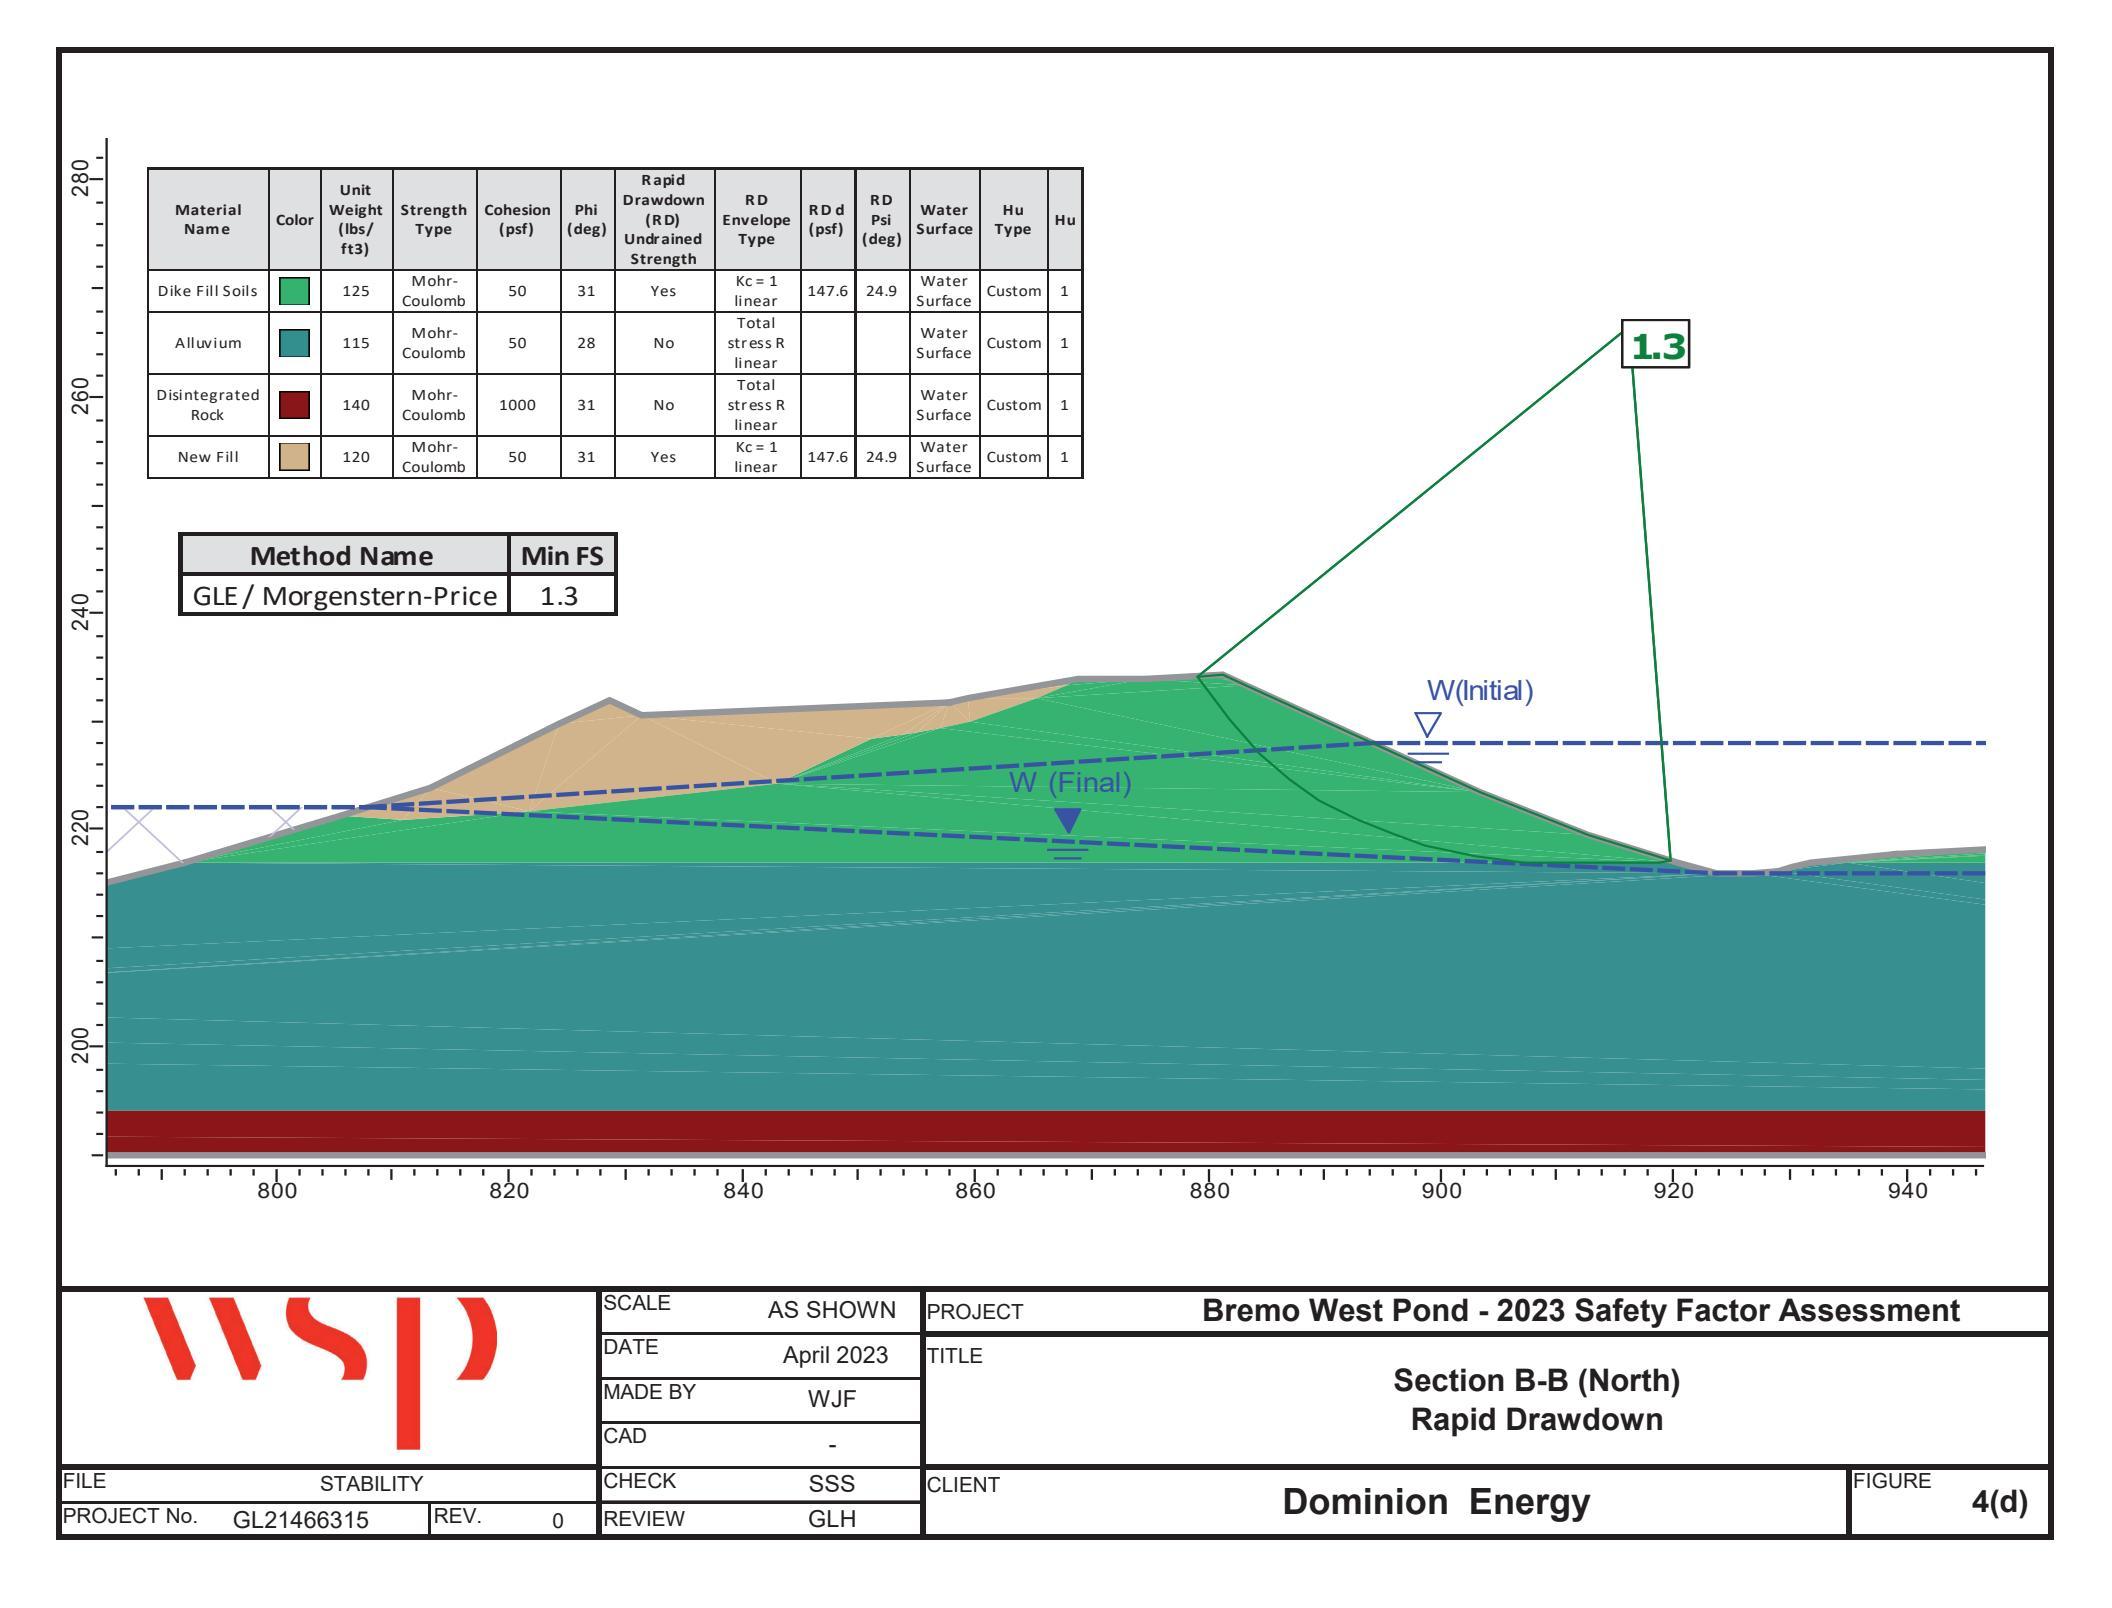
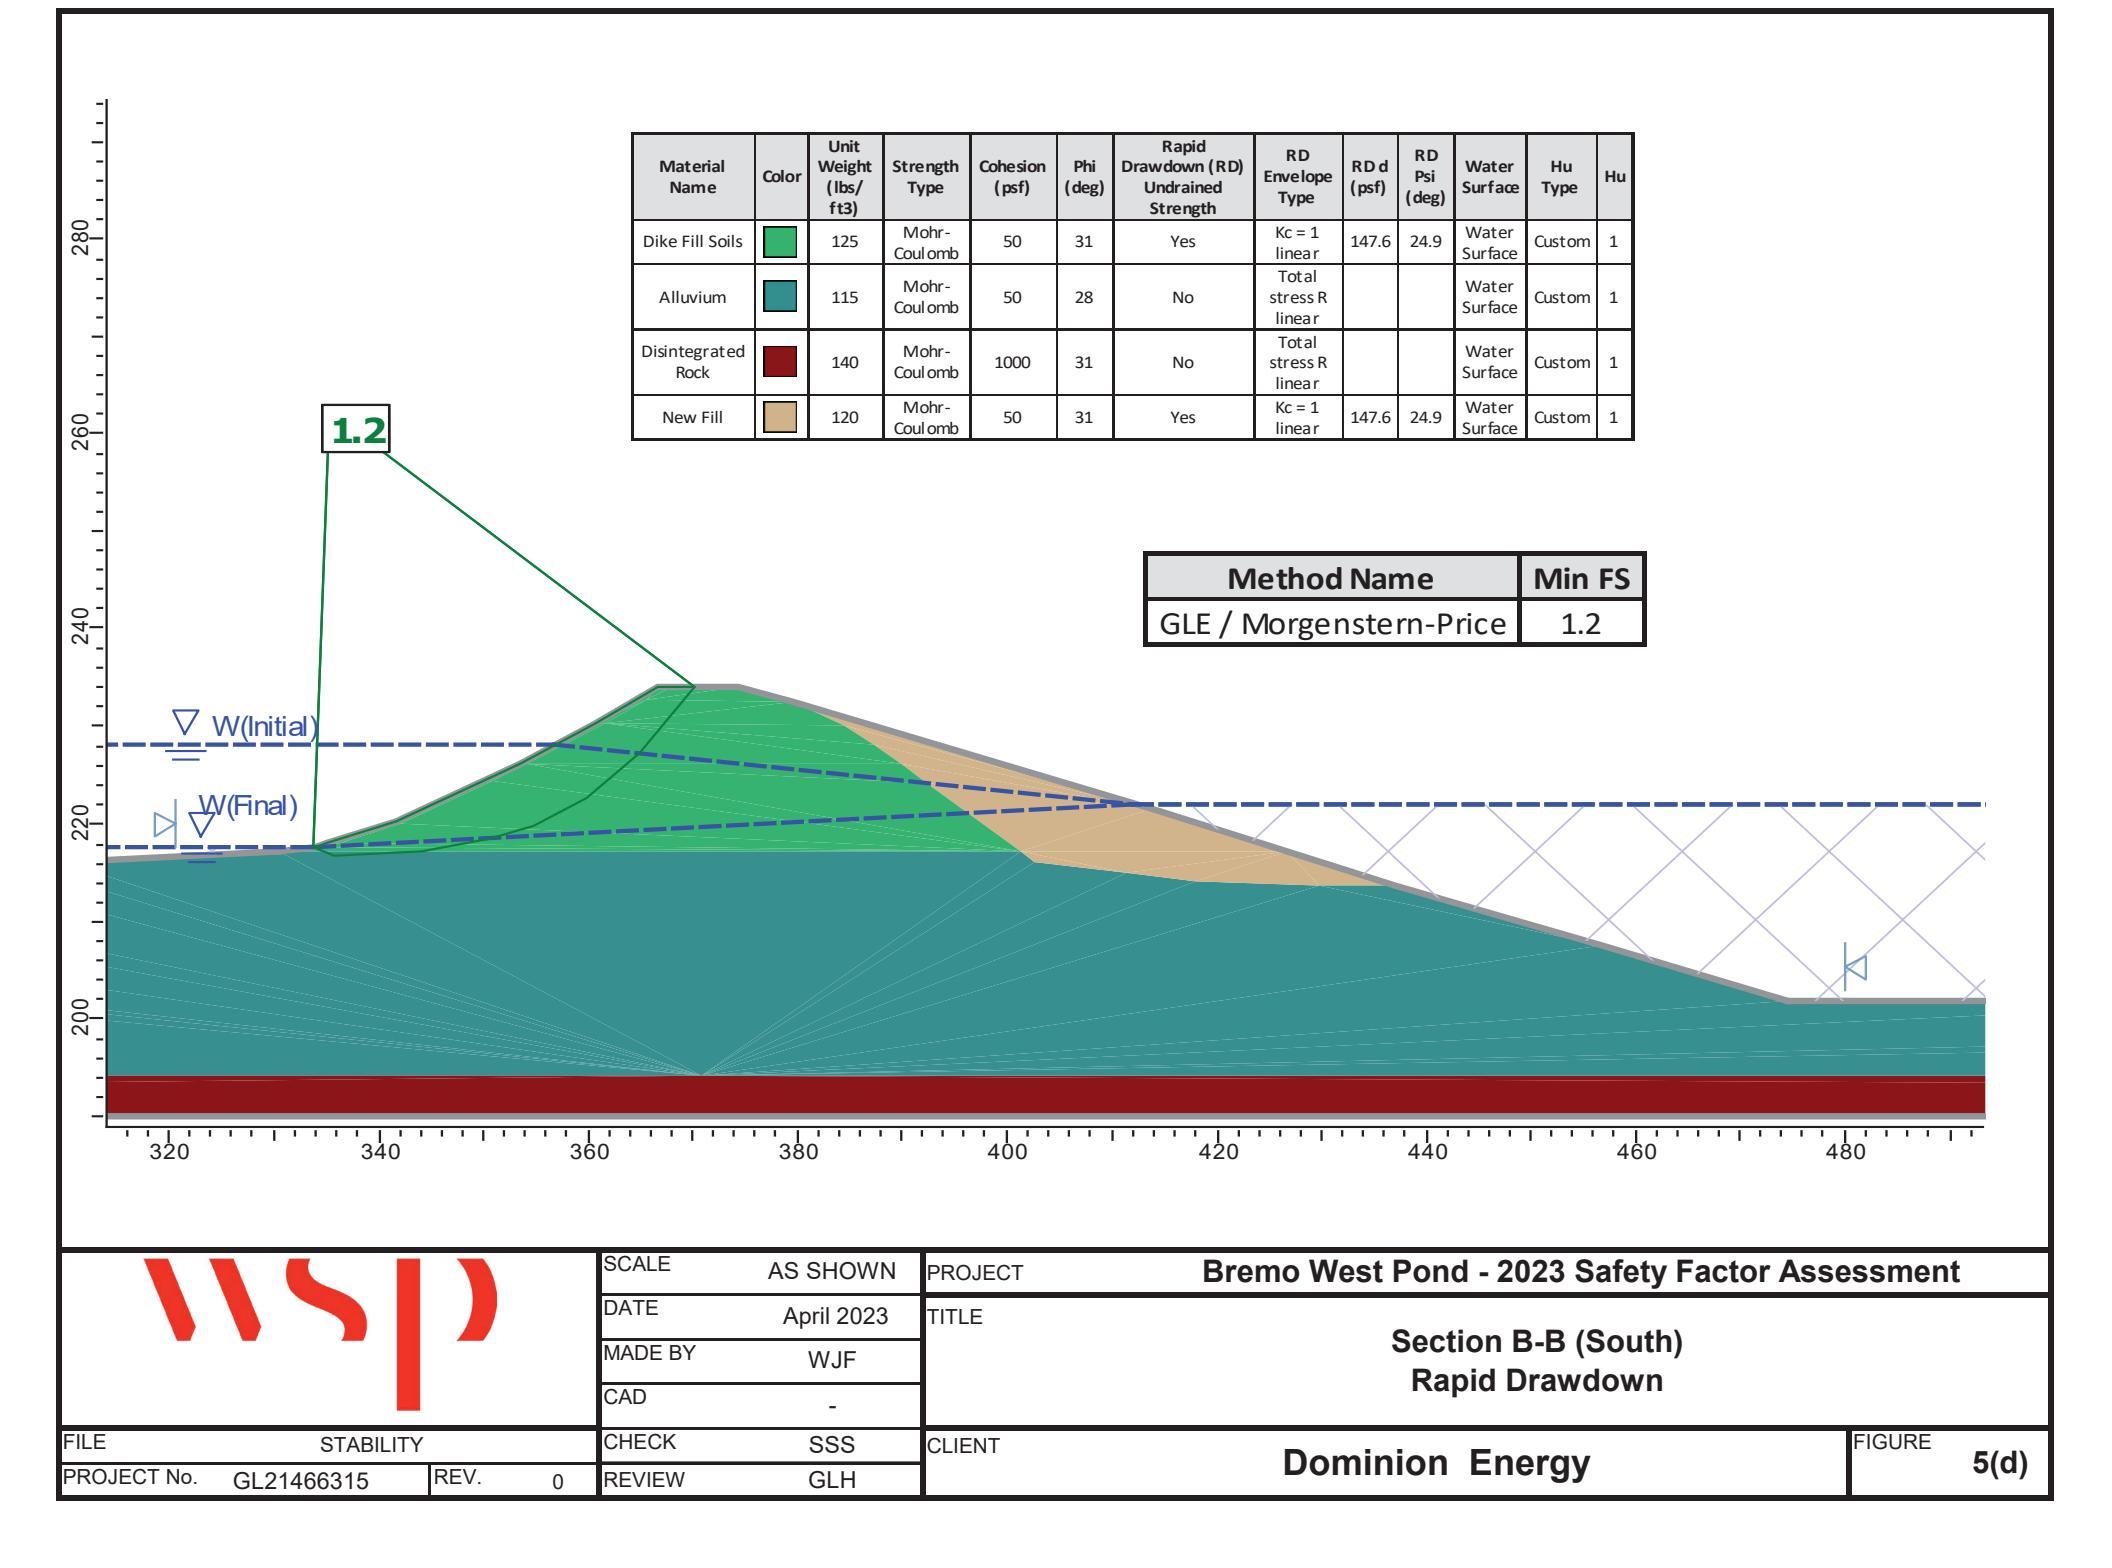
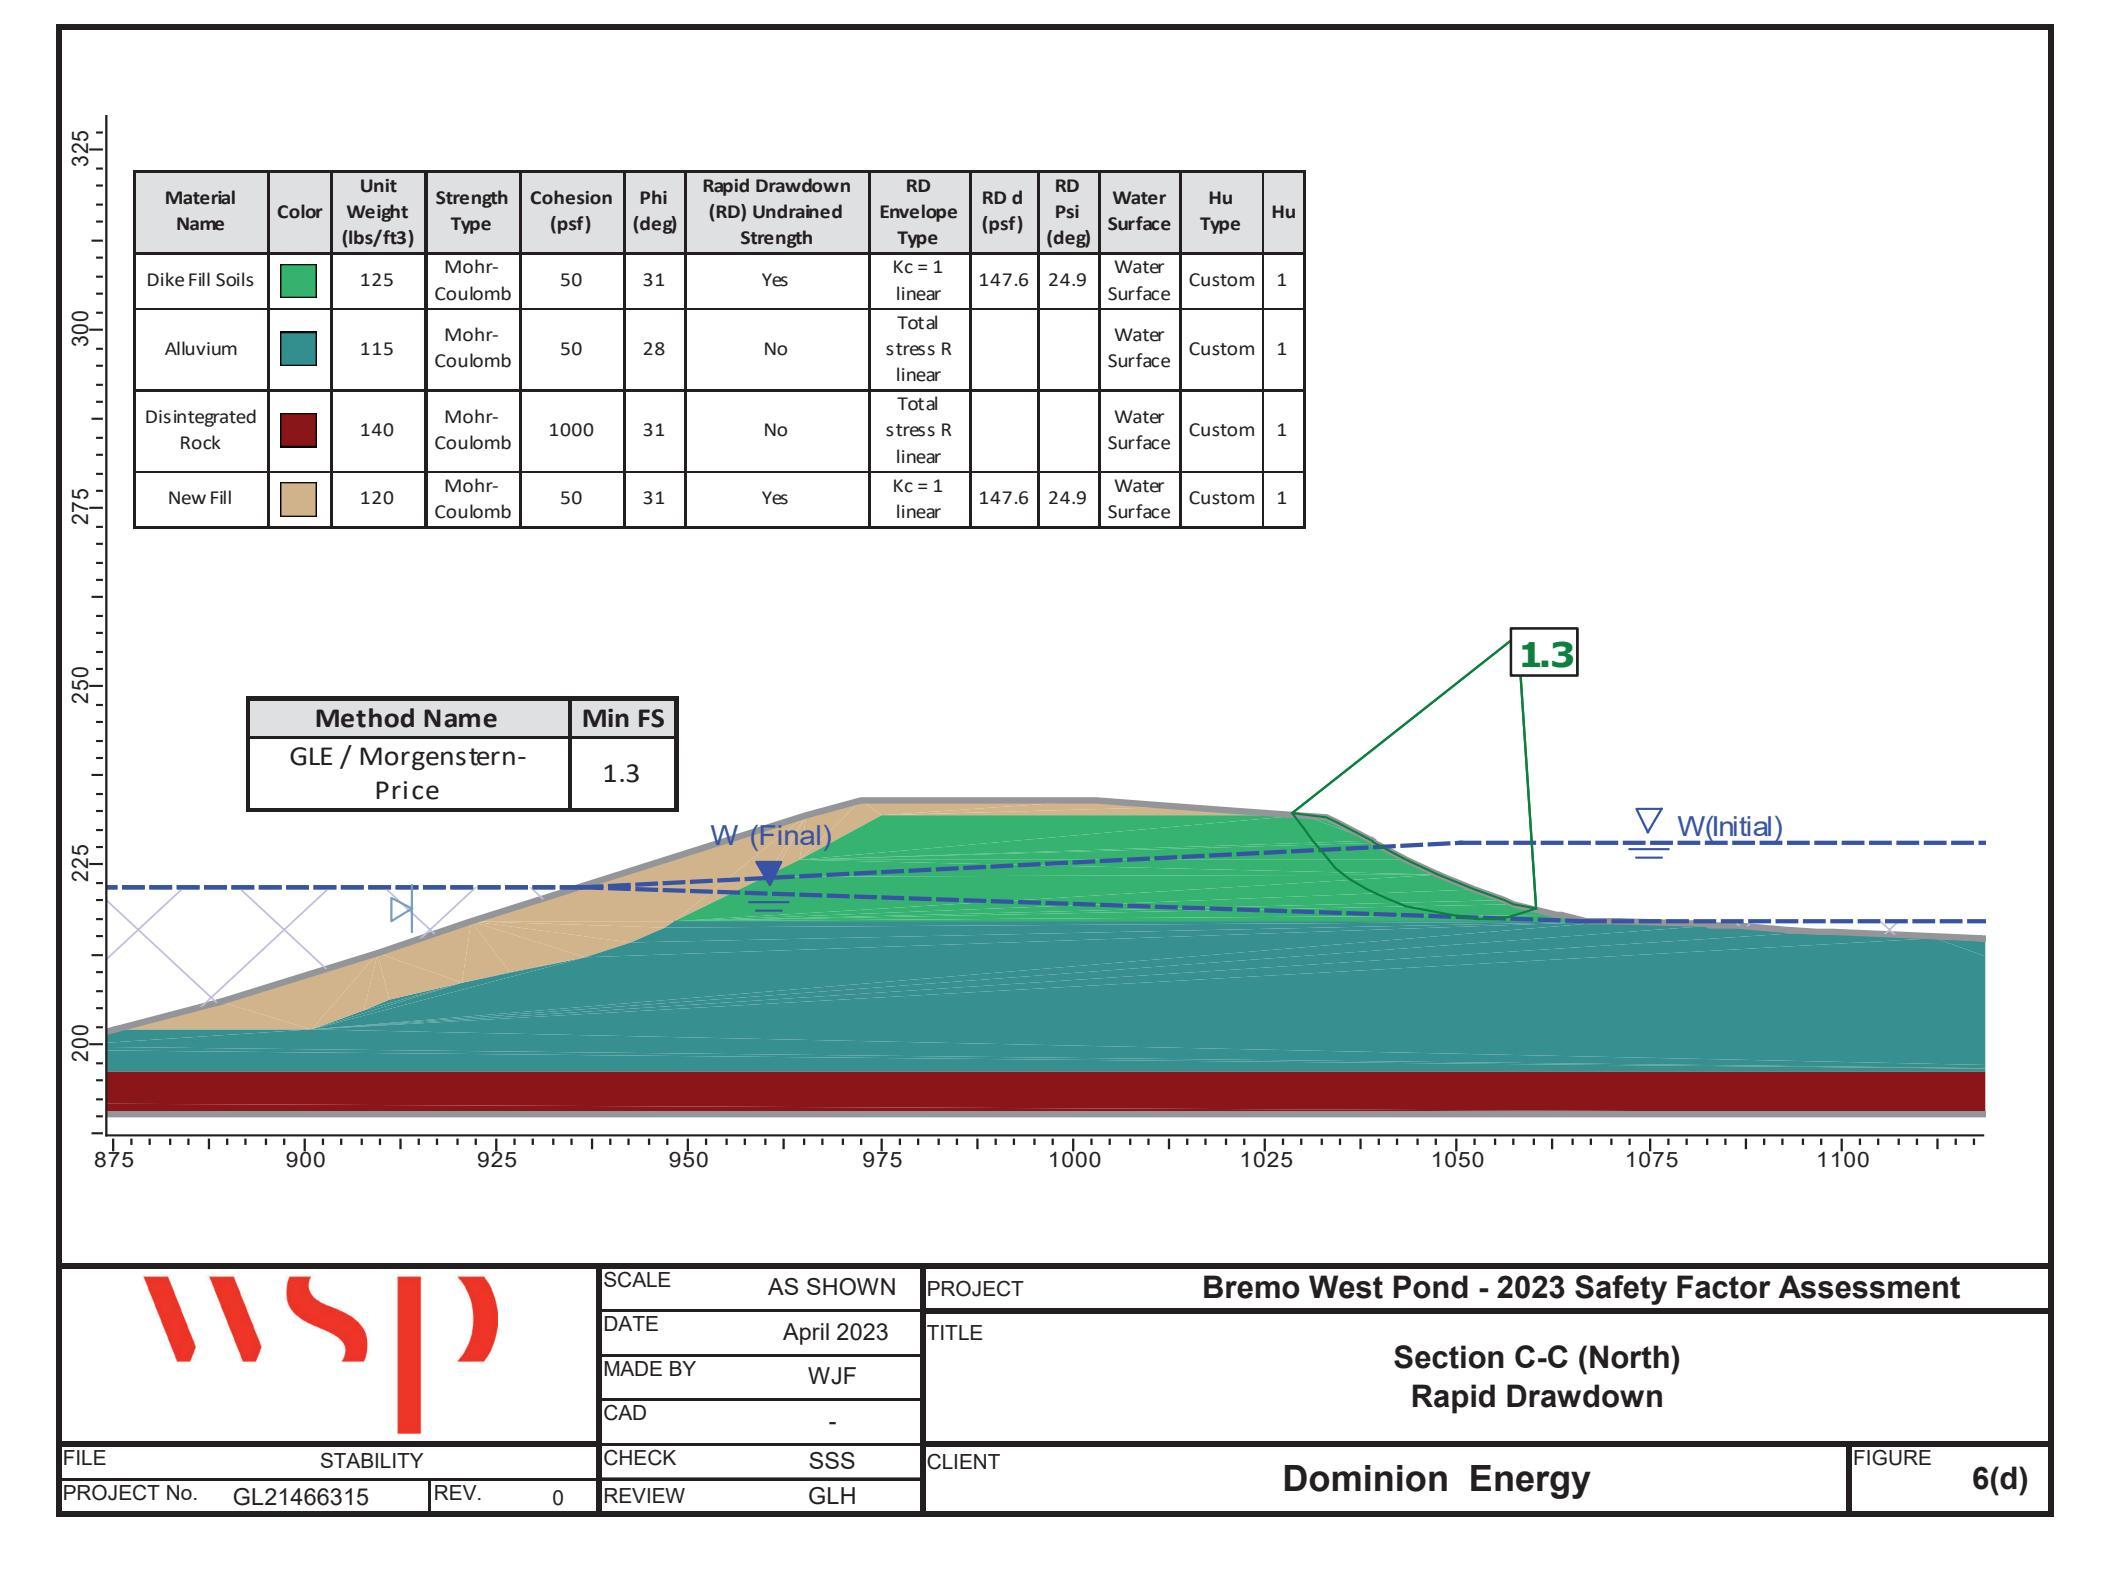
Using the process described above, WSP evaluated the stability of the West Pond dikes under rapid drawdown conditions resulting from the site 100-year flood event. The table below presents the results of the analysis of the dikes surrounding the West Pond. For all sections analyzed, the calculated factors of safety meet or exceed the requirements. The detailed stability result figures are provided in the pages following this text.

Cross-Sections	Factor of Safety
A-A' (East)	1.2
A-A' (West)	1.6
B-B' (North)	1.3
B-B' (South)	1.2
C-C' (North)	1.3
C-C' (South)	1.1
