**SURVEY OF AQUATIC PLANTS**  
**LAKE MURRAY, SC**  
**2018**

South Carolina Electric & Gas Company  
Land Management Department  
Cayce, SC

Cynthia A. Aulbach  
Consulting Ecologist and Botanist  
Lexington, SC 29072

December 2018

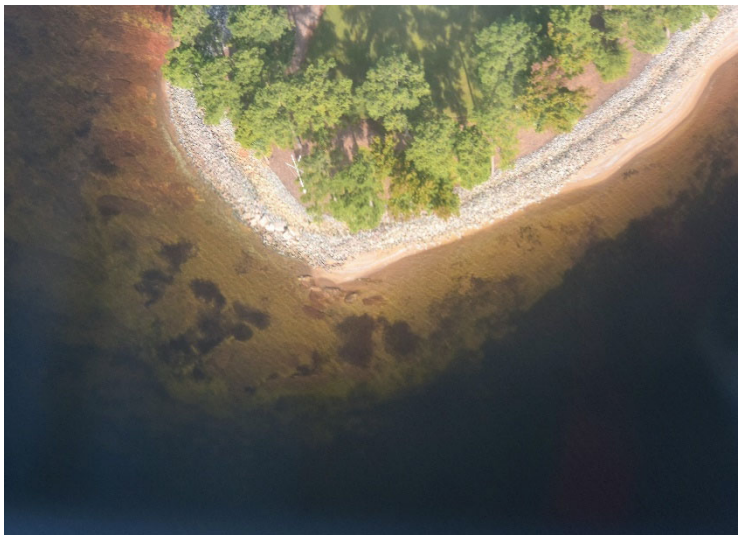
Figure 2. Illinois pondweed growing in large patches in shallow water to 5 feet; southern naiad and *Nitella* growing from 5 to 15 feet, appearing as dark water.

As documented by de Kozlowski (2016), southern naiad (*Najas guadalupensis*) and *Nitella* (Figures 2 and 3) continue to be the most prevalent aquatic plants in Lake Murray. *Chara*, another type of macroscopic algae similar in appearance to *Nitella*, was also found in several areas of the lake but it

Illinois pondweed has become quite prevalent in several areas of the lake. On the north side of the lake, Illinois pondweed is found in shallow water (Figures 2 and 6) from Yacht Cove west to Wessinger Island. In several areas, it grows to at least five feet and is producing seeds as well as floating and submersed leaves (Figures 7 and 8). Some of the more extensive growth is on the north side of Susie Ebert Island. On the south side of the lake, Illinois pondweed is found from the east side Shull Island peninsula to Rocky Well Point and the east side of Lands End. It is very prevalent along both sides of the shoal to Hallmark Key.

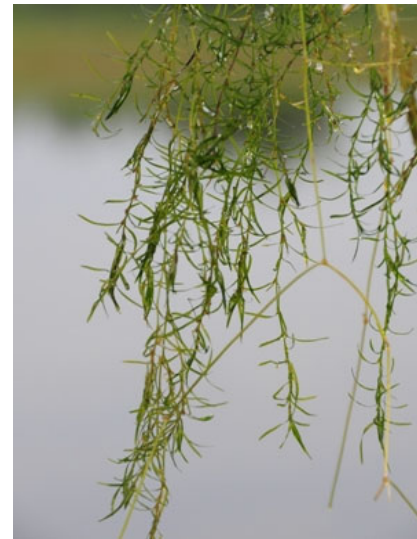
Figure 3. Southern naiad (Keller

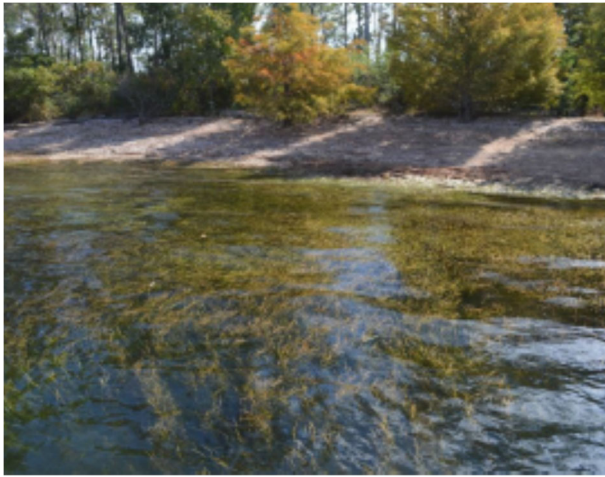
Figure 4. Vallisneria-Wessinger Island (de Kozlowski 2016)

In 2016, de Kozlowski documented the presence of tape grass (*Vallisneria americana*) growing around Wessinger Island (Figure 4). Tape grass has continued to expand its presence around Wessinger Island and is now found in abundance on the lake side (see Figure 5) and along portions of the island facing Lake Point. Tape grass was also found in the cove on the south side of Palmetto Point; three large, circular patches occur there in water to five feet deep.

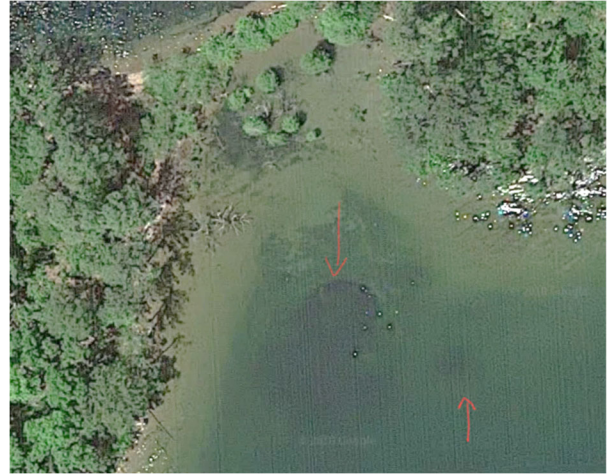
Figure 5. Overhead view of Vallisneria between Wessinger and Leeward Islands

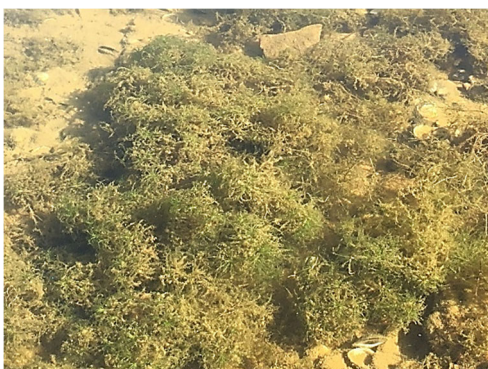
Figure 9. Slender naiad in shallow water at Billy Dreher Island State Park marina.

Slender naiad was found in two locations this year; it hasn't been found in Lake Murray since before 2003. It was found on the north side of the lake at Billy Dreher Island Marina cove (Figure 9) and on the south side near Woods Point Road Cove. It is likely that slender naiad is more prevalent than found in this survey.
