Stantec Consulting Services Inc. (Stantec) was retained by Dominion Energy Virginia (Dominion Energy) to conduct a Stage I Pre-Application Analysis for the proposed partial rebuild of transmission lines between the Charlottesville Substation in Charlottesville, Virginia and the Dooms Substation in Augusta County, Virginia (Figure 1). The total length of the existing right-of-way (ROW) easements and Dominion Energy-owned property to be used for the Charlottesville – Dooms Lines #233 and #291 Rebuild Project (Rebuild Project) is approximately 22.3 miles. Because the existing ROW is adequate to construct the proposed Rebuild Project, no new ROW is necessary.

1.2 Stage I Pre-Application Analysis

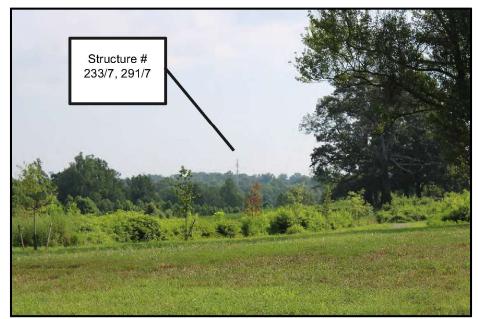
Figure 27. View from McIntire Golf Course (DHR #104-5102), McIntire Municipal Park (DHR # 104-5139; PL 34) Looking Northeast. Existing Transmission Line is Visible.

Structure #233/8, #291/8 is the closest existing structure and approximately 909 feet northeast of the golf course. Structure #233/8, #291/8 is a painted steel DC Monopole with a height of 105 feet (Appendix A). Based on preliminary design, the structure would remain in place. The site visit indicates that, under current conditions, the existing transmission line is visible at certain points within the course and not visible in other locations (Figures 27 and 28). Structure #233/7, #291/7 is visible from Photo Location 34 and it is a 130 feet tall painted steel DC Monopole. Based on preliminary design, the structure would remain in place and not be altered (Figure 27).

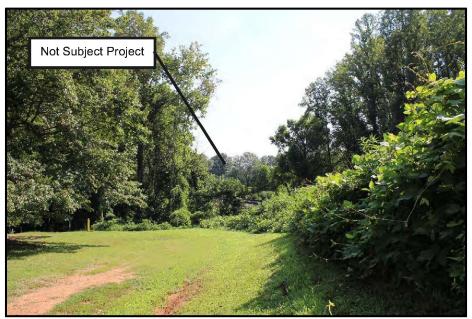
Figure 34. View from McIntire Municipal Park (DHR # 104-5139; PL 36) Looking Northeast.

Existing Transmission Line is Not Visible. Structure in Foreground is not Subject Project.

Structure #233/8, #291/8 is the closest existing structure and is approximately 568 feet northeast of the park. Structure #233/8, #291/8 is 105 feet tall and is a painted steel DC Monopole (Appendix A). Based on preliminary design, the structure would remain in place. The site visit indicates that, under current conditions, the existing transmission line is visible at certain points within the park and not visible in other locations (Figure 34). Structure #233/7, #291/7 is visible from Photo Location 34 and it is a 130 feet tall painted steel DC Monopole. Based on preliminary design, the structure would remain in place (Figure 34).

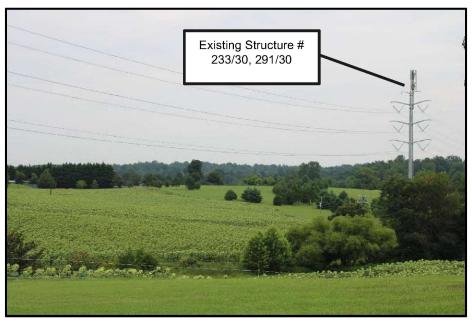
Figure 55. View from Ingleridge Farm (DHR #002-1736; PL 39b), Looking Northeast. Existing Transmission Line is Visible.

As previously stated, the resource has 275 acres and is crossed by the existing ROW of the Rebuild Project; however, only approximately five acres of the resource are within the ROW (Appendix B). The site visit from the public ROW indicates that, under current conditions, the existing transmission line is visible (Figure 55). Existing Structure 233/29, 291/29 to Structure 233/31, 291/31 are within the resource and range in height from 110 feet to 120 feet with an average height of 115 feet. Only existing Structure #233/29, 291/29 would be replaced by a 120 foot, galvanized-steel, DC monopole; the remaining structures within the resource boundary would remain as is. The proposed average height of these three structures would be 118 feet. The existing structures are painted steel DC monopoles and Structure #233/29, 291/29 would be replaced with a galvanized-steel DC monopole.
