**Application, Appendix,
DEQ Supplement, Direct
Testimony and Exhibits of
Virginia Electric and
Power Company**

**Clubhouse-Dry Bread Line
#2201 and Dry Bread-Lakeview
Line #254 230 kV Virginia
Rebuild Project**

Case No. PUR-2020-00269

DEQ Supplement

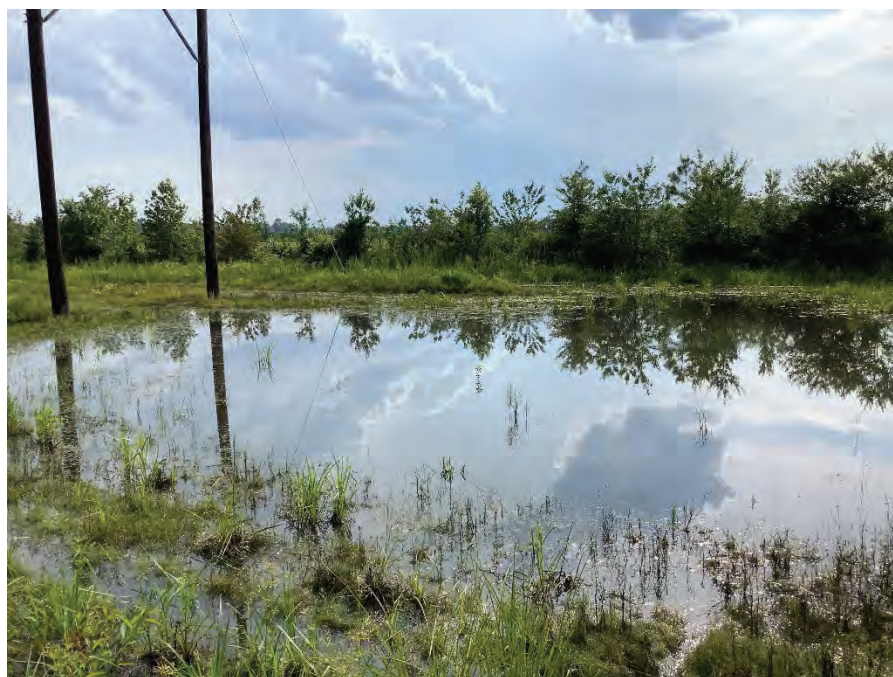
Description: A representative view of open water within a wetland near Structure 254/19.

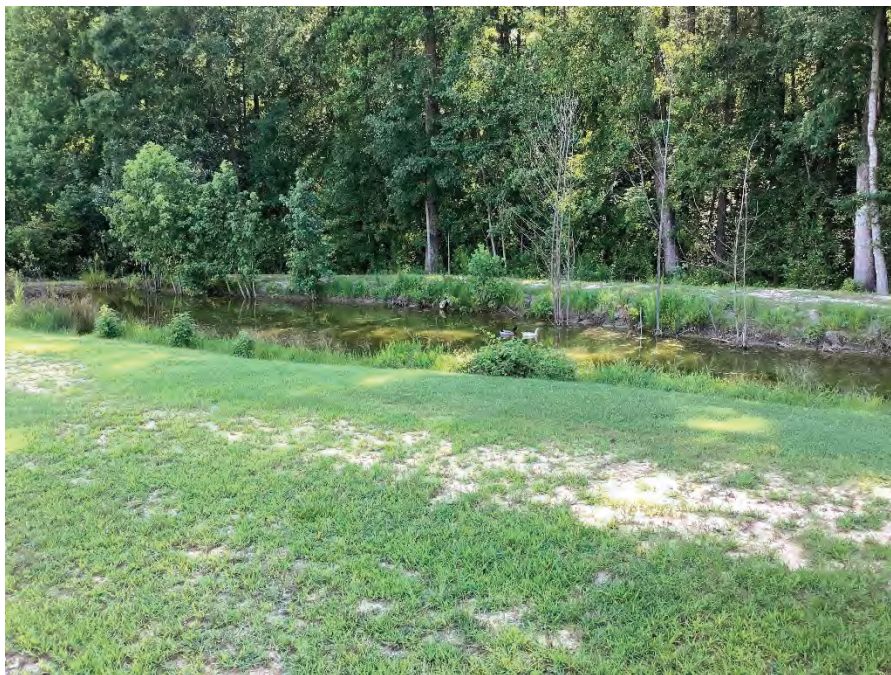
Description: A representative view of a pond at Structure 254/50.

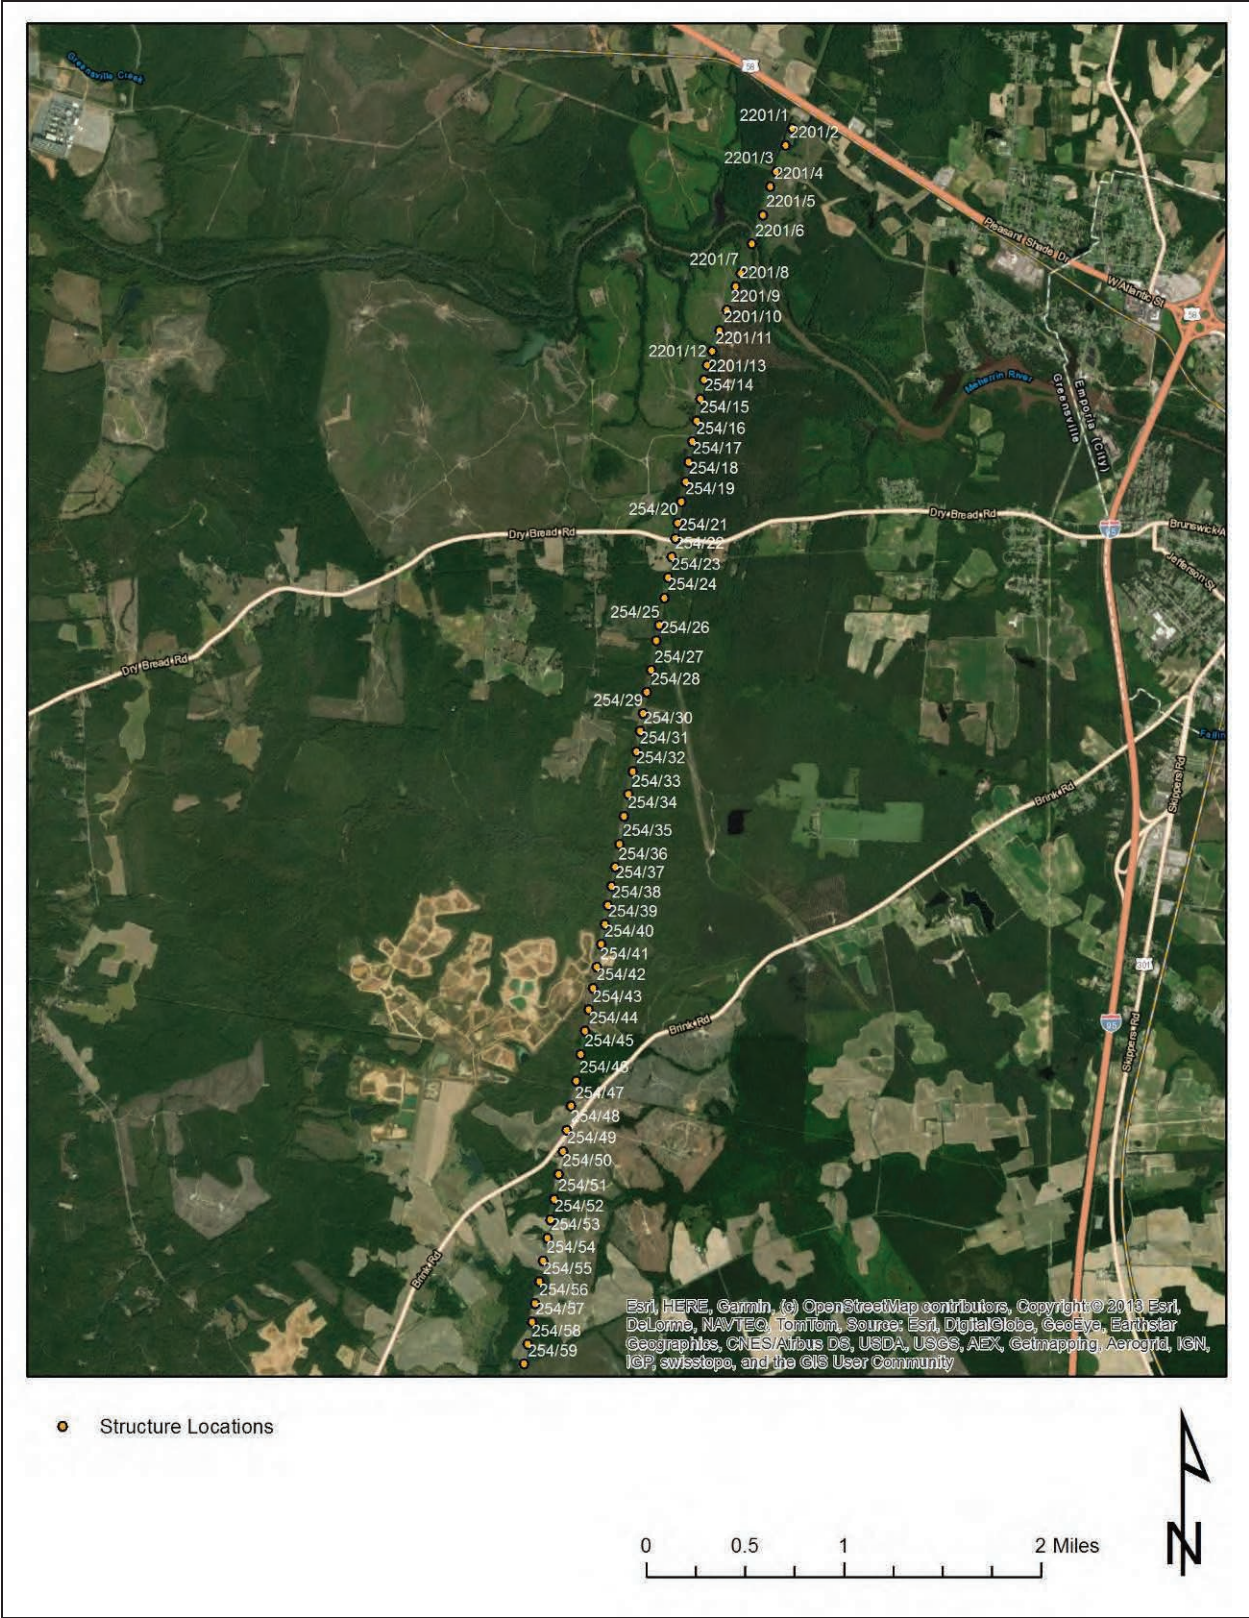
Figure 2-2: Location of Structures to be replaced (North half of alignment). Source: Dominion Energy

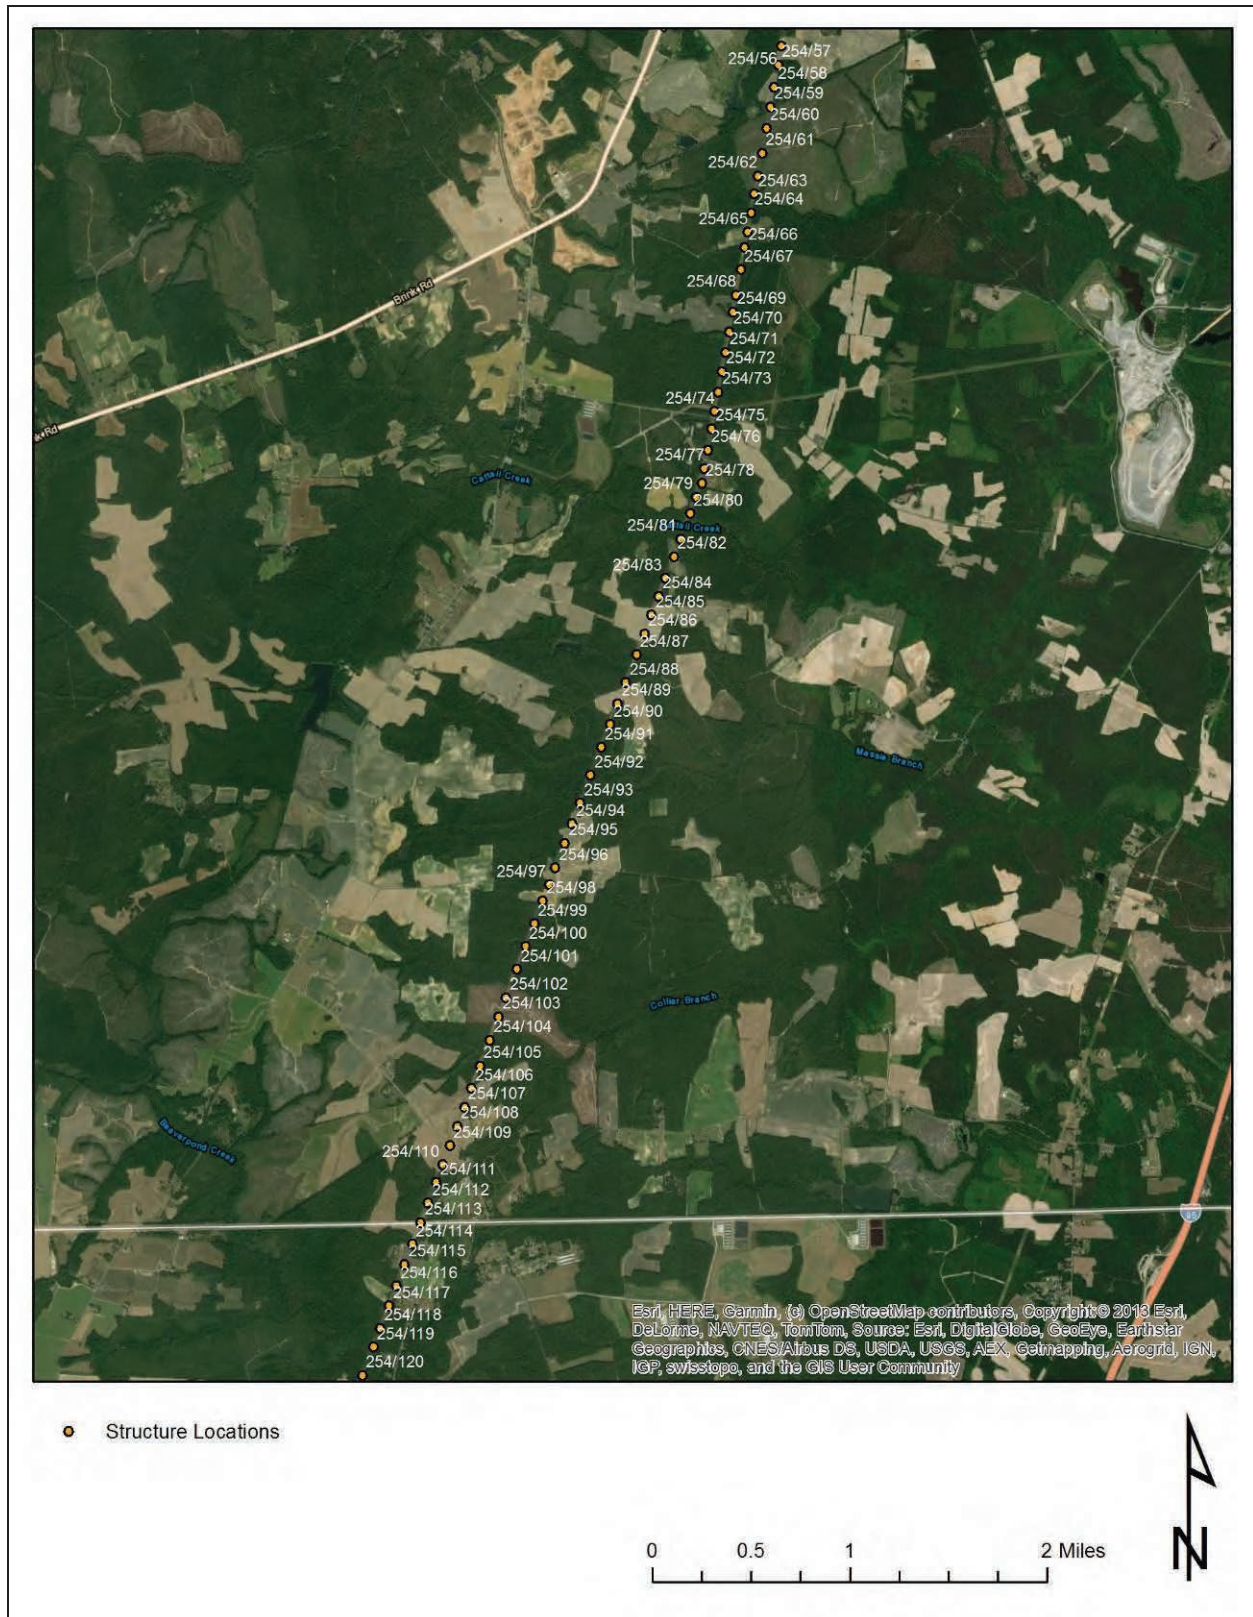
Figure 2-3: Location of Structures to be replaced (South half of alignment). Source: Dominion Energy

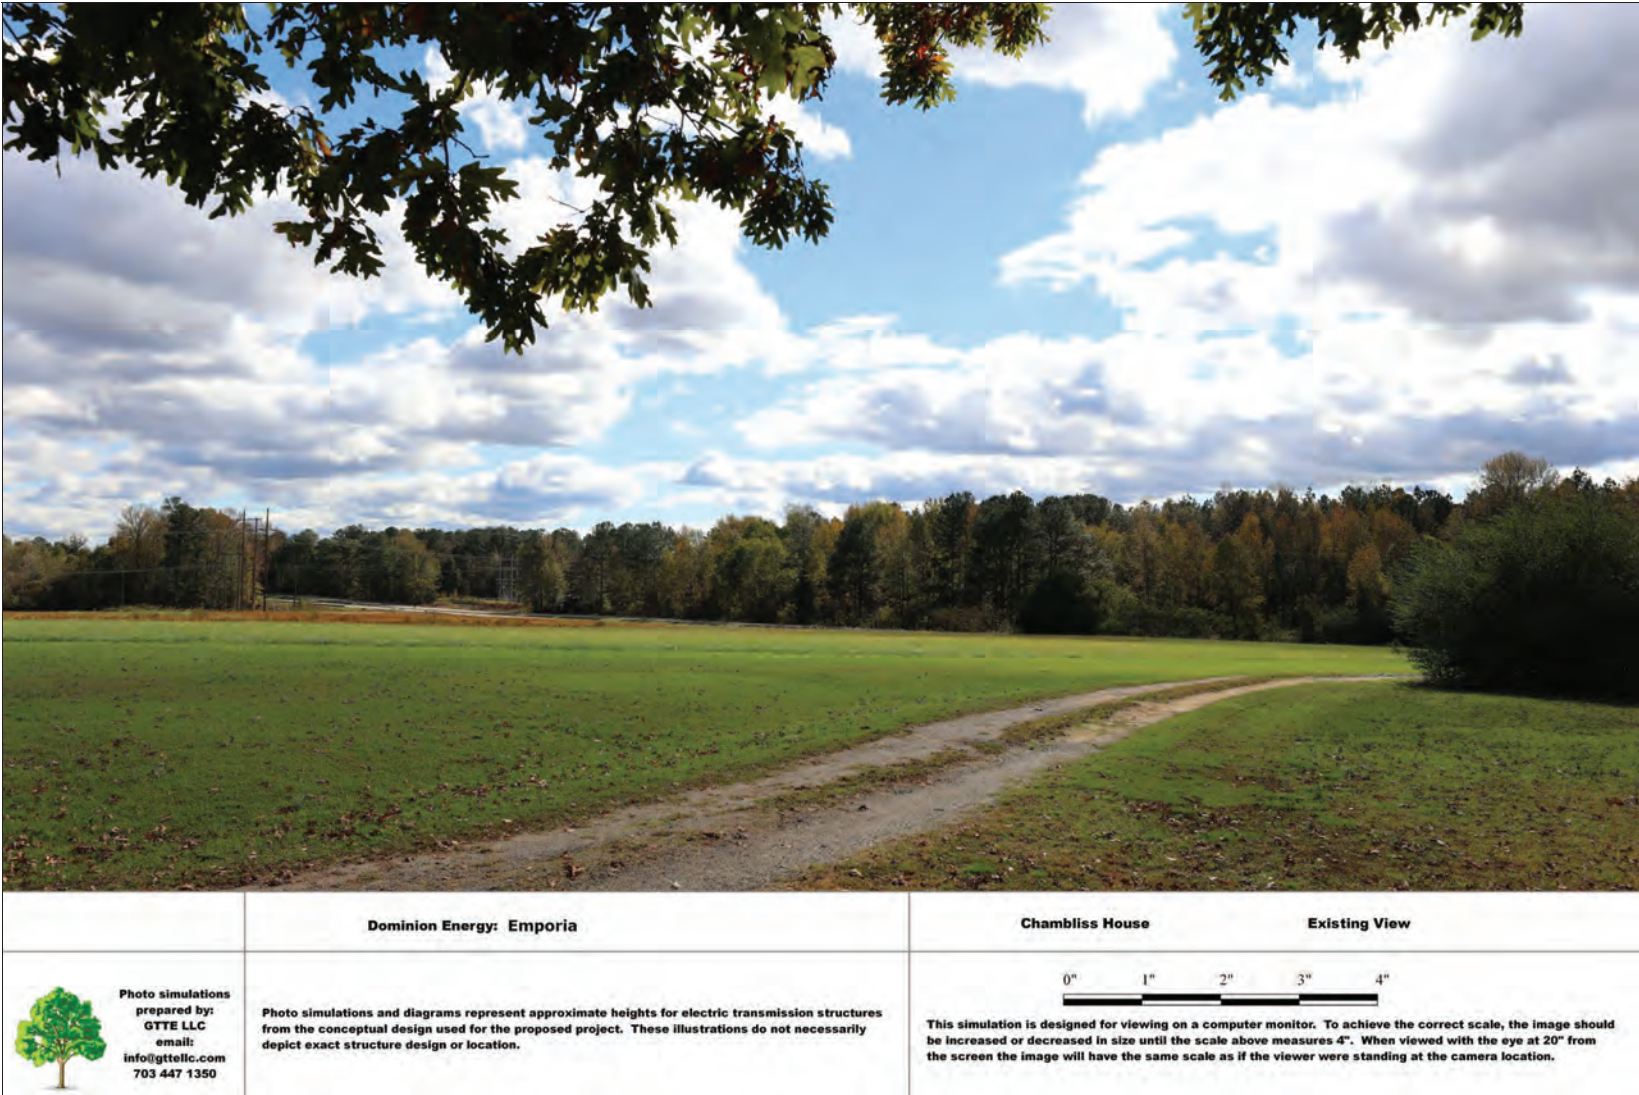
Figure 5-17: Photo Simulation 1 – Existing view from the Chambliss House. Source: GTTE, LLC

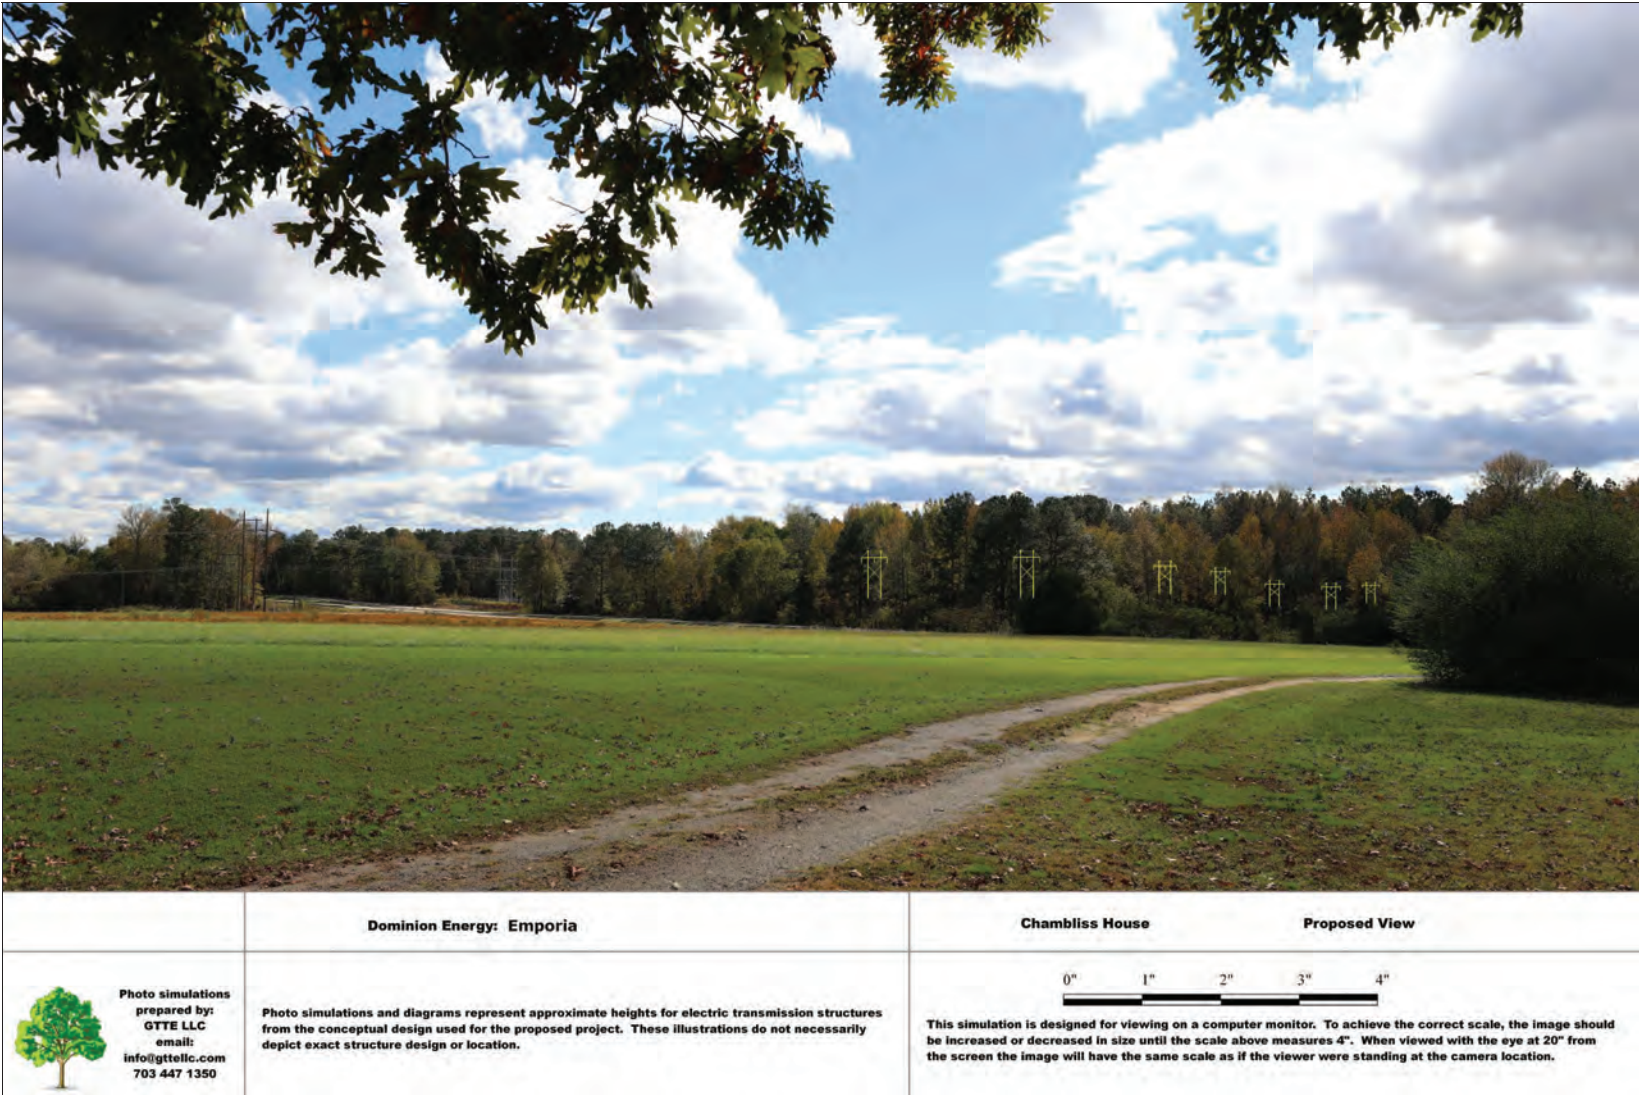
Figure 5-18: Photo Simulation 1 – Proposed view from the Chambliss House (structures not visible). Source: GTTE, LLC
