SURVEY OF AQUATIC PLANTS
LAKE MURRAY, SC
2018

South Carolina Electric & Gas Company
Land Management Department
Cayce, SC

Cynthia A. Aulbach
Consulting Ecologist and Botanist
Lexington, SC 29072

December 2018

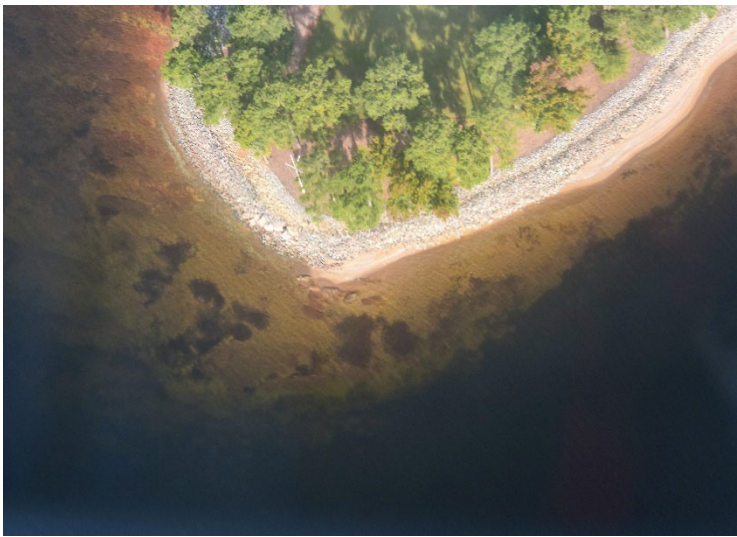
Figure 2. Illinois pondweed growing in large patches in shallow water to 5 feet; southern naiad and *Nitella* growing from 5 to 15 feet, appearing as dark water.

As documented by de Kozlowski (2016), southern naiad (*Najas guadalupensis*) and *Nitella* (Figures 2 and 3) continue to be the most prevalent aquatic plants in Lake Murray. *Chara*, another type of macroscopic algae similar in appearance to *Nitella*, was also found in several areas of the lake but it

Illinois pondweed has become quite prevalent in several areas of the lake. On the north side of the lake, Illinois pondweed is found in shallow water (Figures 2 and 6) from Yacht Cove west to Wessinger Island. In several areas, it grows to at least five feet and is producing seeds as well as floating and submersed leaves (Figures 7 and 8). Some of the more extensive growth is on the north side of Susie Ebert Island. On the south side of the lake, Illinois pondweed is found from the east side Shull Island peninsula to Rocky Well Point and the east side of Lands End. It is very prevalent along both sides of the shoal to Hallmark Key.

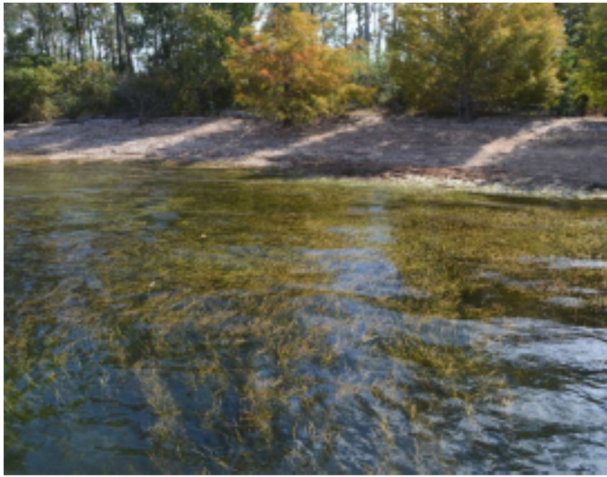
Figure 4. Vallisneria-Wessinger Island (de Kozlowski 2016)

In 2016, de Kozlowski documented the presence of tape grass (*Vallisneria americana*) growing around Wessinger Island (Figure 4). Tape grass has continued to expand its presence around Wessinger Island and is now found in abundance on the lake side (see Figure 5) and along portions of the island facing Lake Point. Tape grass was also found in the cove on the south side of Palmetto Point; three large, circular patches occur there in water to five feet deep.

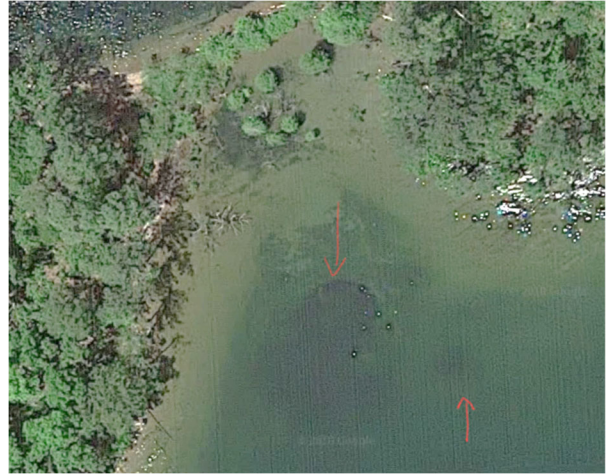
Figure 5. Overhead view of Vallisneria between Wessinger and Leeward Islands

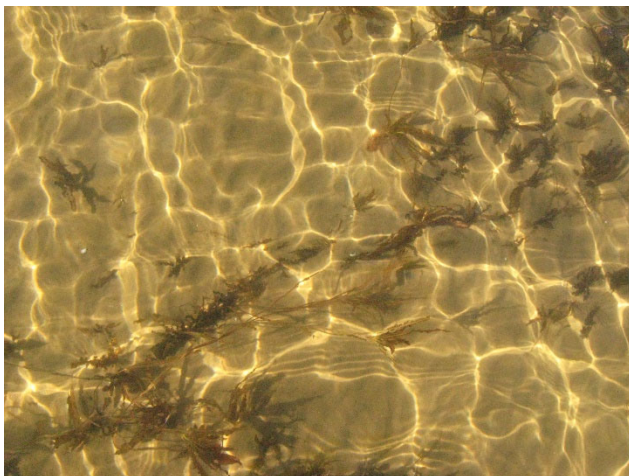
Figure 6. Young Illinois pondweed plants in shallow water

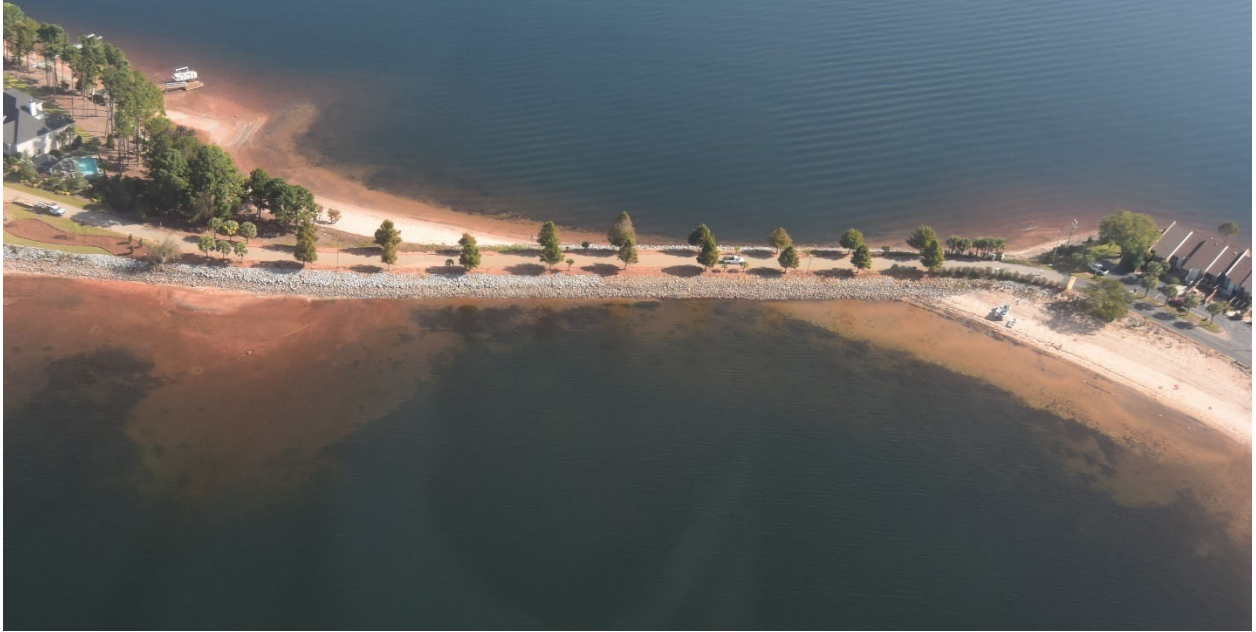
Figure 8. Illinois pondweed in patches along both sides of the causeway at Land's End in shallow water, grading into slender pondweed and southern naiad.

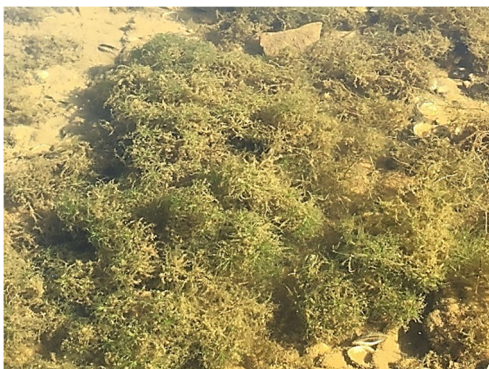
Figure 9. Slender naiad in shallow water at Billy Dreher Island State Park marina.

Slender naiad was found in two locations this year; it hasn't been found in Lake Murray since before 2003. It was found on the north side of the lake at Billy Dreher Island Marina cove (Figure 9) and on the south side near Woods Point Road Cove. It is likely that slender naiad is more prevalent than found in this survey.

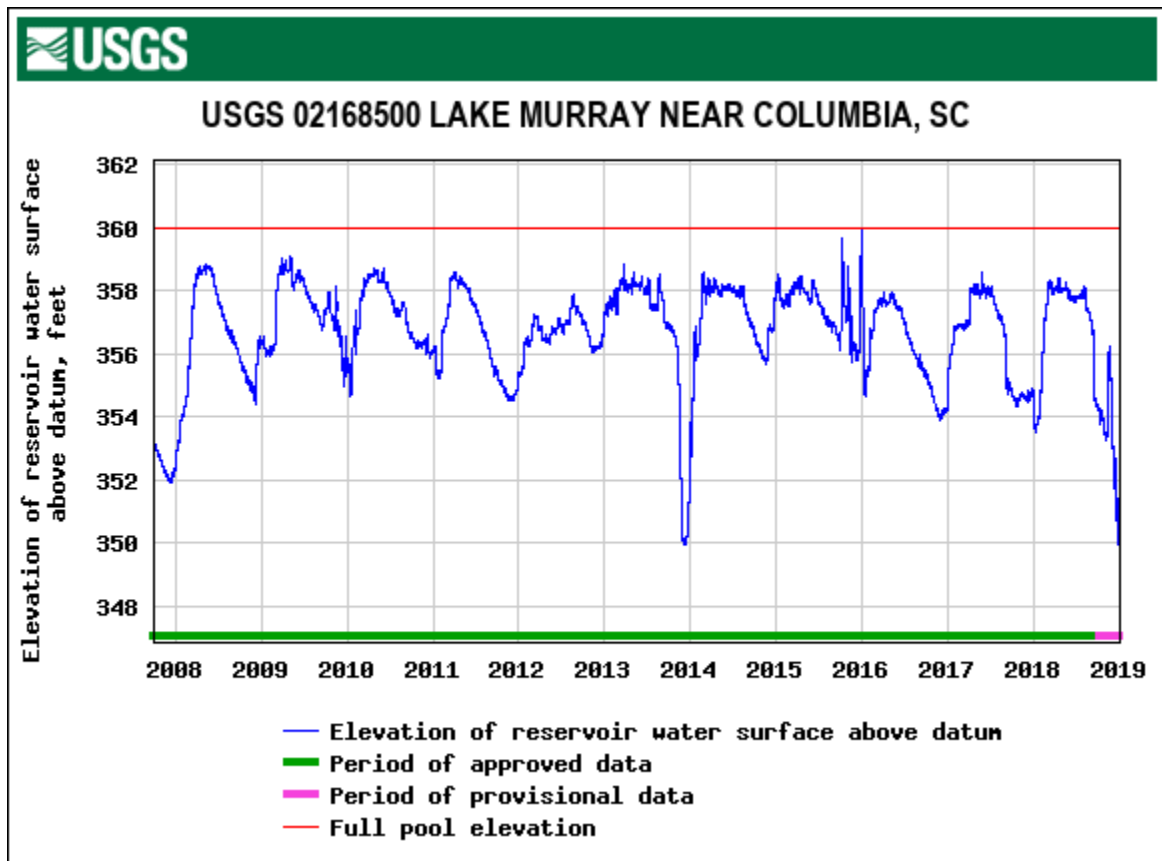
Figure 10. USGS water level data from 2008 to present (USGS 2019)

Native and introduced aquatic plants have been a part of the Lake Murray system for over three decades. When submersed aquatic plants have interfered with recreational use of the lake, various control measures have been used to control the extent and growth of these nuisance plants. Drawdowns of the lake have been done several times since 1990 variously for dam and facility maintenance or construction, aquatic plant control, and to improve water quality. The lake was drawn down in 1990 (345' elevation), 1996 (350' elevation), 2002 (345' elevation), 2006 (350' elevation), [figure 10] (350' elevation), and this year, 2018 [figure 10] (350' elevation).

The increase in submersed aquatic plant growth is likely attributed to the loss of sterile grass carp during the historic rainfall and flooding in early October of 2015 (Page 2018). Approximately 20 inches of rainfall over a period of just a few days caused the water level of Lake Murray to increase almost to full pool (360' elevation). SCE&G opened a floodgate at the spillway to drop water levels due to the flooding (Breslin 2015). According to Page, it's likely that more than 75% of the triploid grass carp remaining in Lake Murray were lost during this major flood event. Very high numbers of grass carp were found at Saluda Shoals Park along the Lower Saluda River downstream from the Lake Murray dam (Page, personal communication). The spillway was opened again in late December of 2015 due to another major flooding event (Lowe 2015). See figure 10 for historic water level information.
