Application, Appendix, DEQ Supplement, Direct Testimony and Exhibits of Virginia Electric and Power Company

Lanexa-Northern Neck Line #224 230 kV Transmission Line Partial Rebuild Projects

Case No. PUR-2018-00090

Filed: June 18, 2018

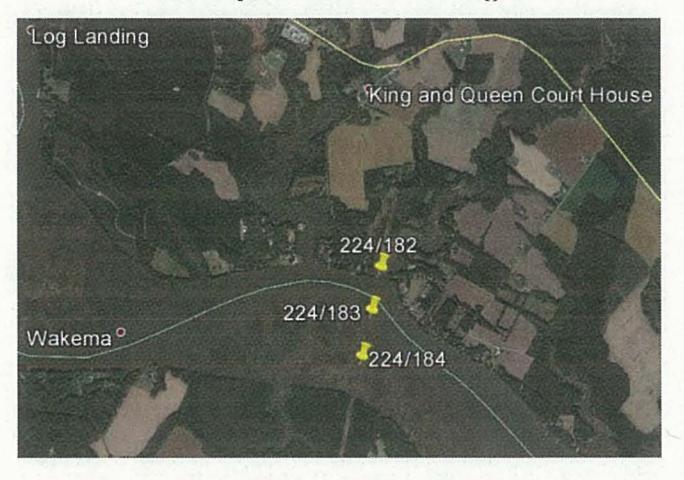
Mattaponi River Crossing

deteriorating condition of the COR-TEN<sup>®</sup> lattice structures' foundations. Severe concrete deterioration has reduced the structural capacity of these foundations, jeopardizing the reliability of the Line #224.

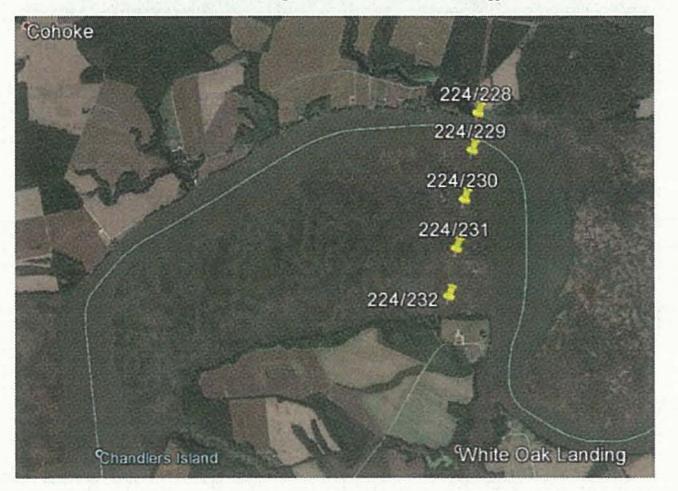
## **Pamunkey River Crossing**

- a. The purpose of the Pamunkey River Rebuild is to remove and replace six double circuit COR-TEN<sup>®</sup> lattice structures (Structures #224/228 #224/233), one tubular 3-pole steel structure (Structure #224/227), and two wood H-frame structures (Structures #224/226 and #224/234), which are currently carrying a single transmission circuit, and foundations spanning the Pamunkey River and crossing adjacent tidal marshlands due to the deteriorating condition of the COR-TEN<sup>®</sup> lattice structures' foundations. Severe concrete and steel deterioration has reduced the structural capacity of these foundations, jeopardizing the reliability of Line #224.

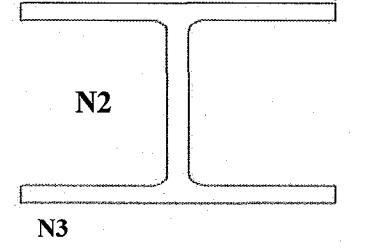
TOWER NO.	<b>FOUNDATION</b>		<b>RECORI</b>	DED MEASU	JREMENTS		
224/230	<u>&amp; PILE NO.</u>	<u>NDT</u>	MEASURE	MENT	DISTA	NCE FROM	I CAP
		N1	N2	N3	N1	N2	N3
	1A	0.590	0.595	0.585	5"	5"	5"
	1B						
	1C	<u> </u>					
	1D -						
	2A		· · ·				
	2B						
	2C	0.585	0.610	0.620	4"	4"	4"
•	2D						
	3A						
	3B						
	3C	0.625	0.610	0.595	5"	5"	5"
	3D						
	4A	·					
	4B	0.585	0.590	0.575	3"	3"	3"
	4C	•					
	4D		*				
COMMENTS:							
2 A PILE KNIFE EDGING, BE	GINNING 54" FROM	CAP. 4" LONG	AND UP TO 1" I	DEEP INTO THE	FLANGE.		2
2 A PILE AND C PILE SHOW	ONLY MODERATE S	CALE.					
1 A, B AND C PILES SHOW C	ONLY MODERATE SC	ALE.				· · · ·	
3 A, B AND C PILES SHOW (	ONLY MODERATE SC	ALE.					
4 A, B AND C PILES SHOW (	ONLY MODERATE SC	ALE.

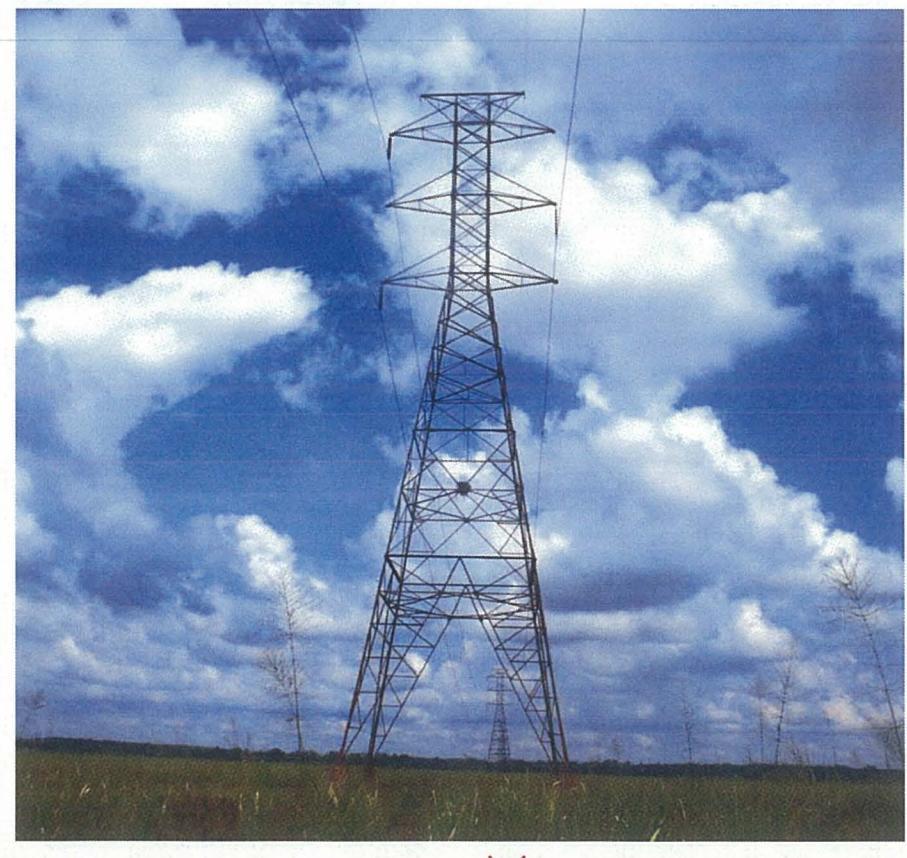
OVERALL CONDITION OF FOUNDATION GOOD FOR POOR NOTES:

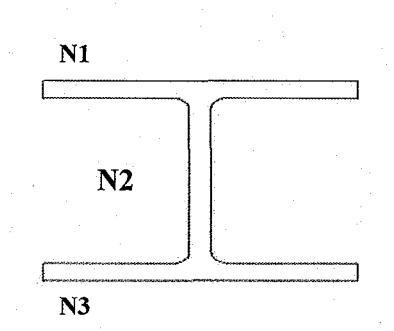
TOWER NO.	<b>FOUNDATION</b>		RECOR	DED MEAS	UREMENTS		
224/232	<u>&amp; PILE NO.</u>	NDT	MEASURE	MENT	DIST	ANCE FROM	I CAP
		N1	N2	N3	N1	N2	N3
	1A	0.565	0.585	0.600	20"	20"	20"
	1B						
	1C	· · ·					
	1D .						а 1.
	2A						
	2B	0.535	0.575	0.540	15"	15"	15"
	2C						
	2D					-	
	3A						
	3B						
	3C	0.575	0.590	0.605	45"	45"	45"
	3D						
	4A	0.580	0.575	0.590	36"	36"	36"
	4B						
	4C						
	4D						
COMMENTS:							
NDT READINGS TAKEN	<b>3 INCHES BELOW MUDL</b>	INE.					
1 A, B AND C PILES SH	OW ONLY MODERATE SC	ALE.					
2 A, B AND C PILES SH	OW ONLY MODERATE SC	ALE.					
3 A, B AND C PILES SH	OW ONLY MODERATE SC	ALE.					
4 A, B AND C PILES SH	OW ONLY MODERATE SC	ALE.					
					1.
