Application of Virginia Electric and Power Company for approval and certification of electric transmission facilities: Fentress-Yadkin 500 kV Line #588 Rebuild and New 500 kV Fentress-Yadkin Line #5005
Case No. PUR-2024-00105

ATTACHMENT I.A.1
PROJECT OVERVIEW MAP
 Fentress-Yadkin 500 KV Line #588 Rebuild and
 New 500 KV Fentress-Yadkin Line #5005
 City of Chesapeake, Virginia

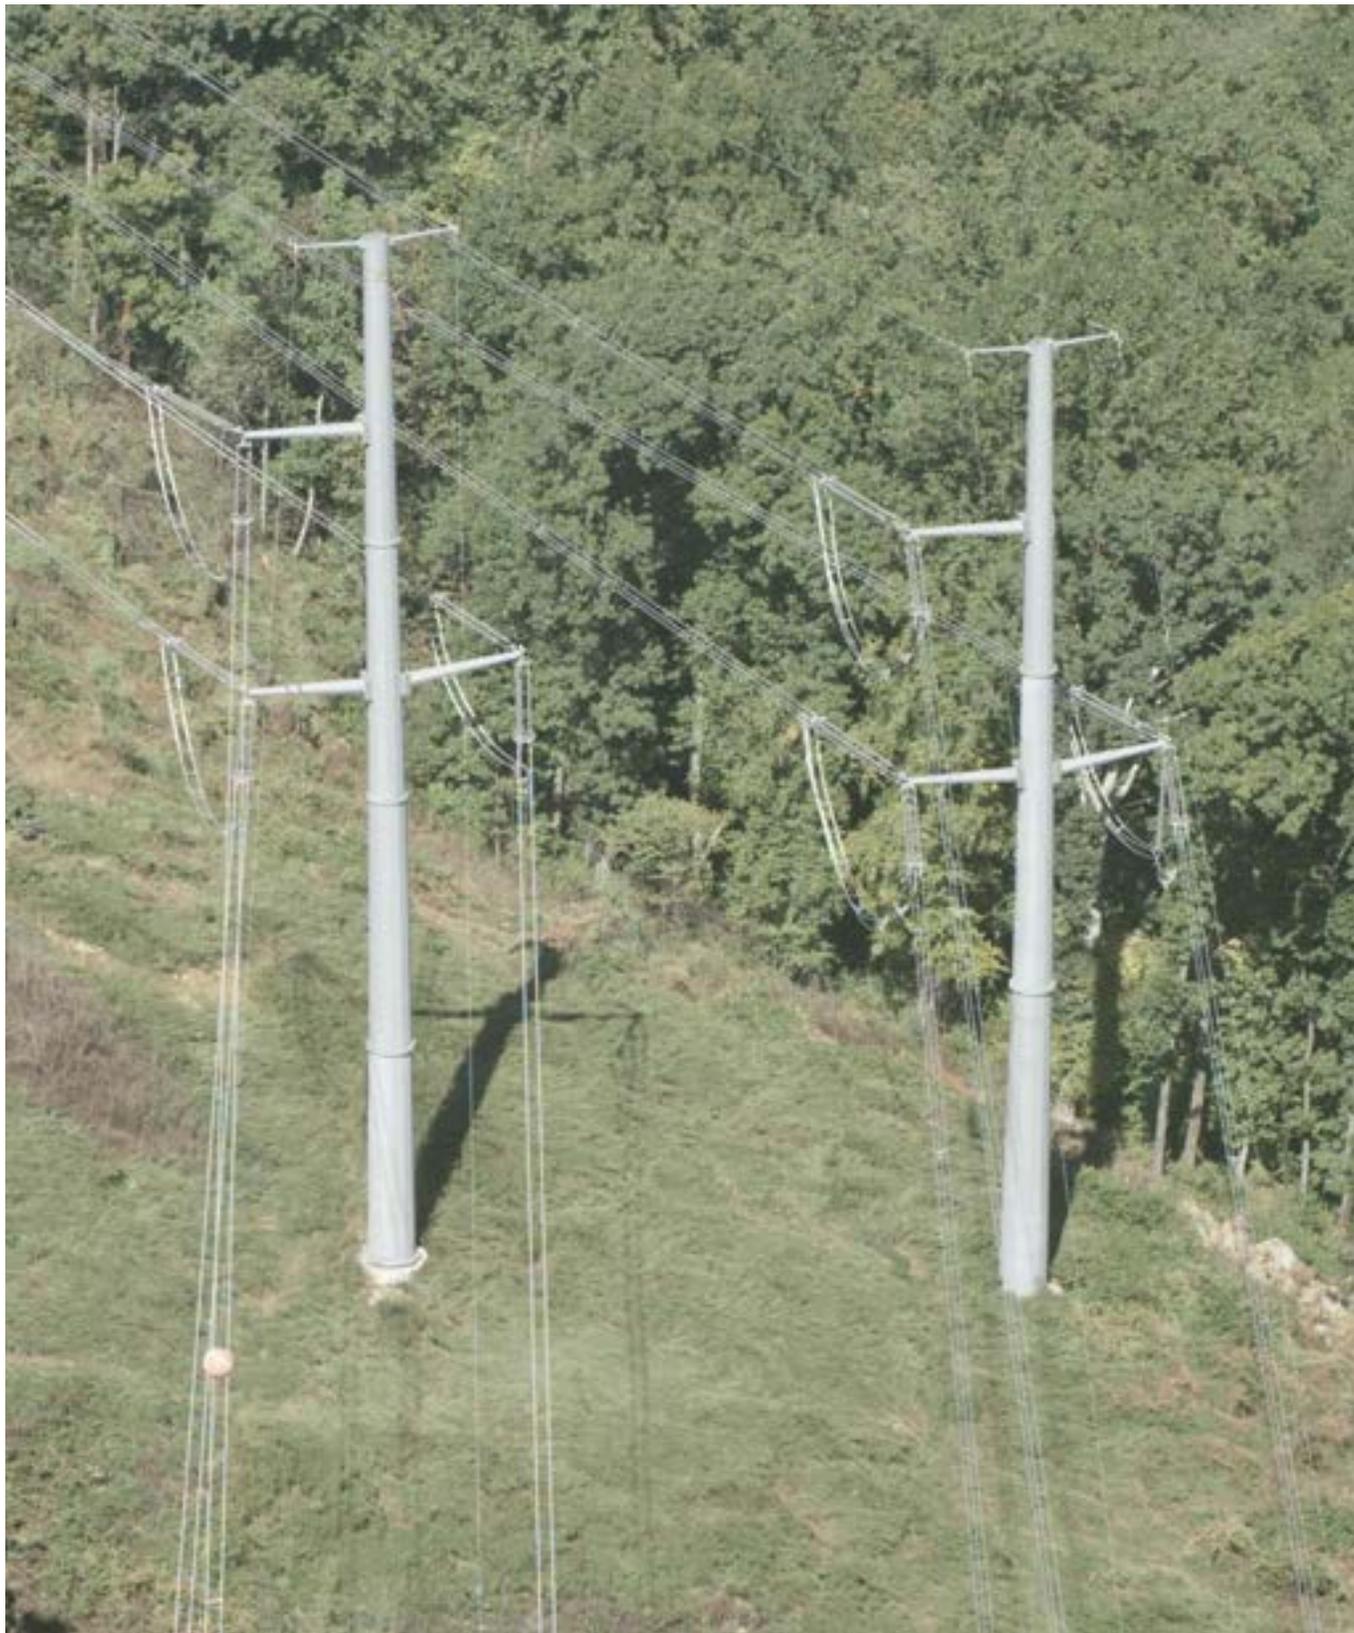
Proposed Structure Type:
500 kV Single Circuit Galvanized Steel Suspension Pole
Design Constraint Segment, Delta Configuration
***each lower arm would be on the inside of the structure**

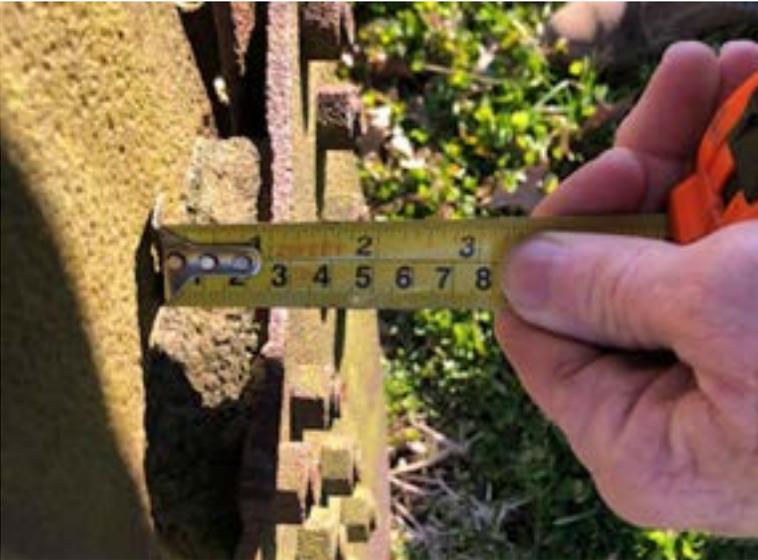
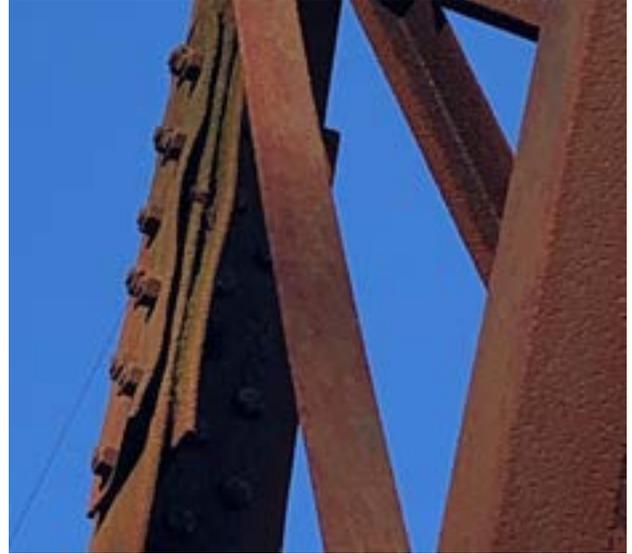
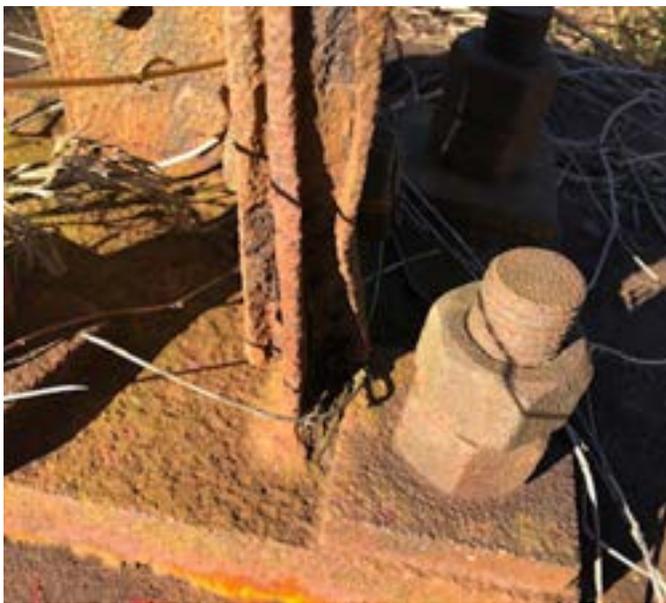
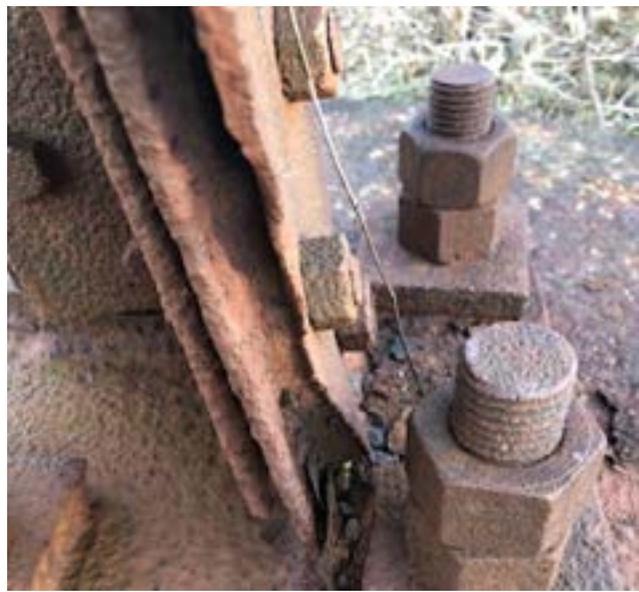
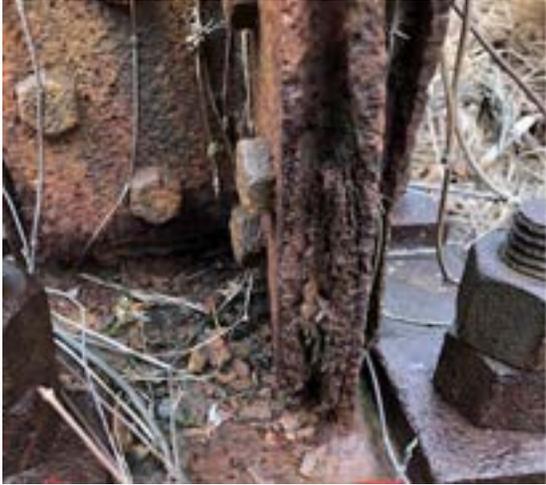
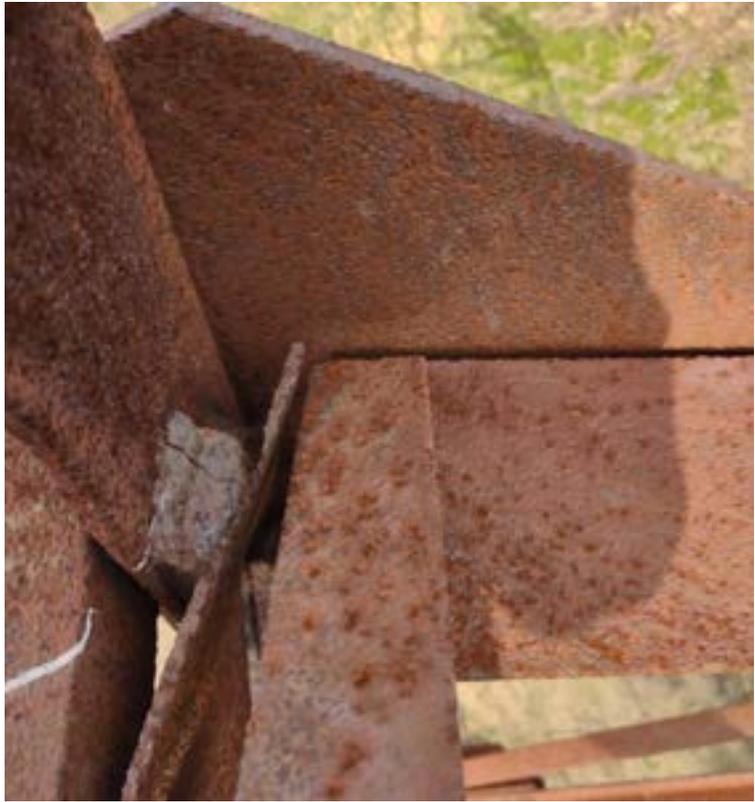
Severe Packout to Leg Members

(Strs. 186, 192, 193, 197, 198, 202, 203, 205, 207, 216, 217, 218, 220, 226)

Response: The proposed Line #588 Rebuild will replace aging infrastructure that is approaching the end of its service life. See Attachment I.L.1 for an overview of the rebuild, representative pictures of the deterioration of structures supporting Line #588, and non-structural related outstanding notifications. See also Attachment I.L.2 for the Transmission Specification Book containing the COR-TEN[®] Tower Monitoring Program for Line #588 Yadkin to Fentress and Attachment I.L.3 for Weathering Steel Tower Inspection/Rehabilitation Data Sheets.

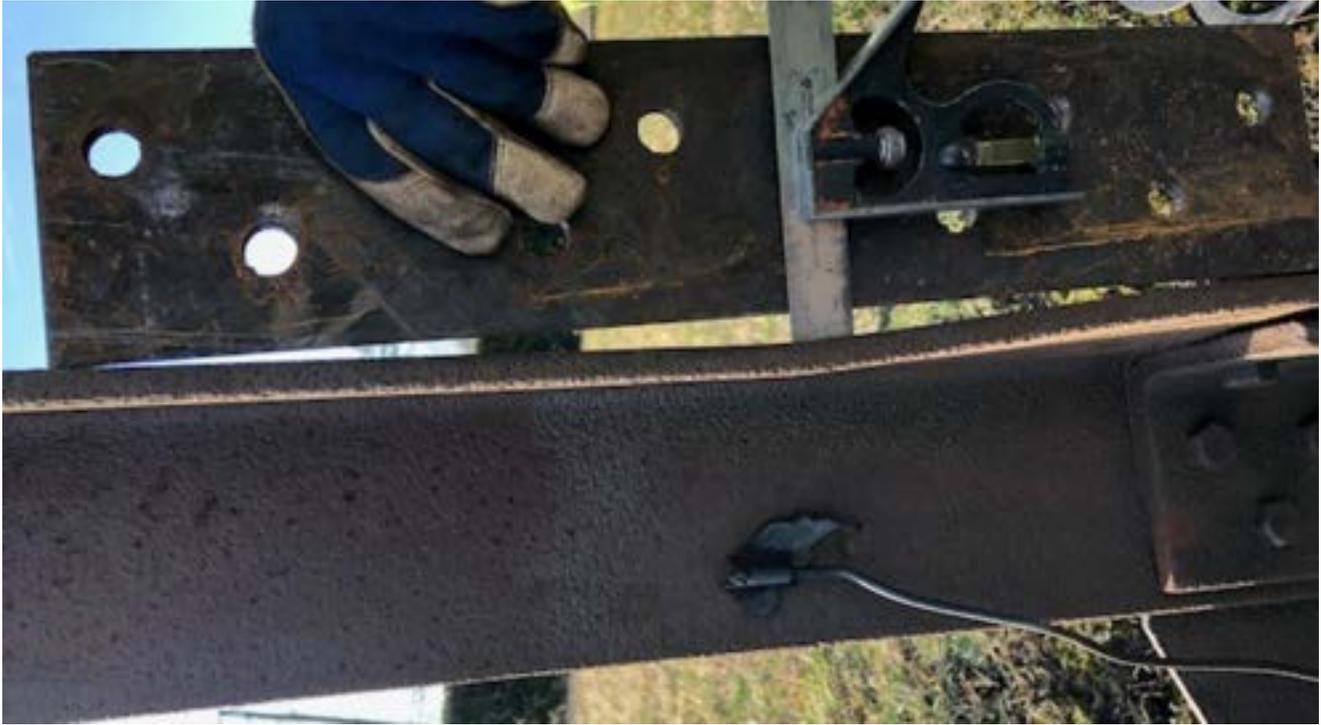
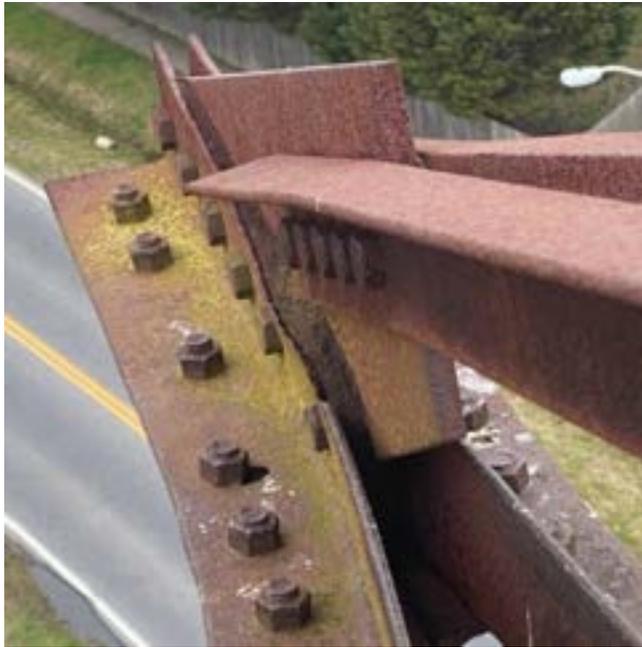
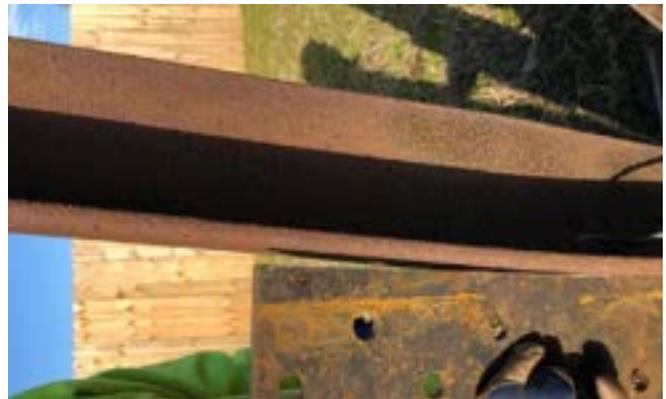
Bent Members
(Strs. 196, 237)

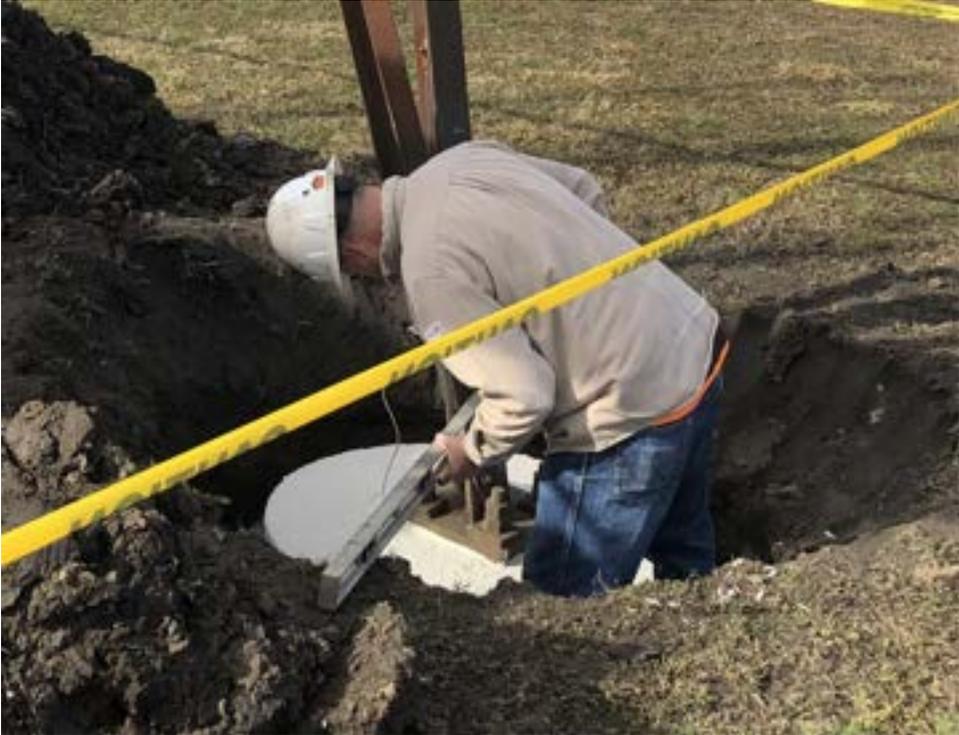
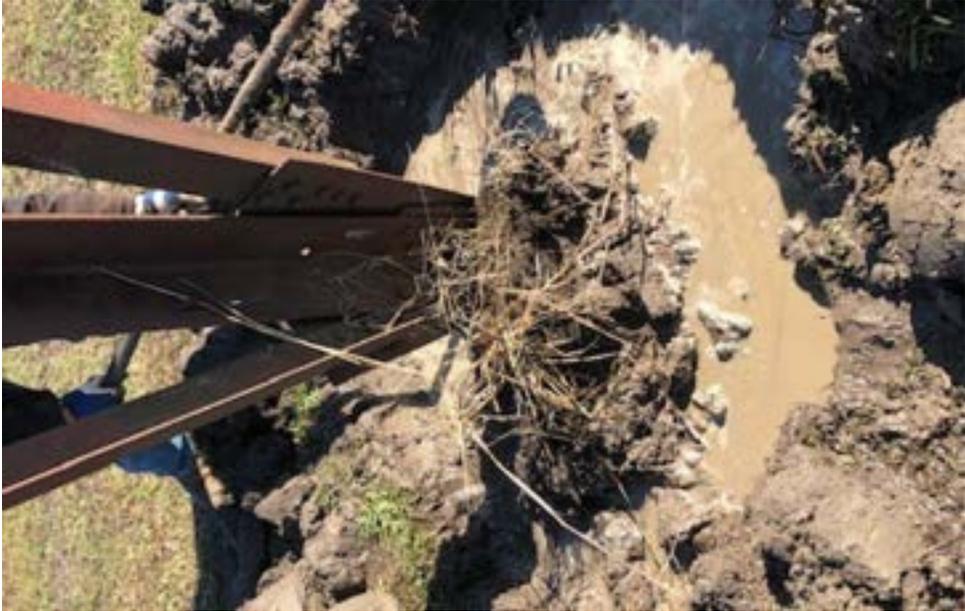
Foundation Rehab

(Str. 195)

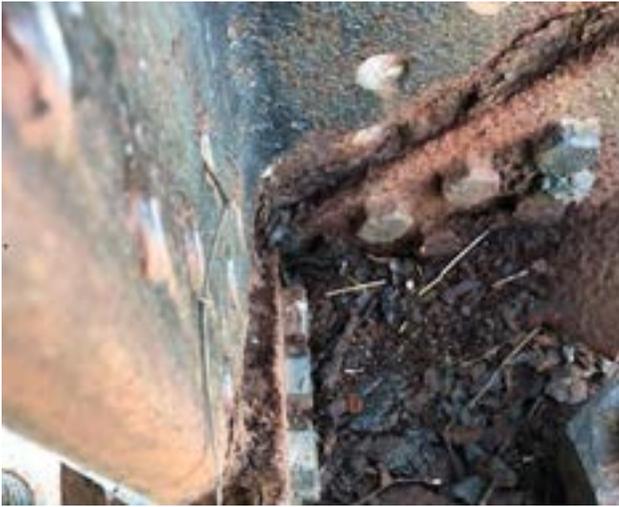
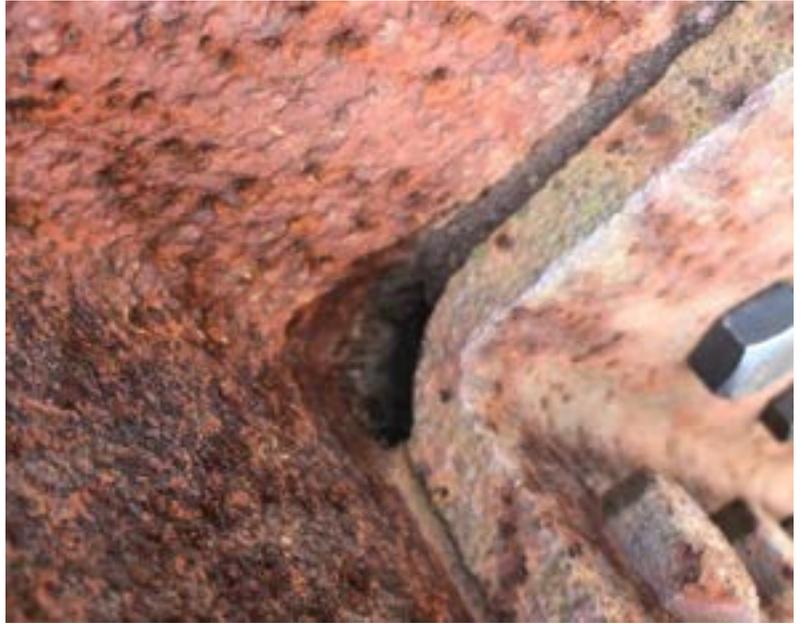
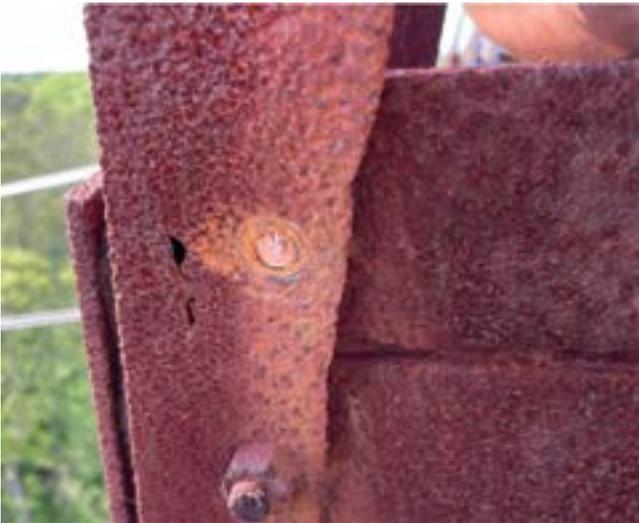
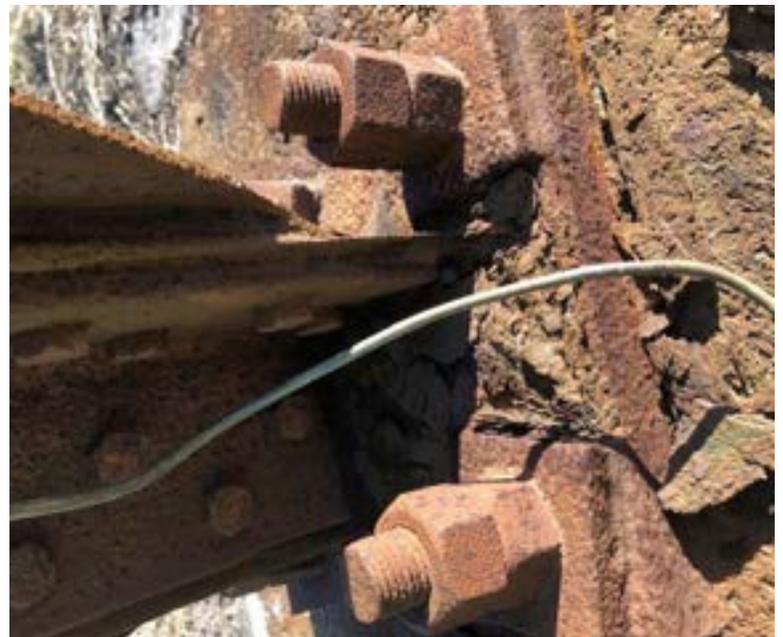
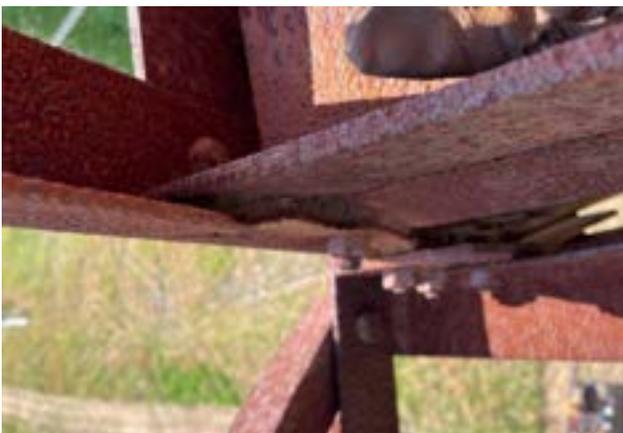
Corrosion and Member Thinning
(Strs. 197, 222, 227, 229, 237)

- Third party assessment has determined that the towers have corroded to a point where they exhibit pre-mature thinning of structure members and pack-out at joints. If left unaddressed these issues could result in failure of structures and potentially the collapse of the line. (DOM-O1)

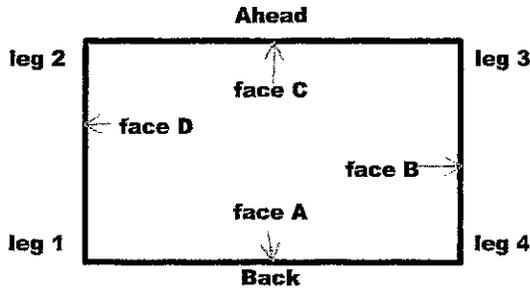
Structure No: 192

Tower Orientation

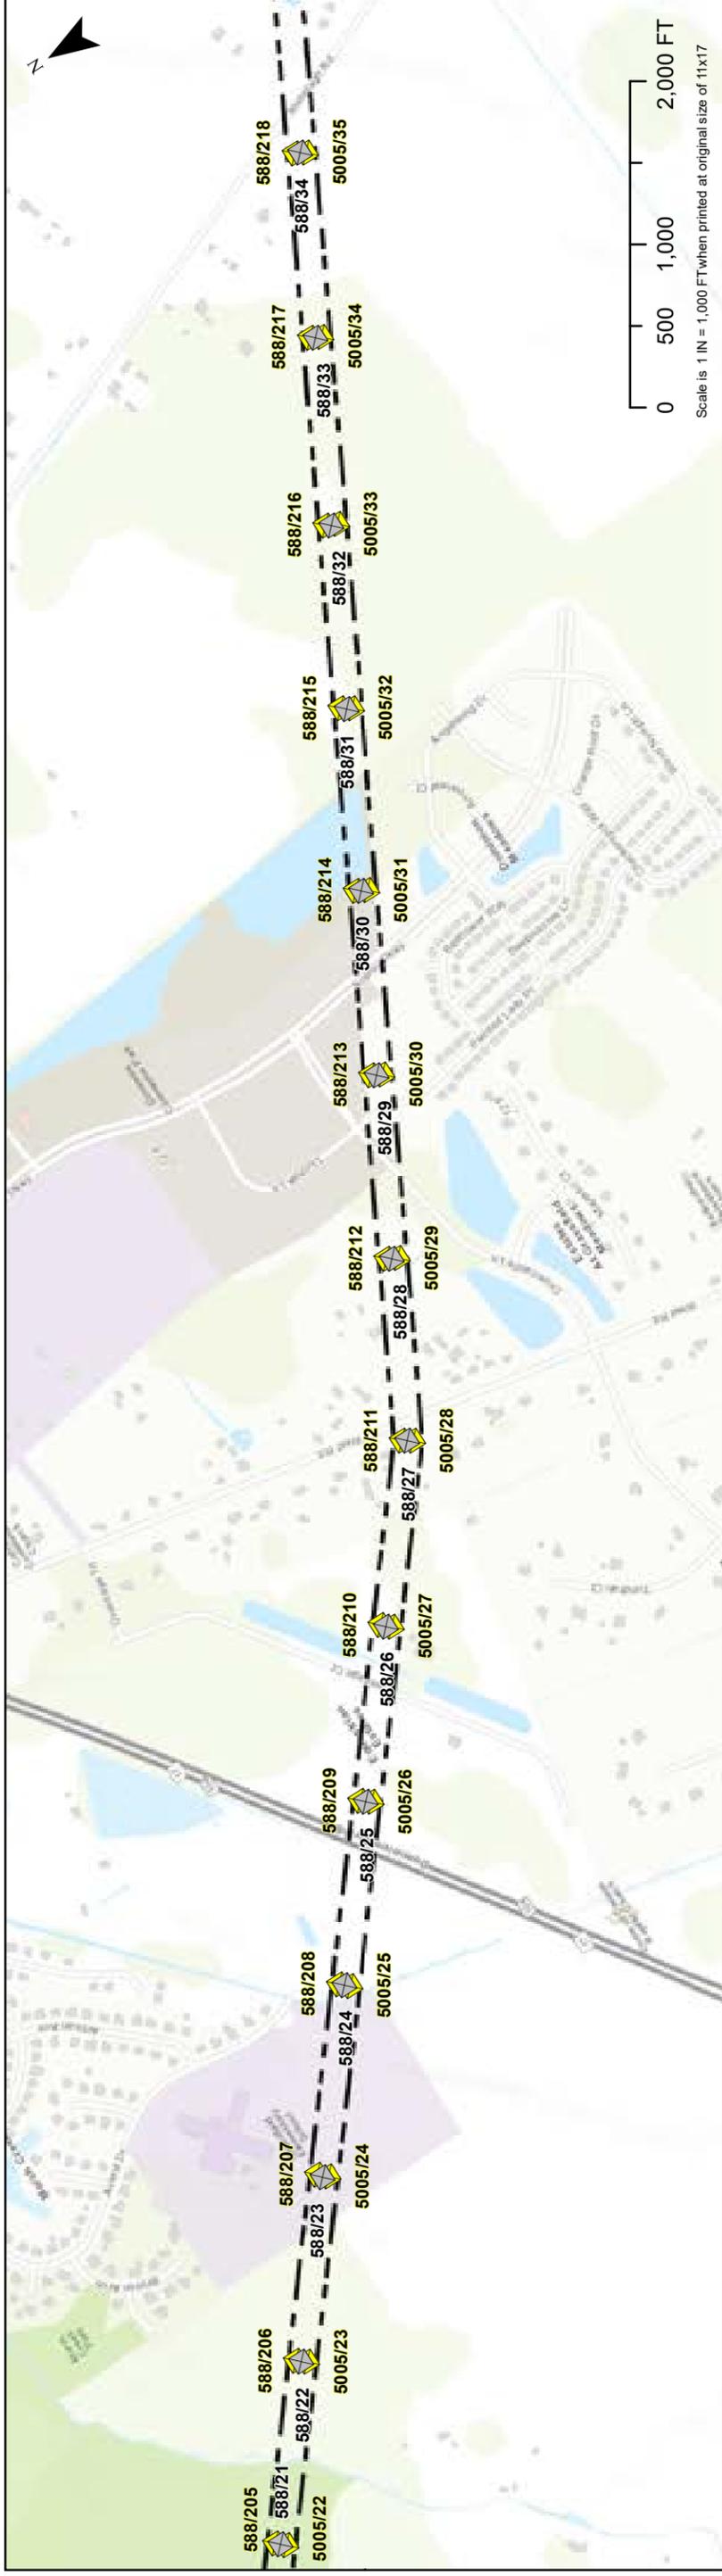
SHEET 3 OF 6

Existing Line #588 Structure Number	588/21	588/22	588/23	588/24	588/25	588/26	588/27	588/28	588/29	588/30	588/31	588/32	588/33	588/34
Existing Height (FT)	116	116	116	127	106	121	121	111	121	111	121	116	121	116
Proposed Line #588 Structure Number	588/205	588/206	588/207	588/208	588/209	588/210	588/211	588/212	588/213	588/214	588/215	588/216	588/217	588/218
Proposed Height (FT)	187	187	192	187	187	192	182	197	197	187	187	187	187	187
Proposed Line #5005 Structure Number	5005/22	5005/23	5005/24	5005/25	5005/26	5005/27	5005/28	5005/29	5005/30	5005/31	5005/32	5005/33	5005/34	5005/35
Proposed Height	187	187	192	187	187	192	182	197	197	187	187	192	187	187

1. Structure locations and heights provided by Dominion Energy Virginia.
2. Project and structures are subject to change based on final engineering design. The proposed structure heights are above ground level, and exclude foundation reveal.
3. Basemap from ESRI Topographic and World Street Map.

Response: See Attachment II.B.3.d for approximate structure locations and existing and proposed structure heights for the proposed Project. The proposed approximate structure heights are from the conceptual design created to estimate the cost of the proposed Project and are subject to change based on final engineering design. The approximate structure heights do not include foundation reveal.

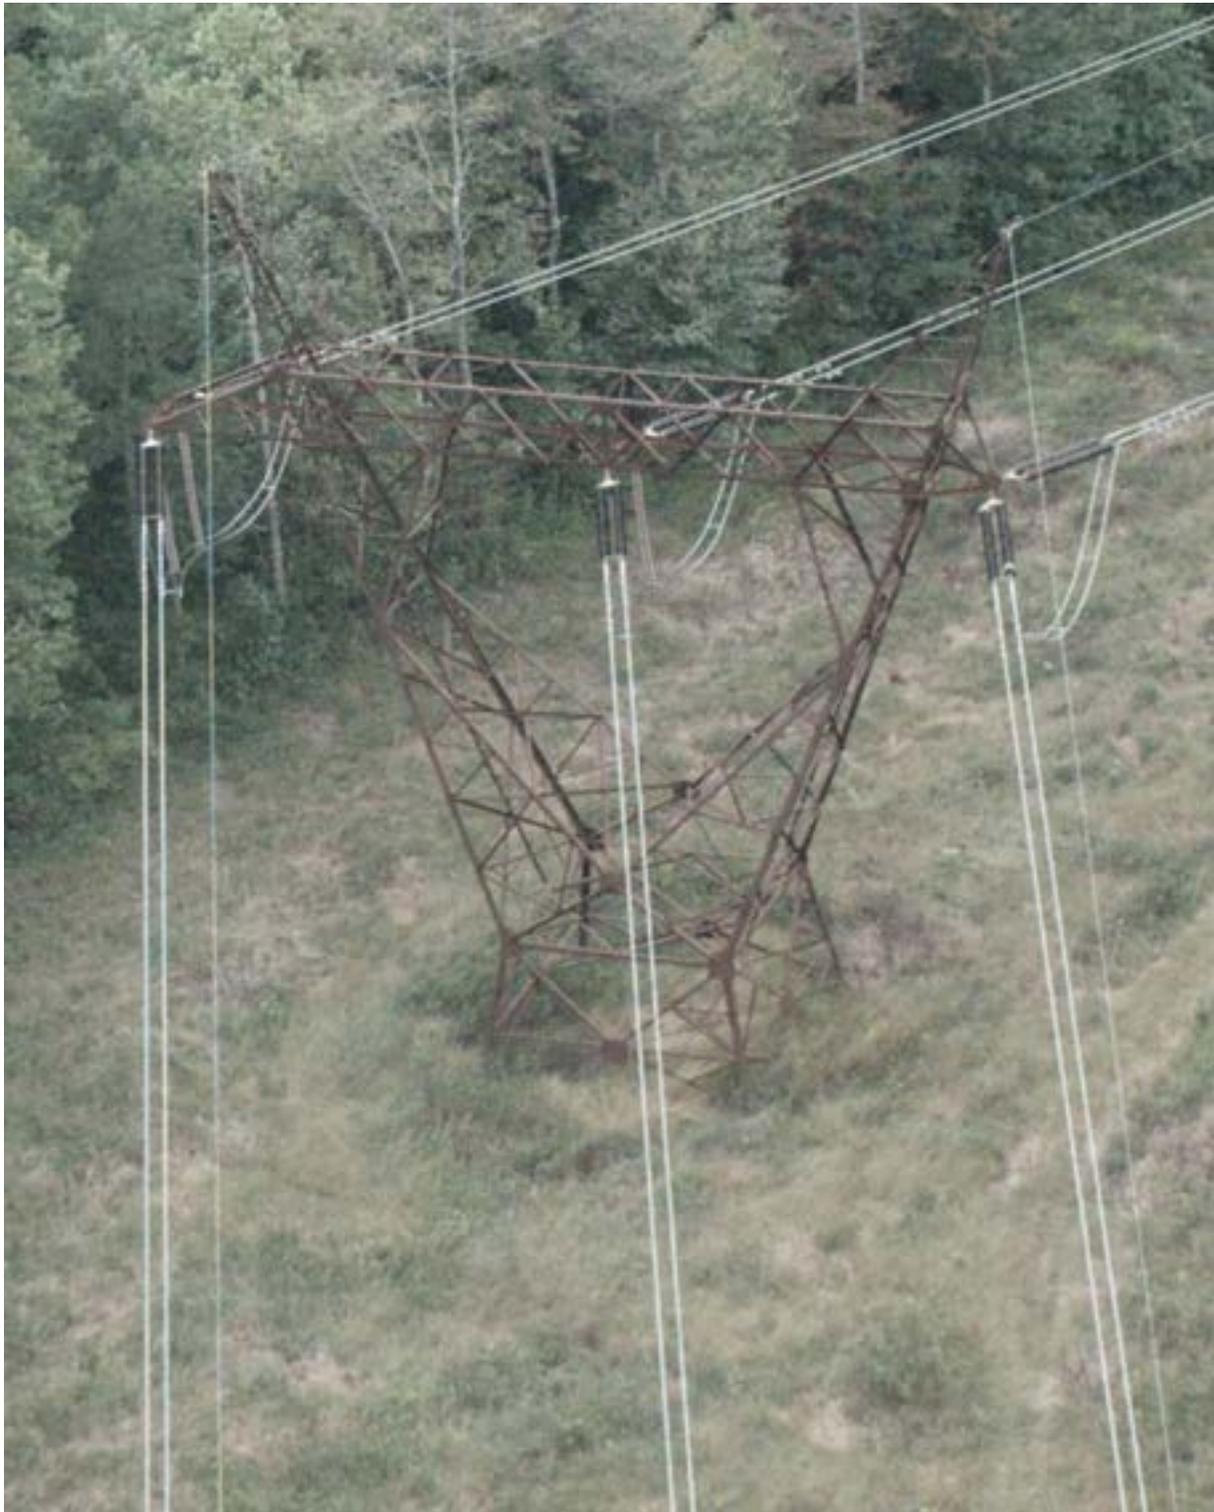
**Existing Structure Type:
500 kV Single Circuit Weathering Steel Tower (Double Deadend)**

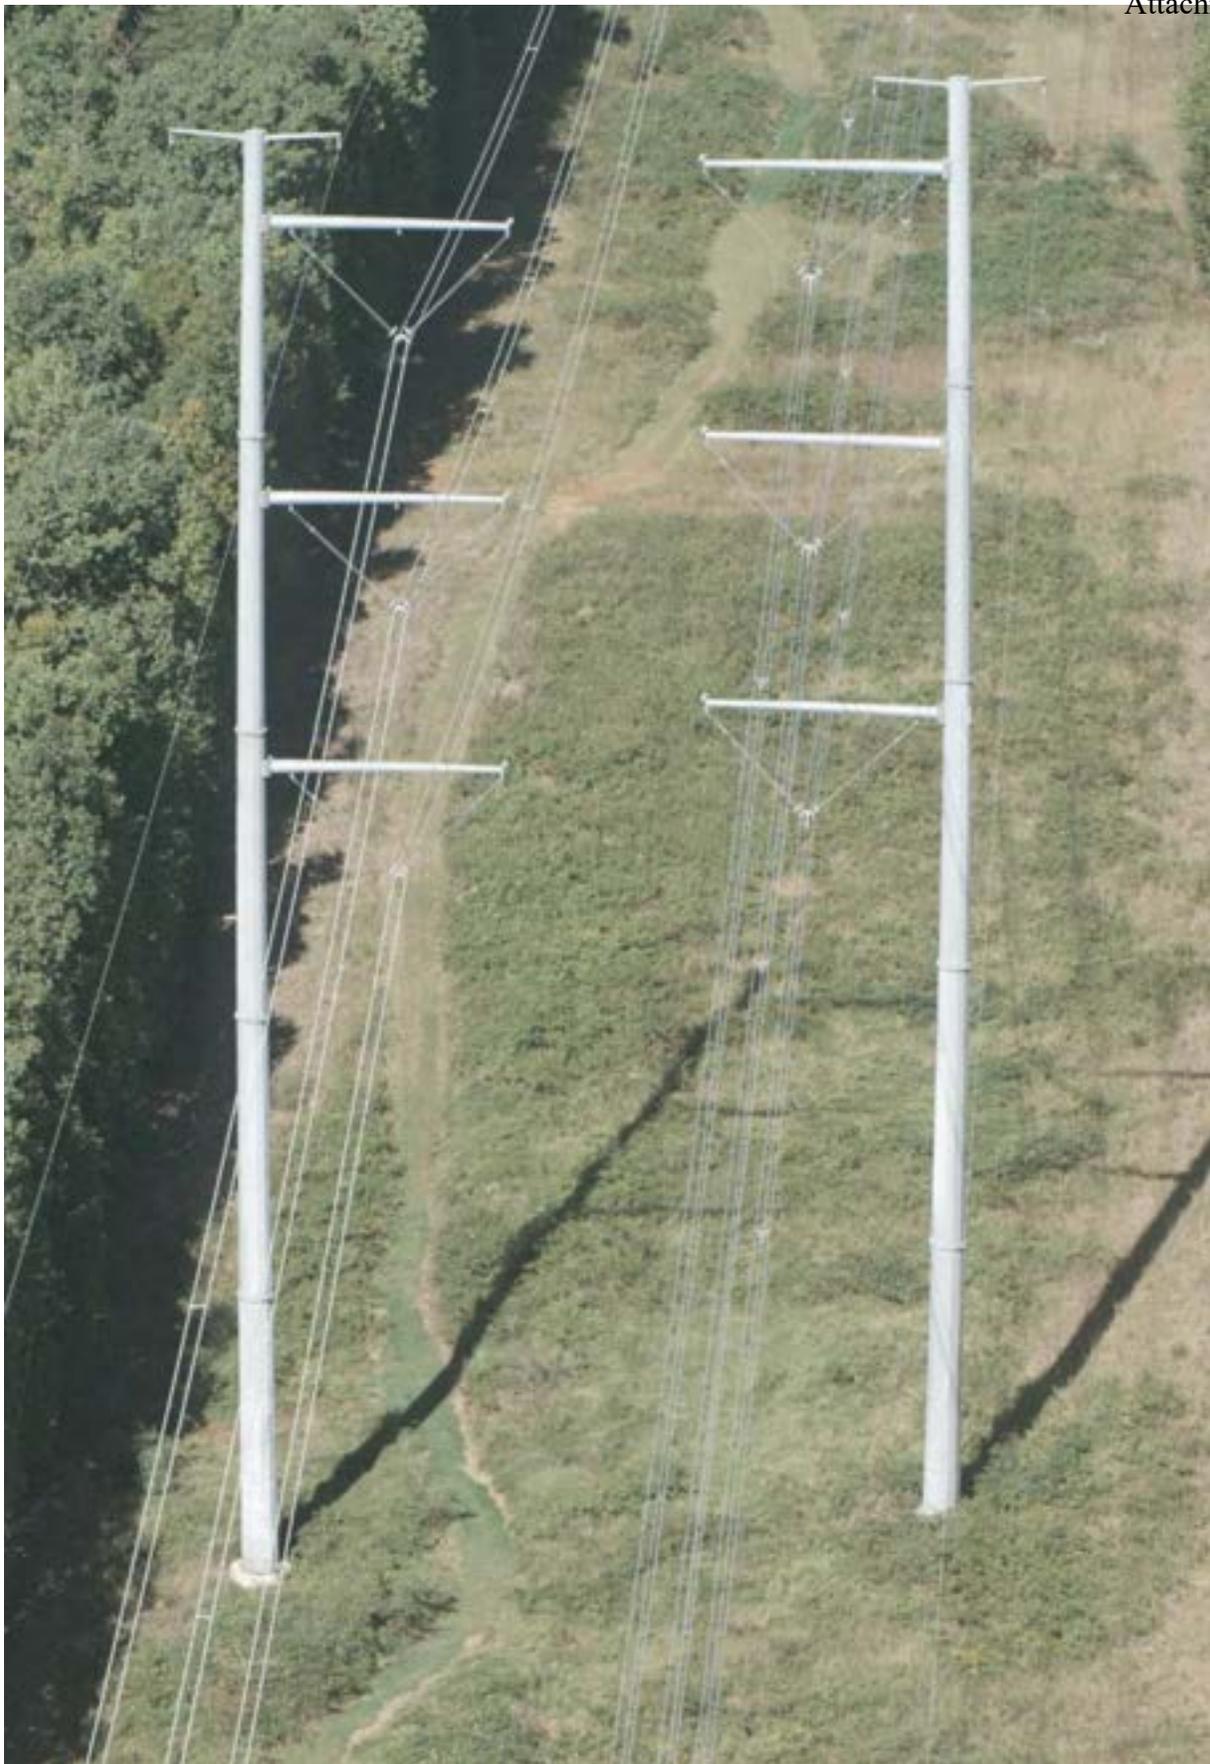
Attachment II.B.6.b.i

**Proposed Structure Type:
500 kV Single Circuit Galvanized Steel Suspension Pole**

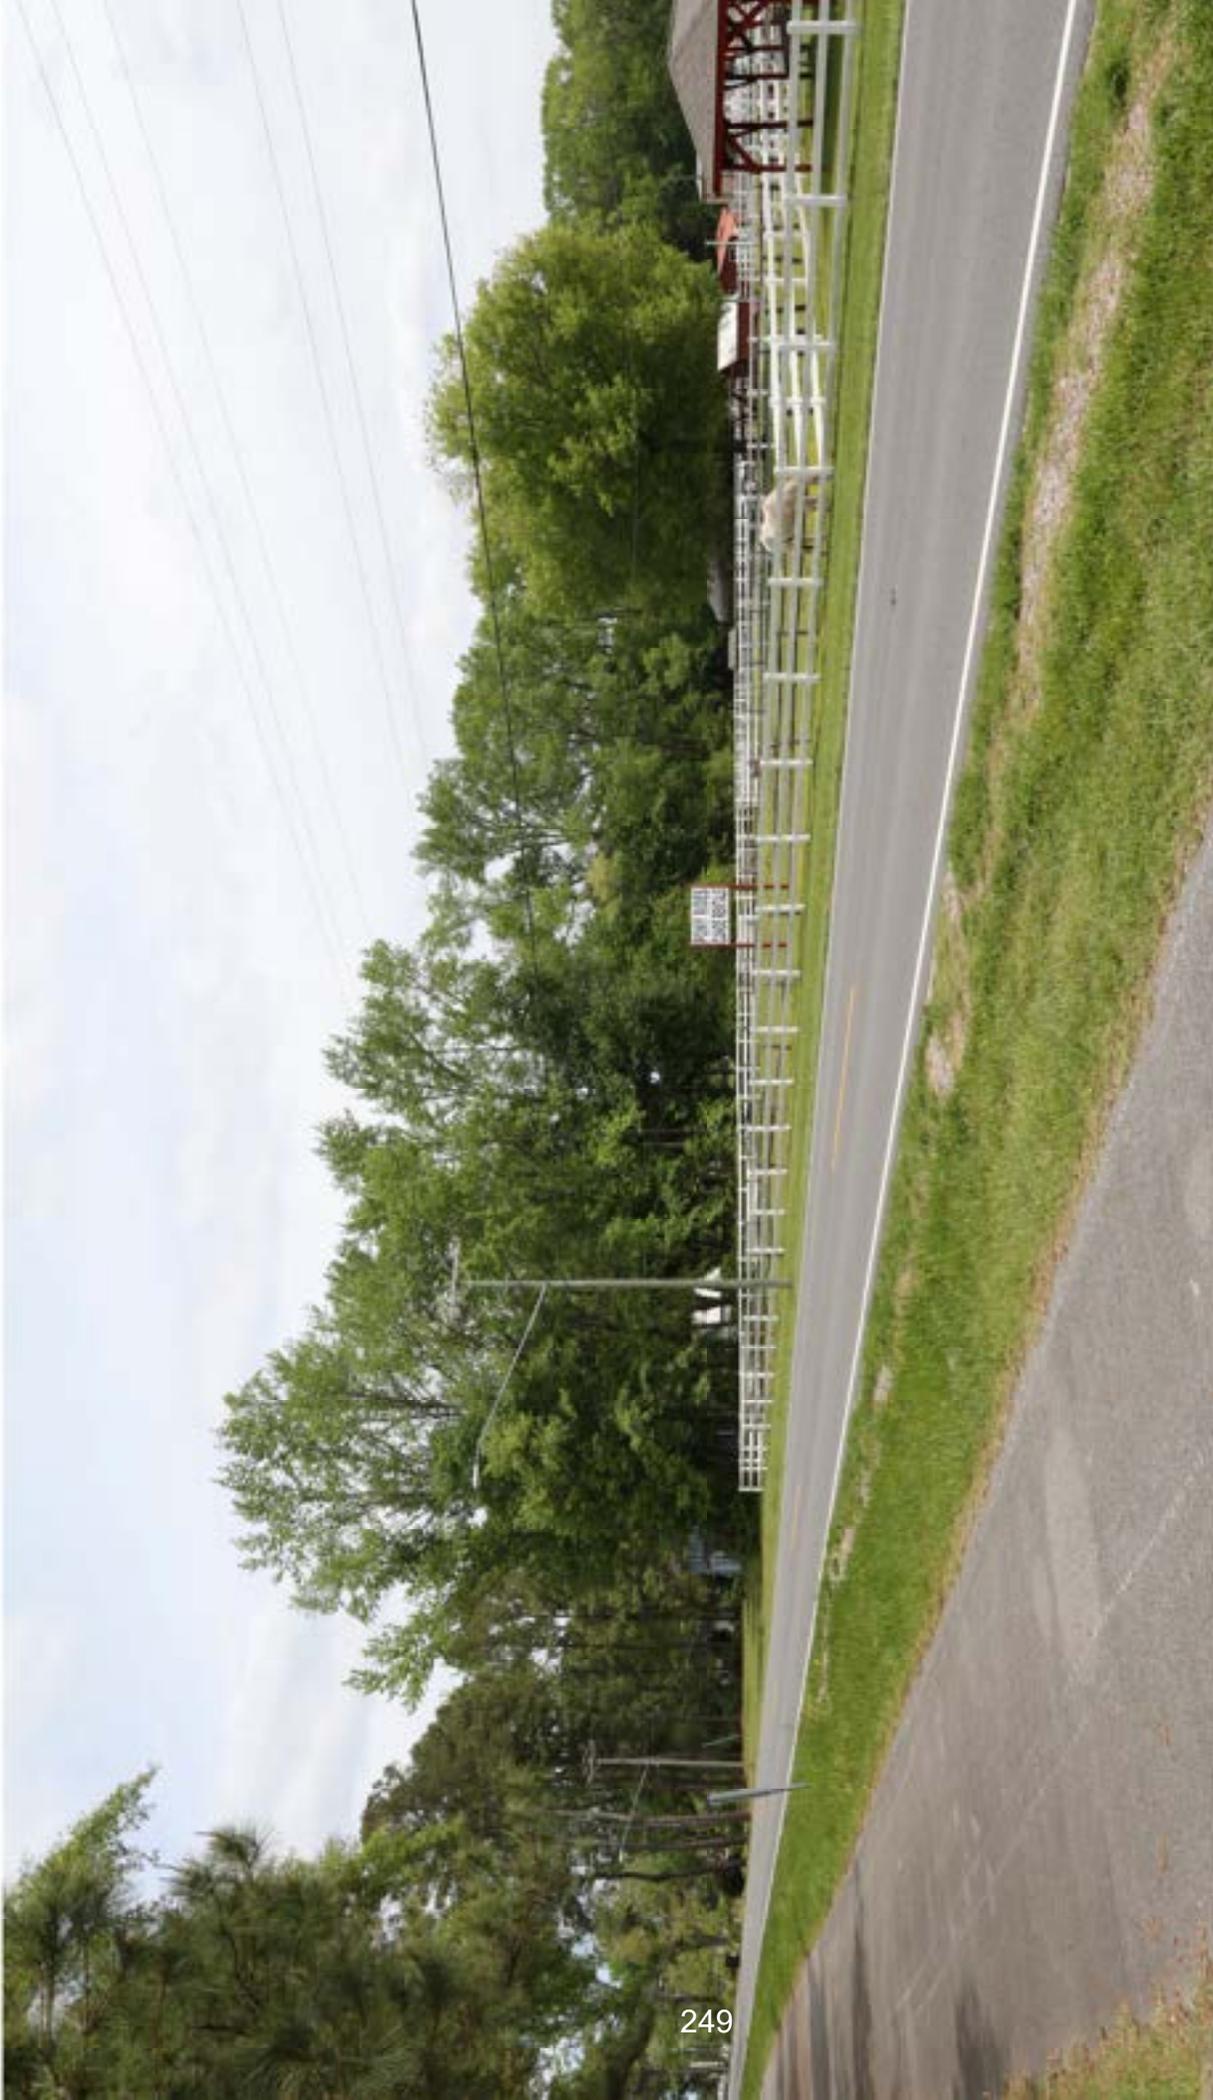
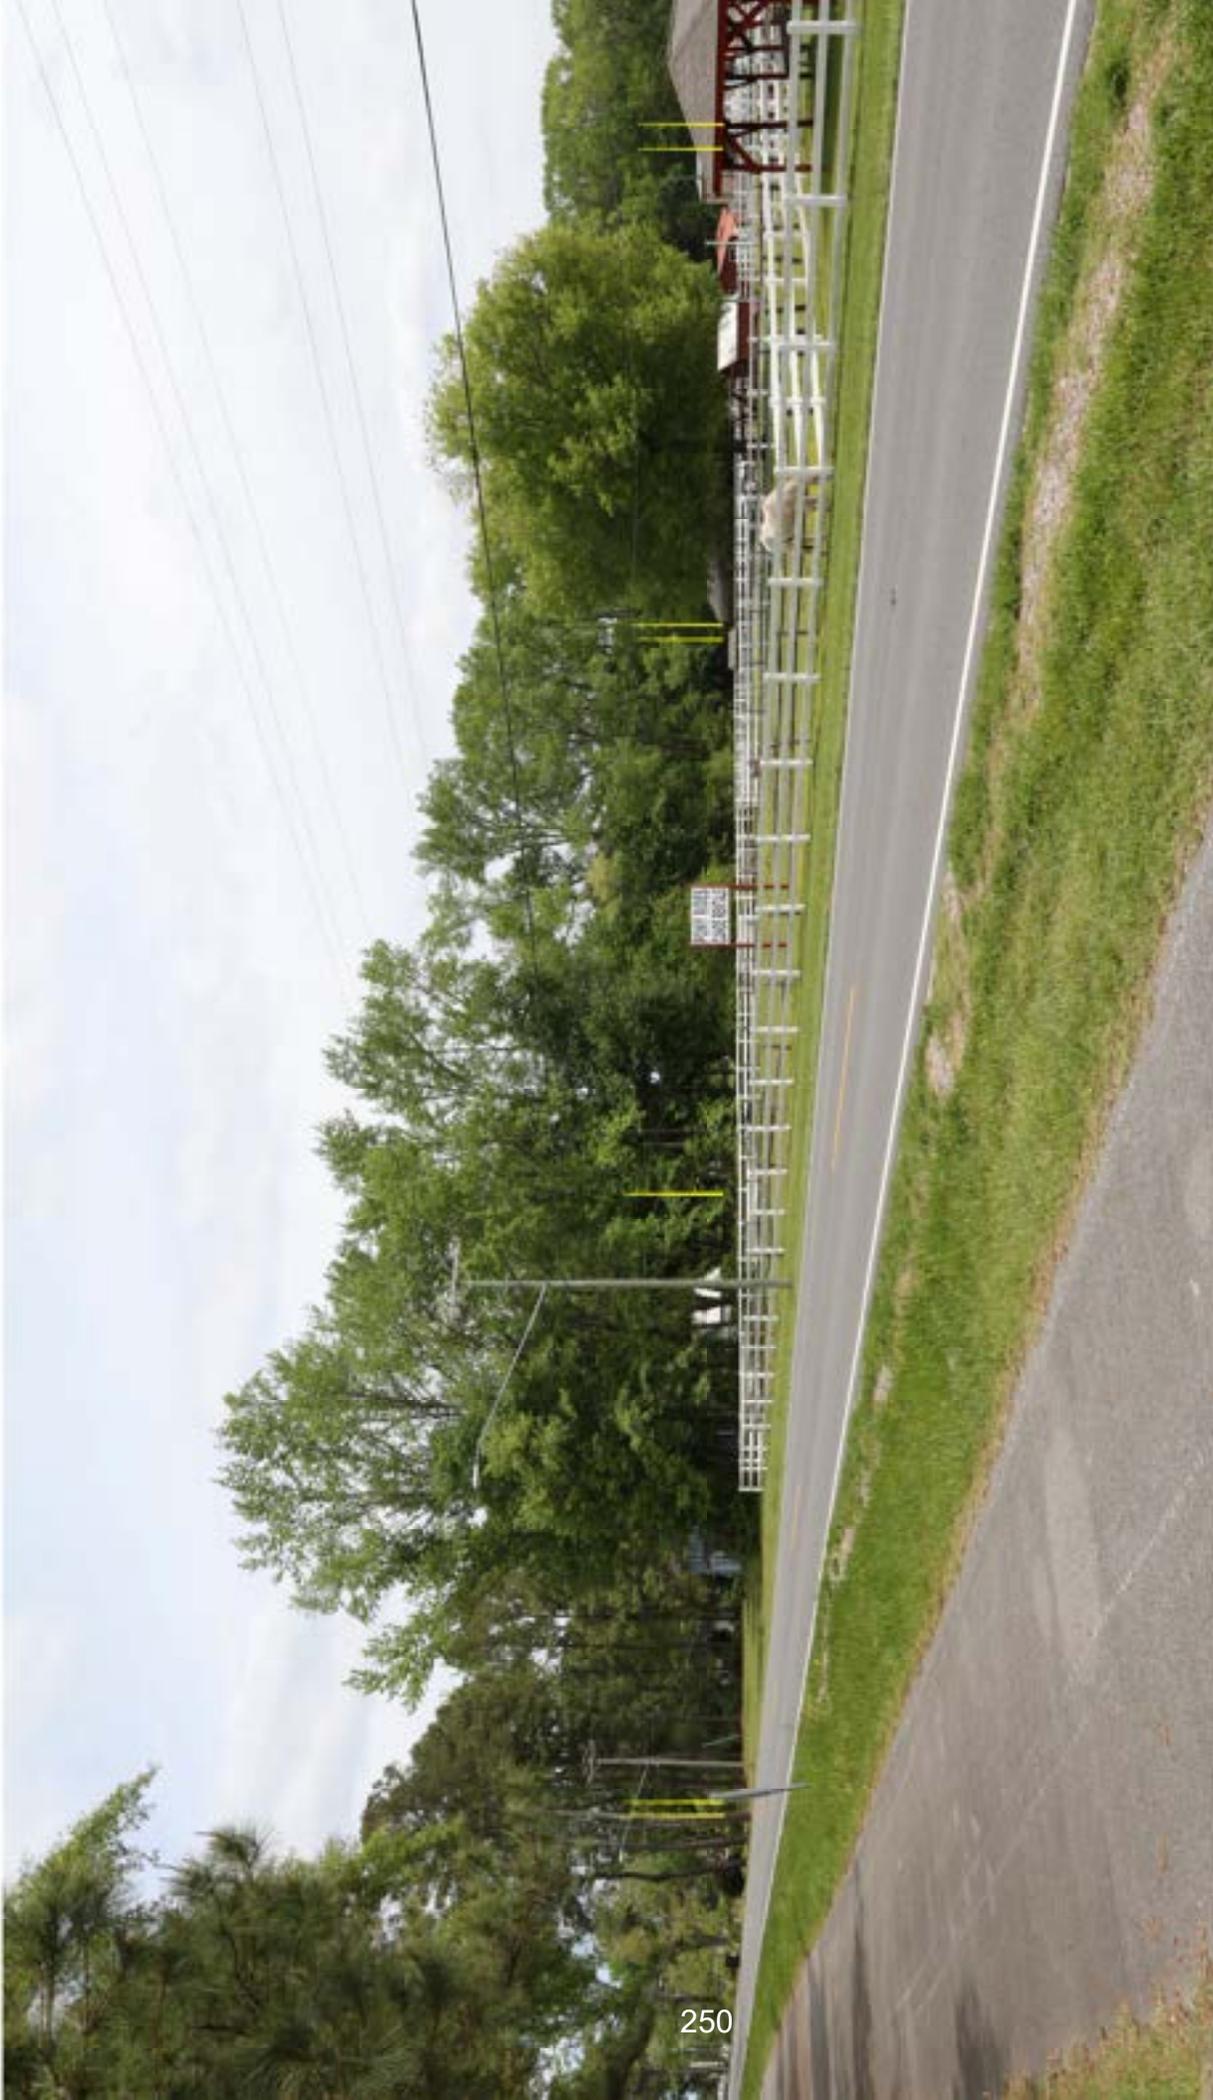
Viewpoint 1: Dismal Swamp Canal

<p>Photo simulations prepared by: GTE LLC info@gteinc.com 703.447.1350</p>	<p>Fentress-Yadkin 500kV Line #588 Rebuild & New 500kV Fentress-Yadkin Line #5005</p> <p>Photo Simulations and diagrams represent approximate heights for electric transmission structures from the conceptual design used for the proposed project. These illustrations do not necessarily depict exact structure design or location.</p>	<p>Viewpoint 1 Dismal Swamp Canal</p>	<p>Proposed View (Location of towers not visible are overlaid with yellow lower icons)</p>
