Application of Virginia Electric and Power Company for approval and certification of electric transmission facilities: Fentress-Yadkin 500 kV Line #588 Rebuild and New 500 kV Fentress-Yadkin Line #5005
Case No. PUR-2024-00105

ATTACHMENT I.A.1
PROJECT OVERVIEW MAP
 Fentress-Yadkin 500 KV Line #588 Rebuild and
 New 500 KV Fentress-Yadkin Line #5005
 City of Chesapeake, Virginia

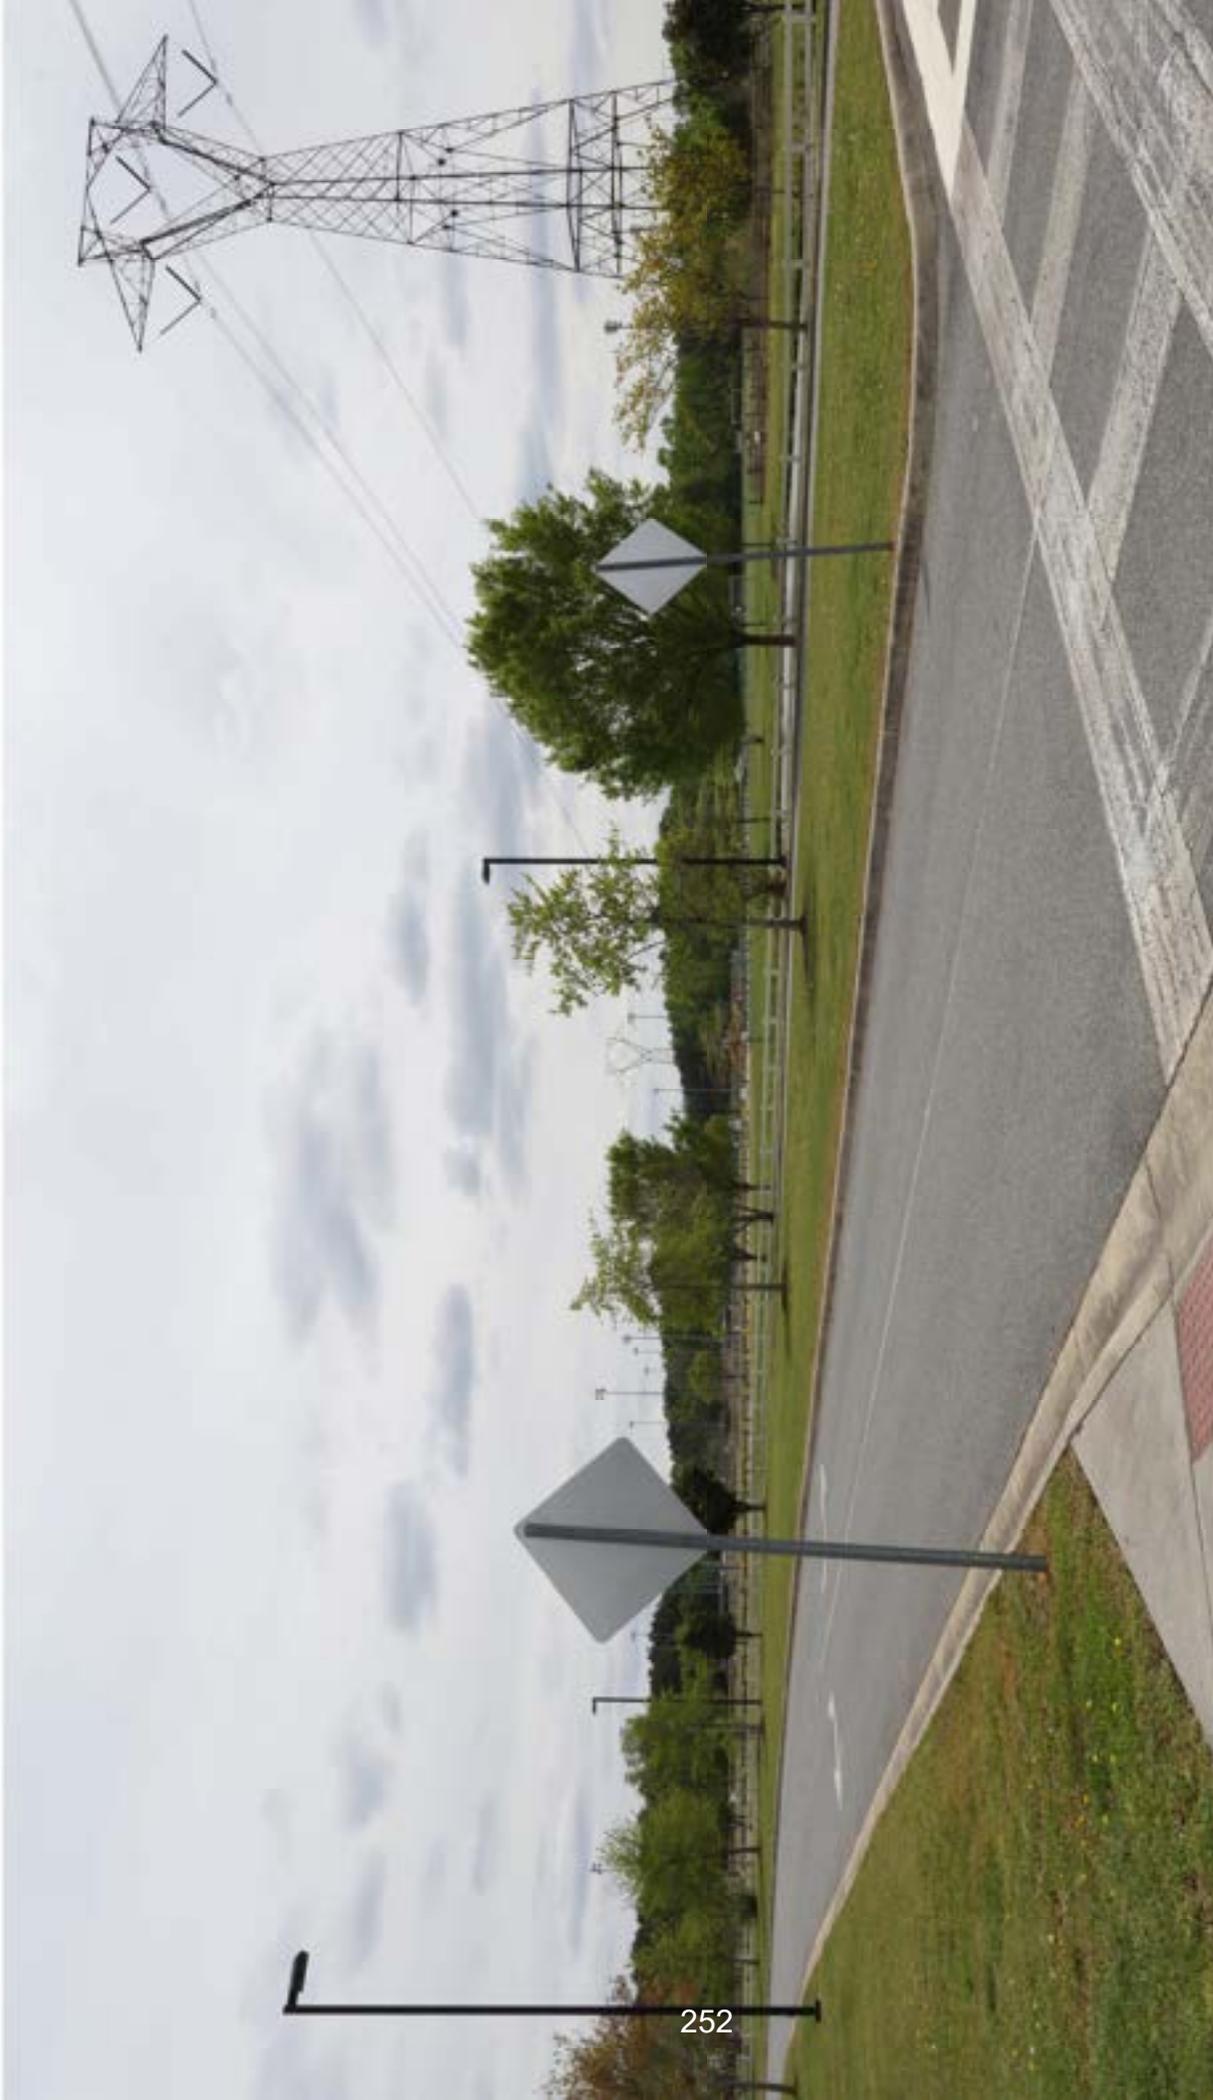
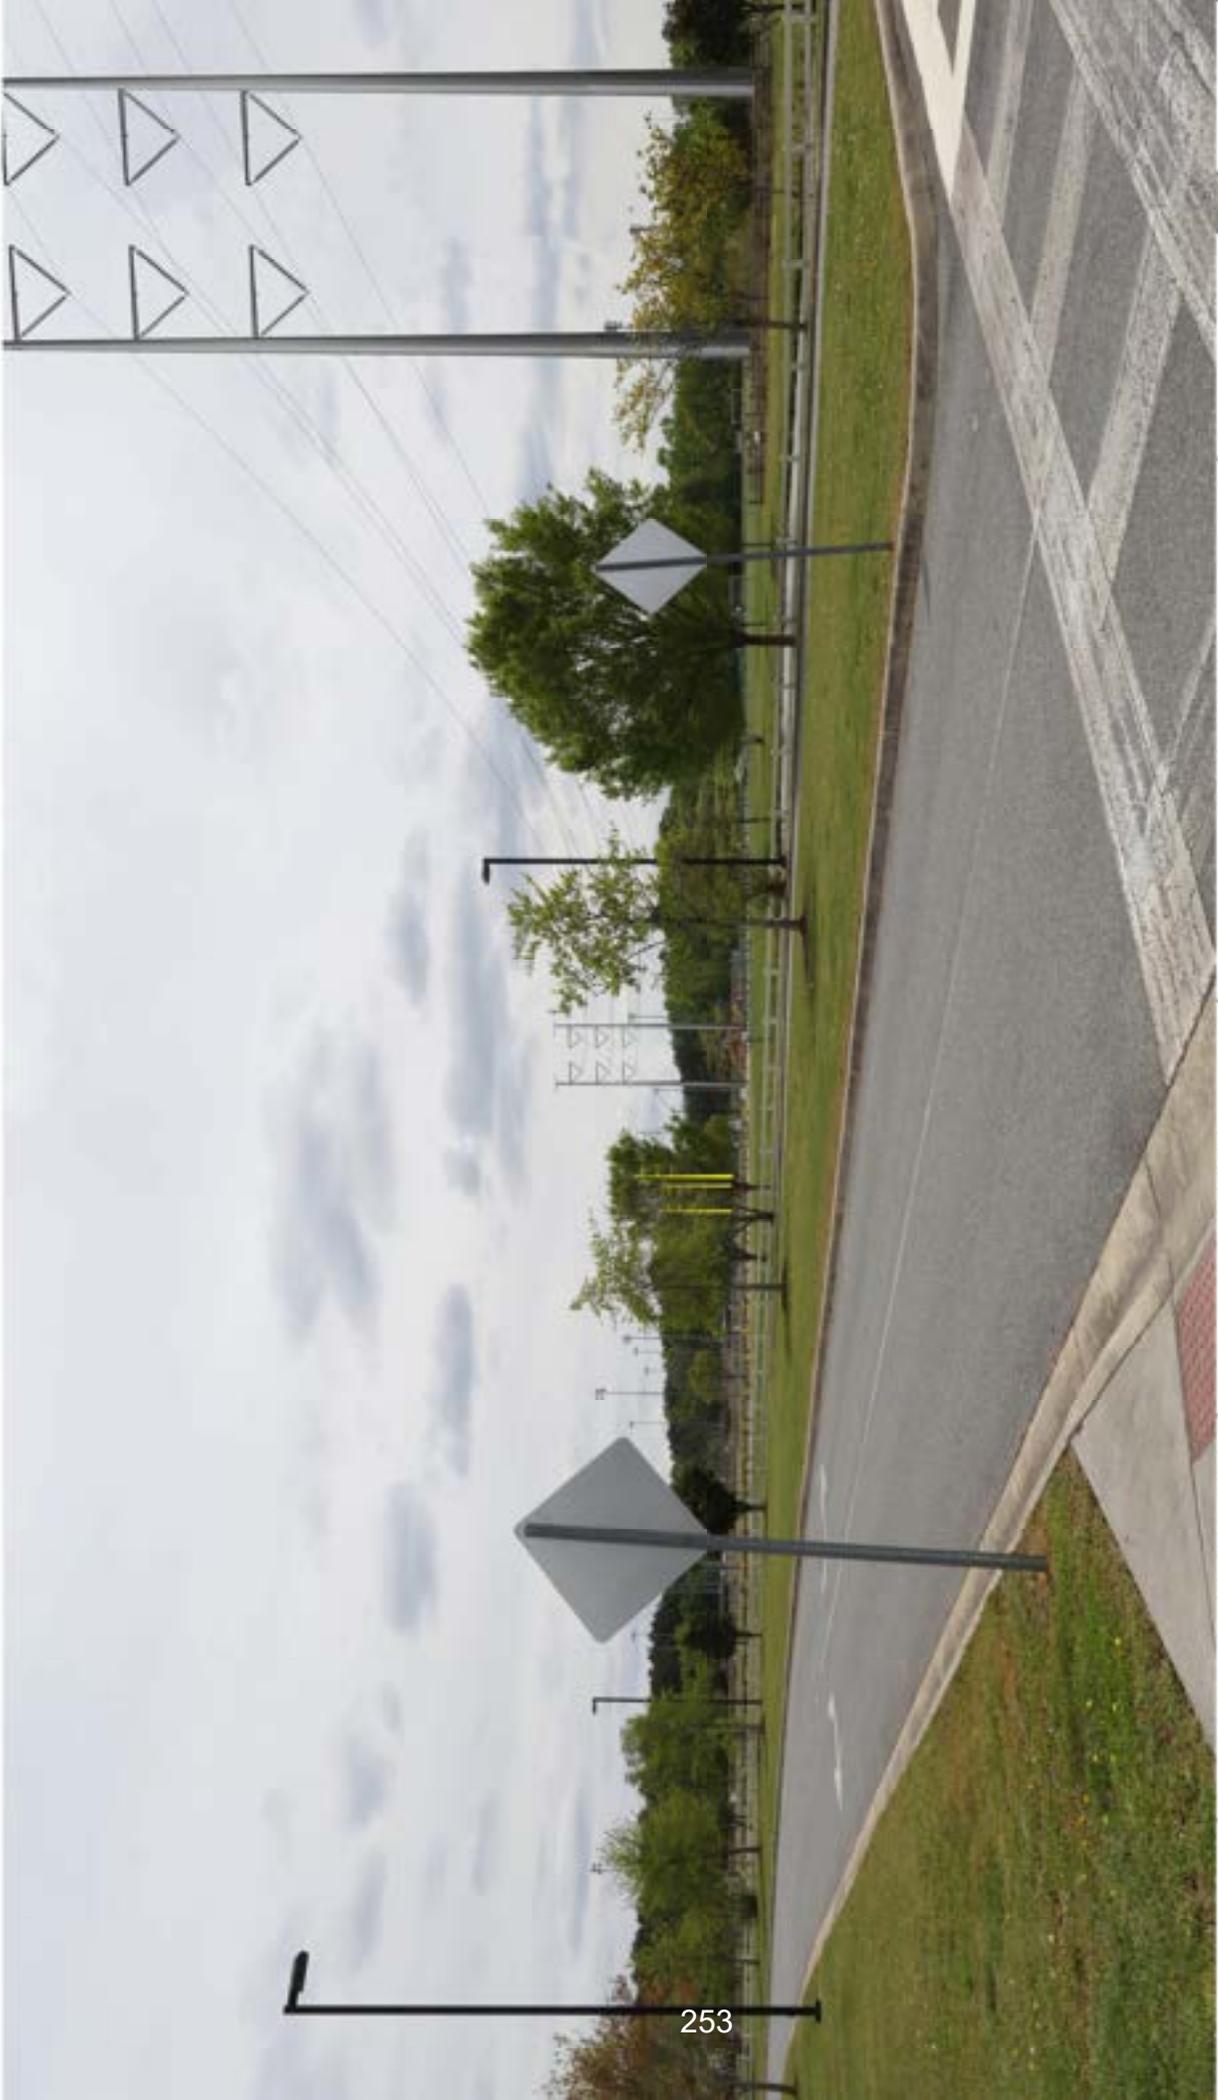
Viewpoint 2 Dismal Swamp Canal

**Viewpoint 2
Dismal Swamp Canal**

Photo Simulations and diagrams represent approximate heights for electric transmission structures from the conceptual design used for the proposed project. These illustrations do not necessarily depict exact structure design or location.

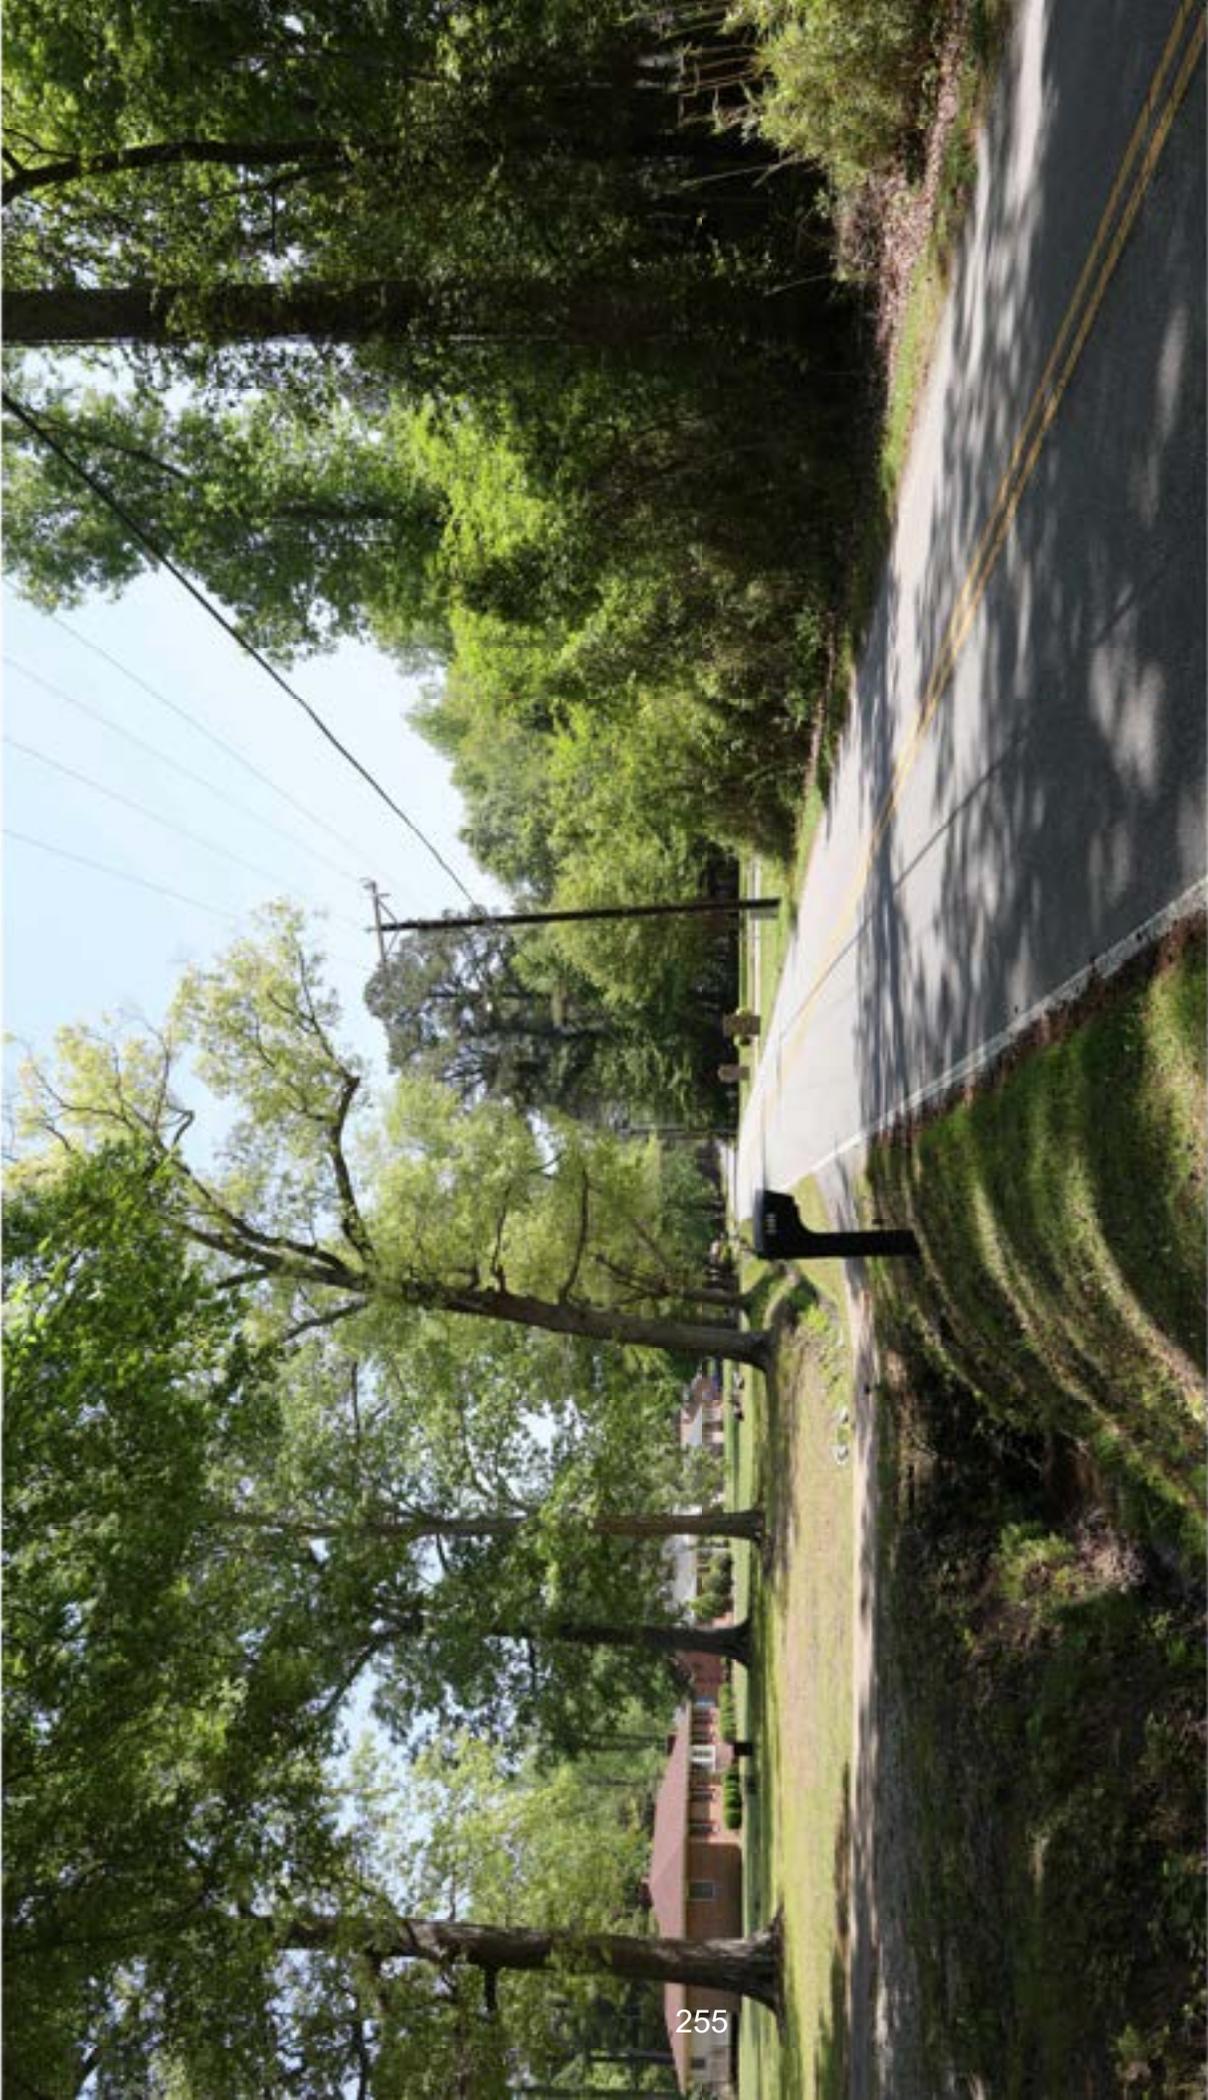
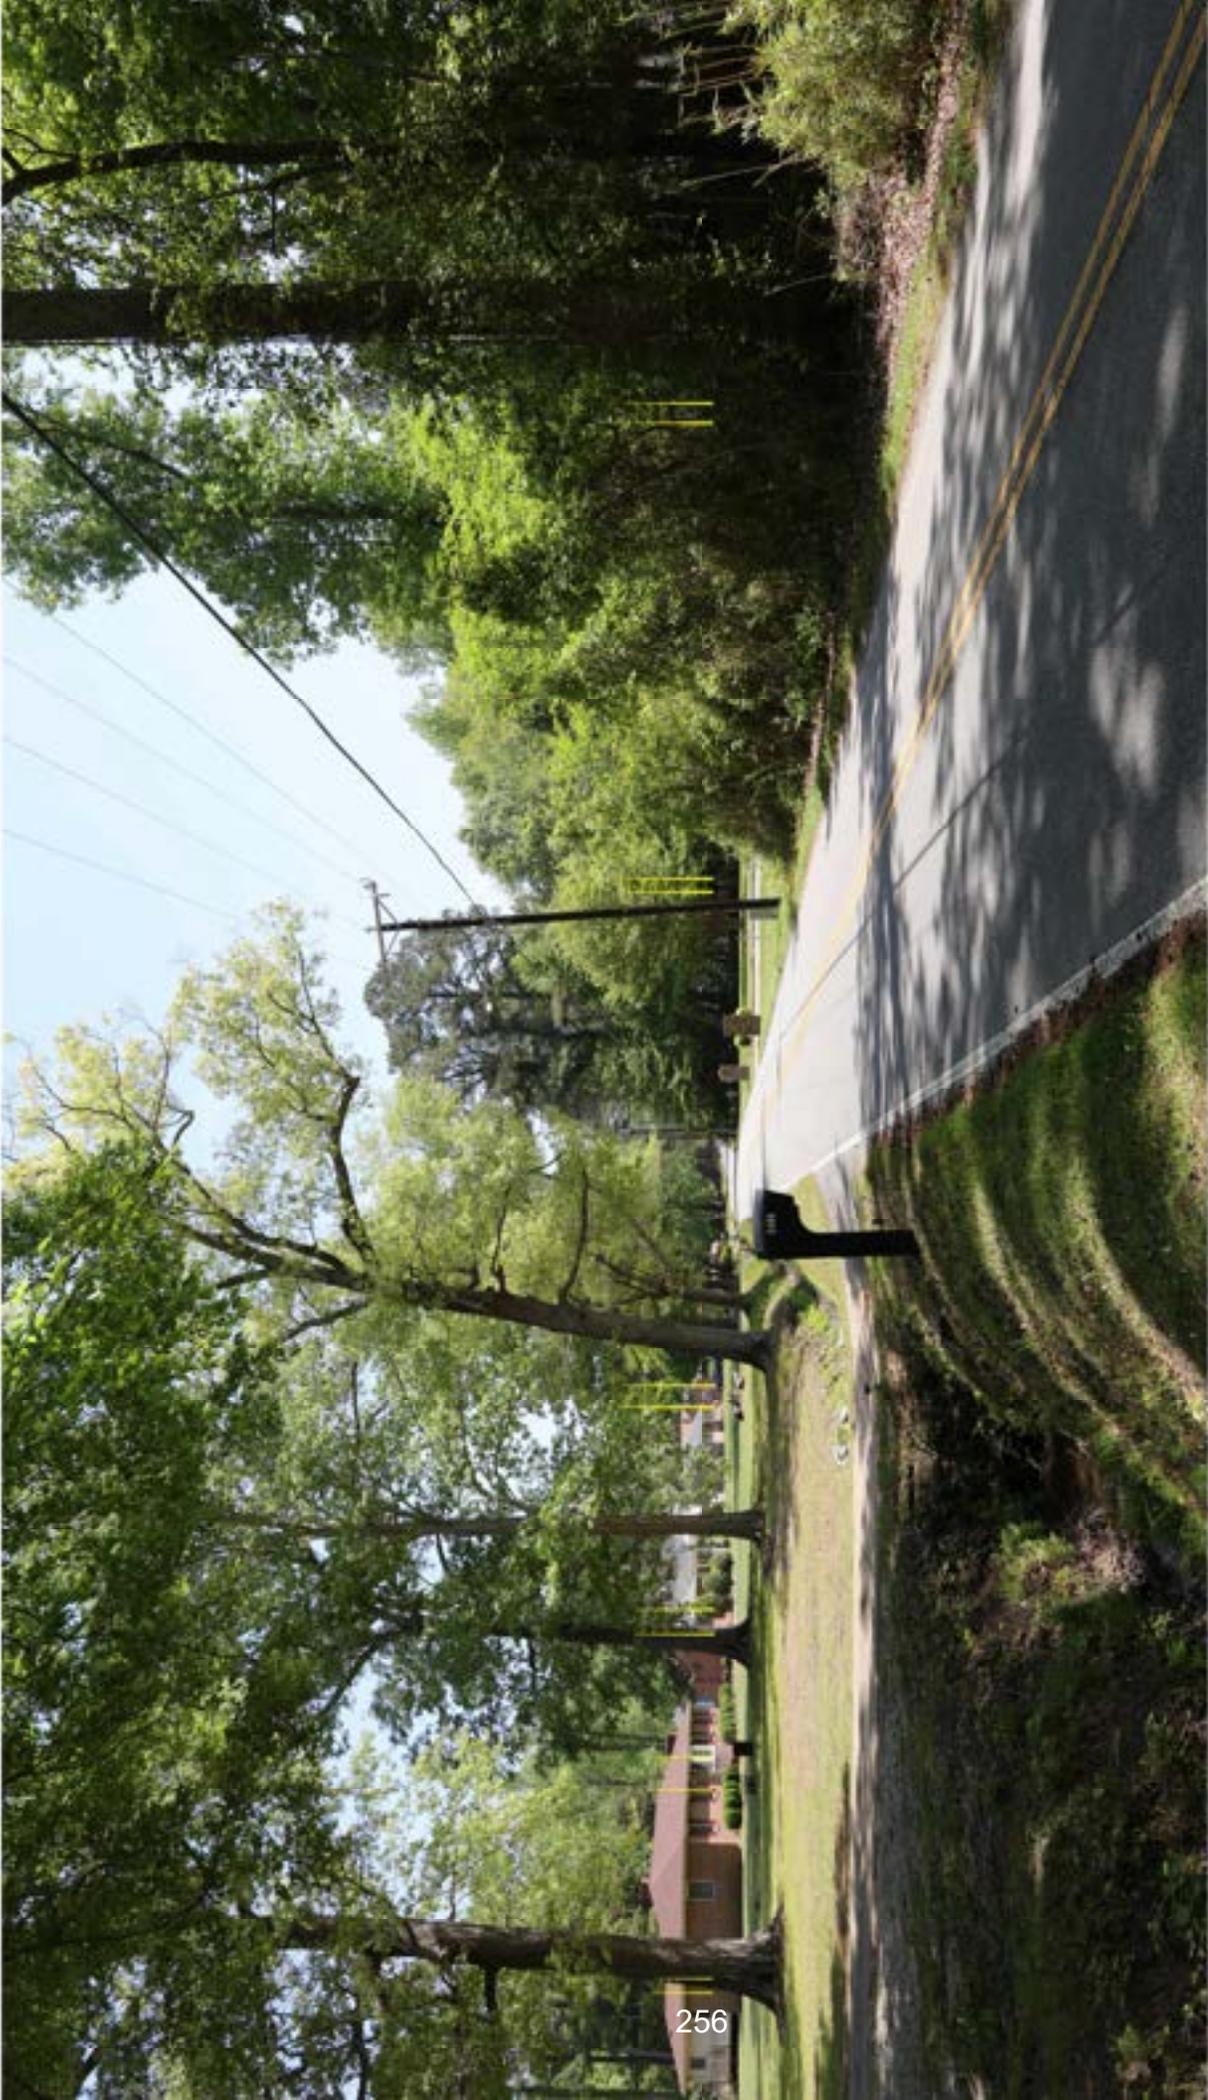
Viewpoint 3: Portsmouth Ditch

Photo Simulations and diagrams represent approximate heights for electric transmission structures from the conceptual design used for the proposed project. These illustrations do not necessarily depict exact structure design or location.

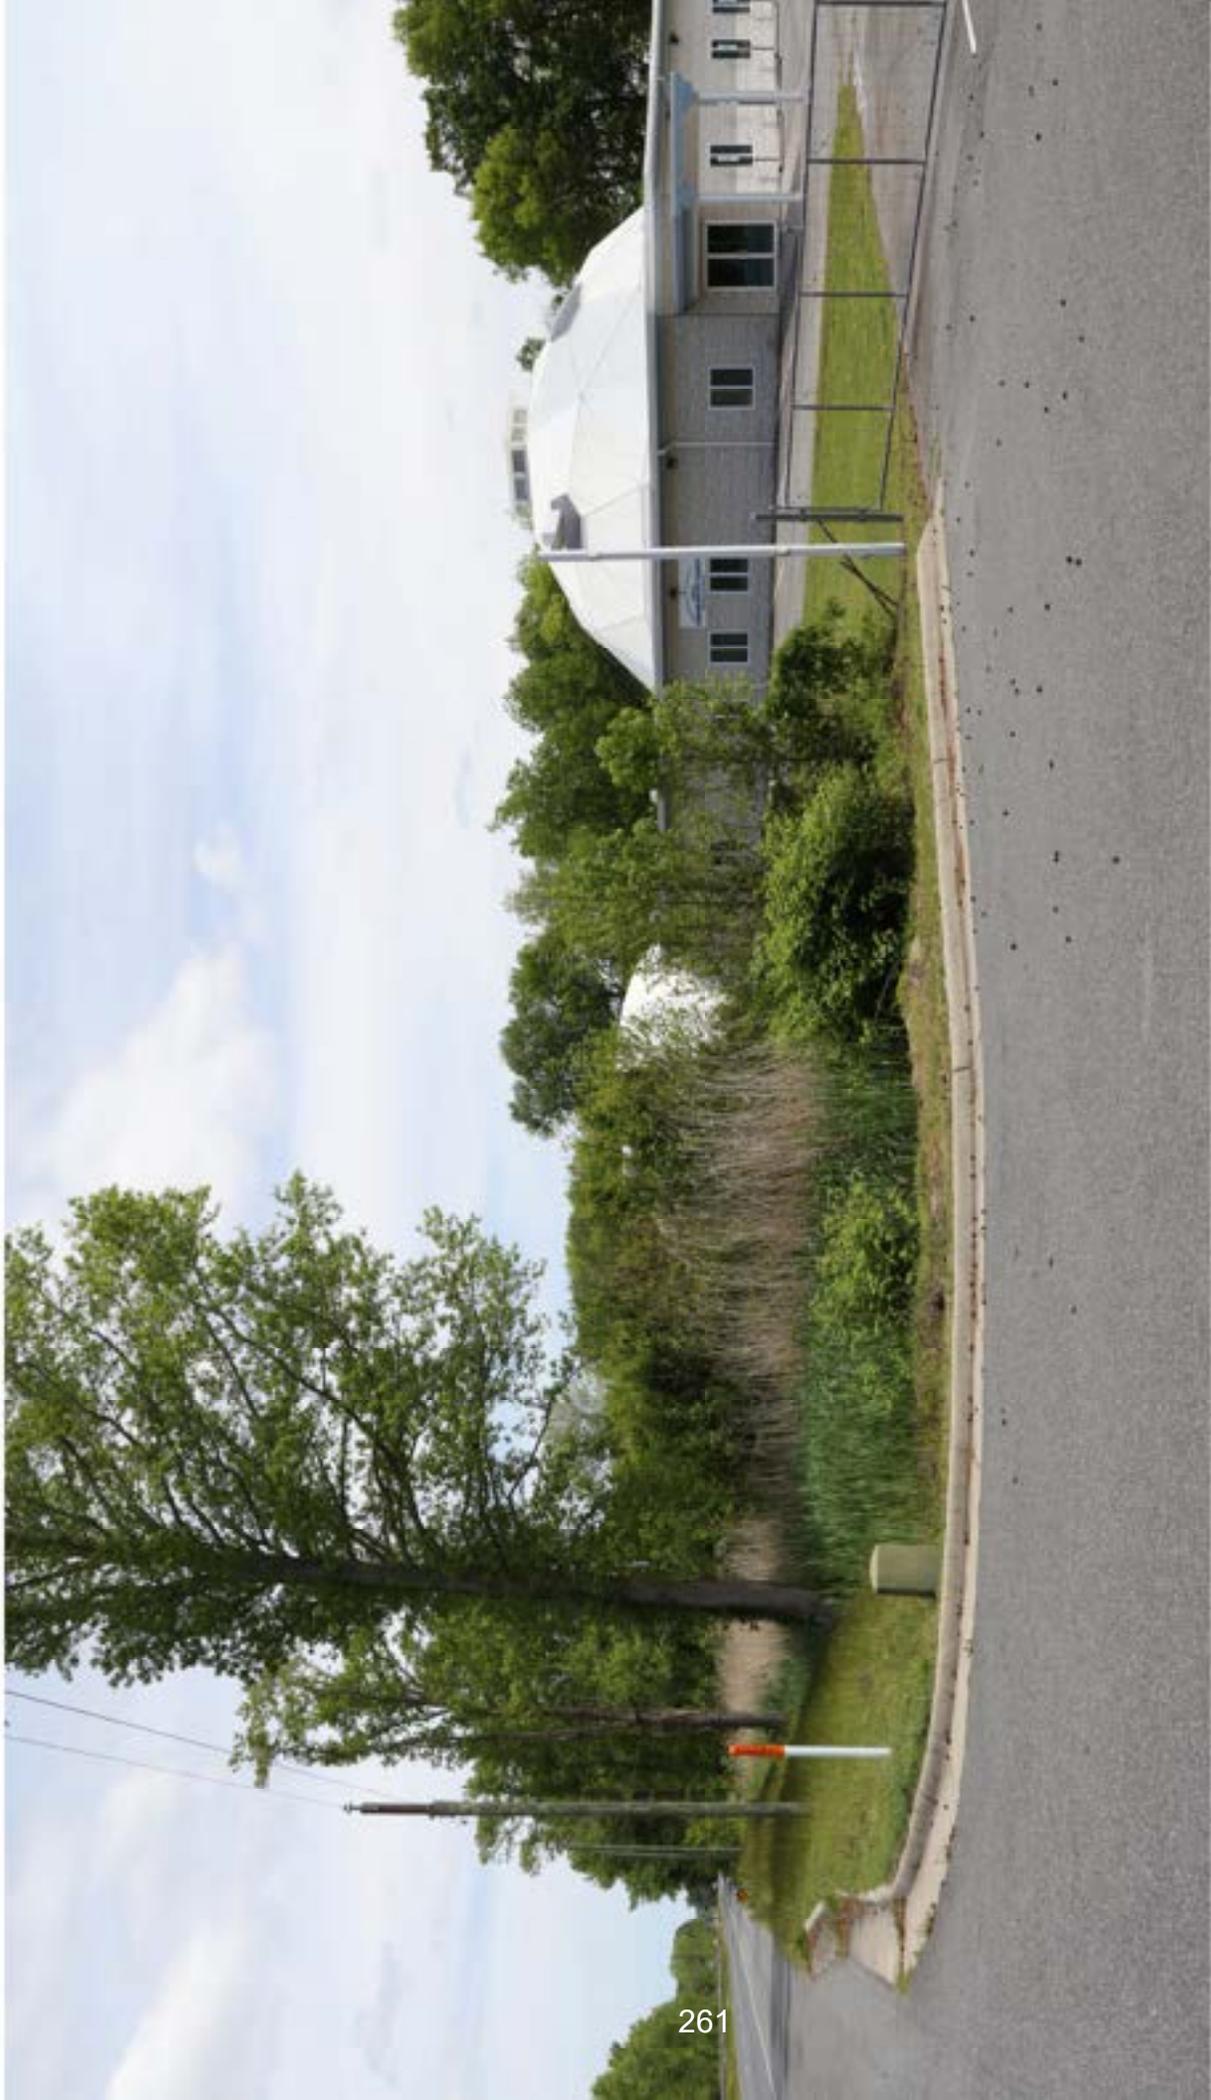
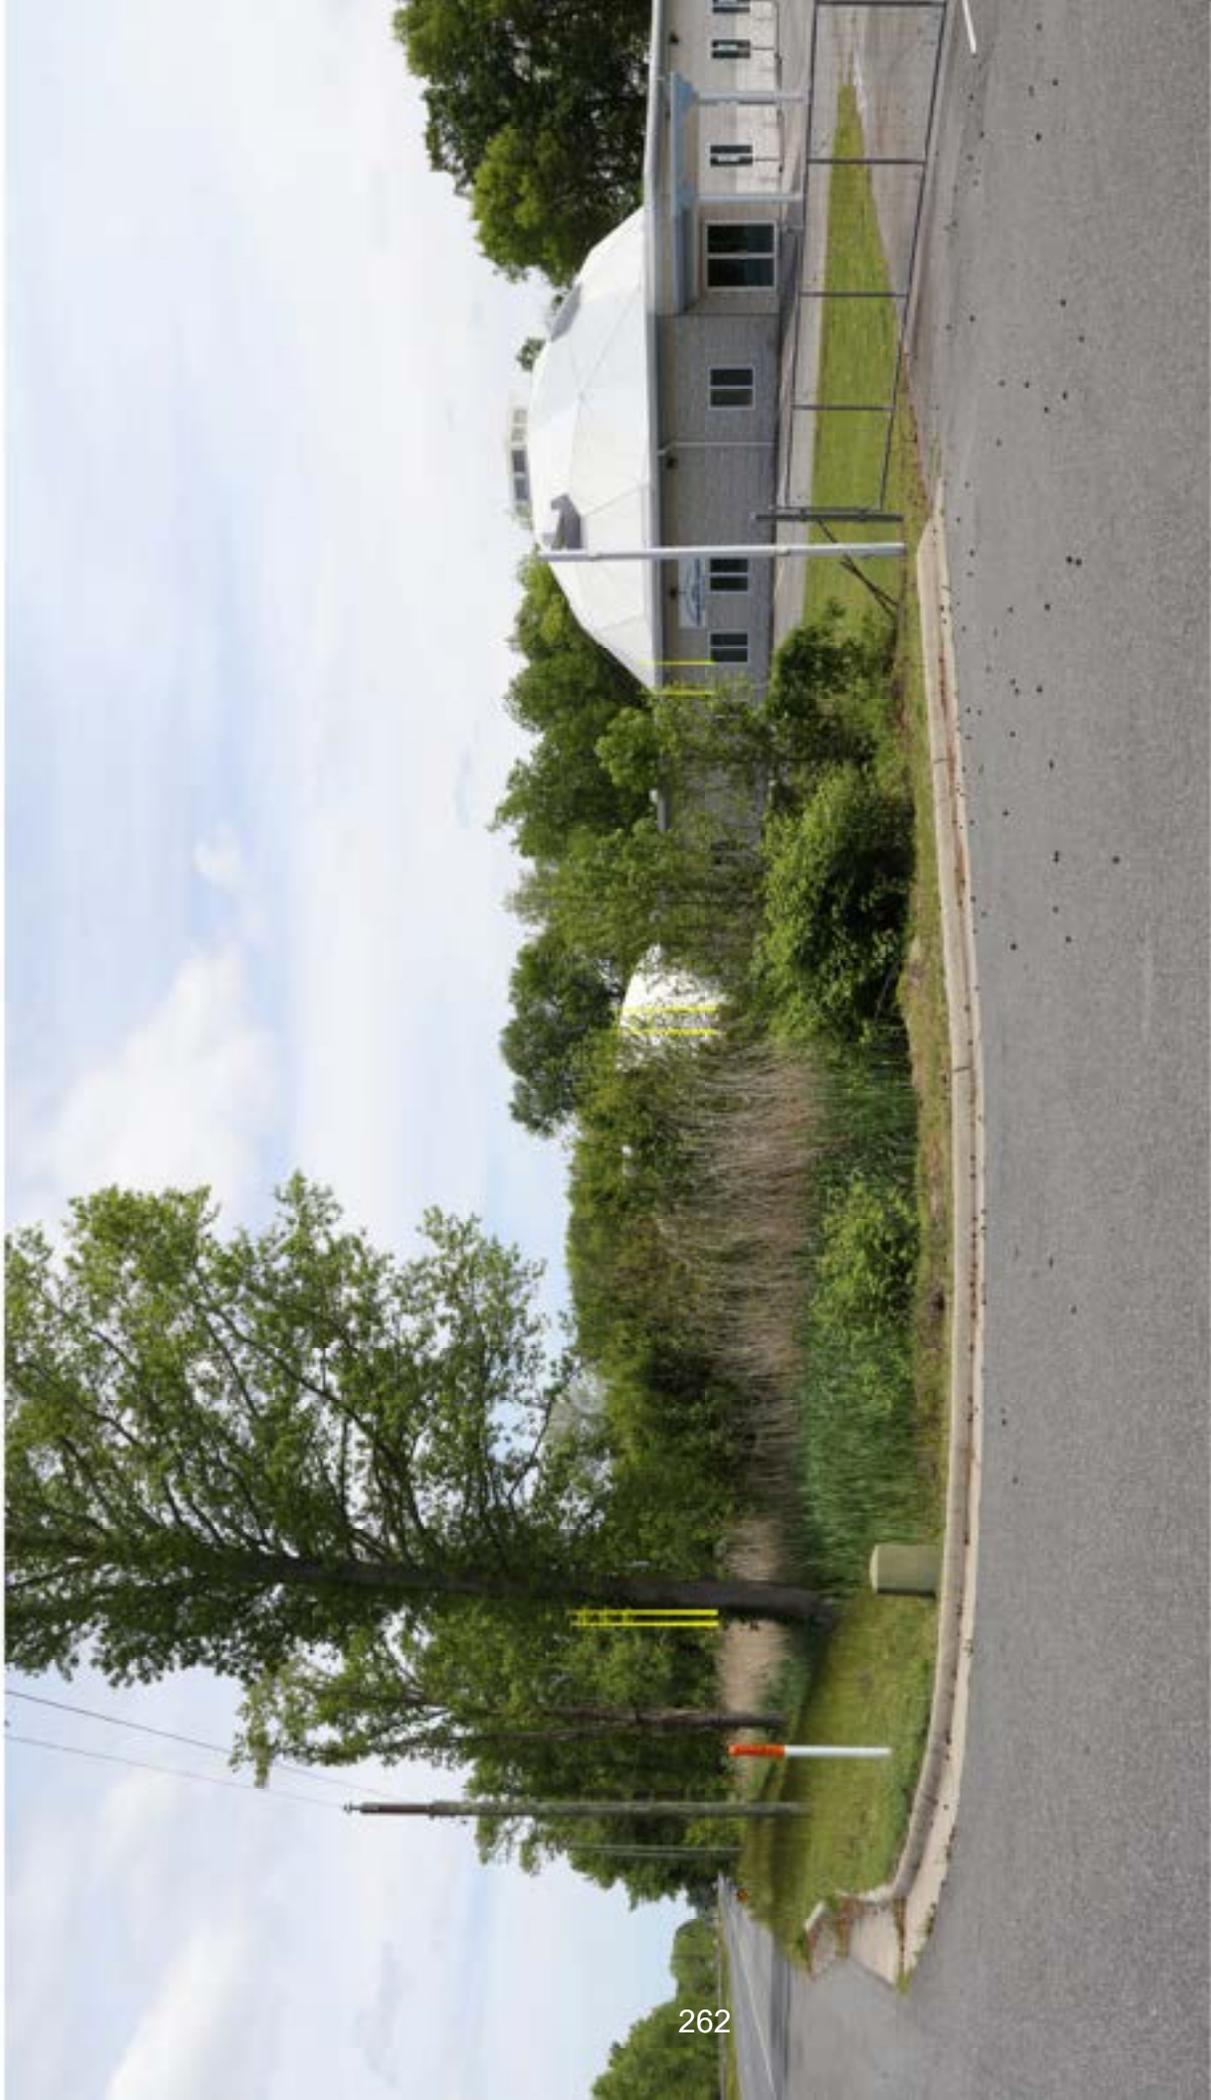
Viewpoint 5: Lindsay Canal

<p>Photo simulations prepared by: GTTE LLC info@gttelc.com 703 447 1350</p>	<p>Fentress-Yadkin 500kV Line #588 Rebuild & New 500kV Fentress-Yadkin Line #5005</p>	<p>Viewpoint 5 Lindsay Canal</p>	<p>Existing View</p>

<p>Photo Simulations and diagrams represent approximate heights for electric transmission structures from the conceptual design used for the proposed project. These illustrations do not necessarily depict exact structure design or location.</p>		<p>This simulation is designed for viewing on a computer monitor. To achieve the correct scale, the image should be increased or decreased in size until the scale above measures 4". When viewed with the eye at 31" from the screen the image will have the same scale as if the viewer were standing at the camera location.</p>

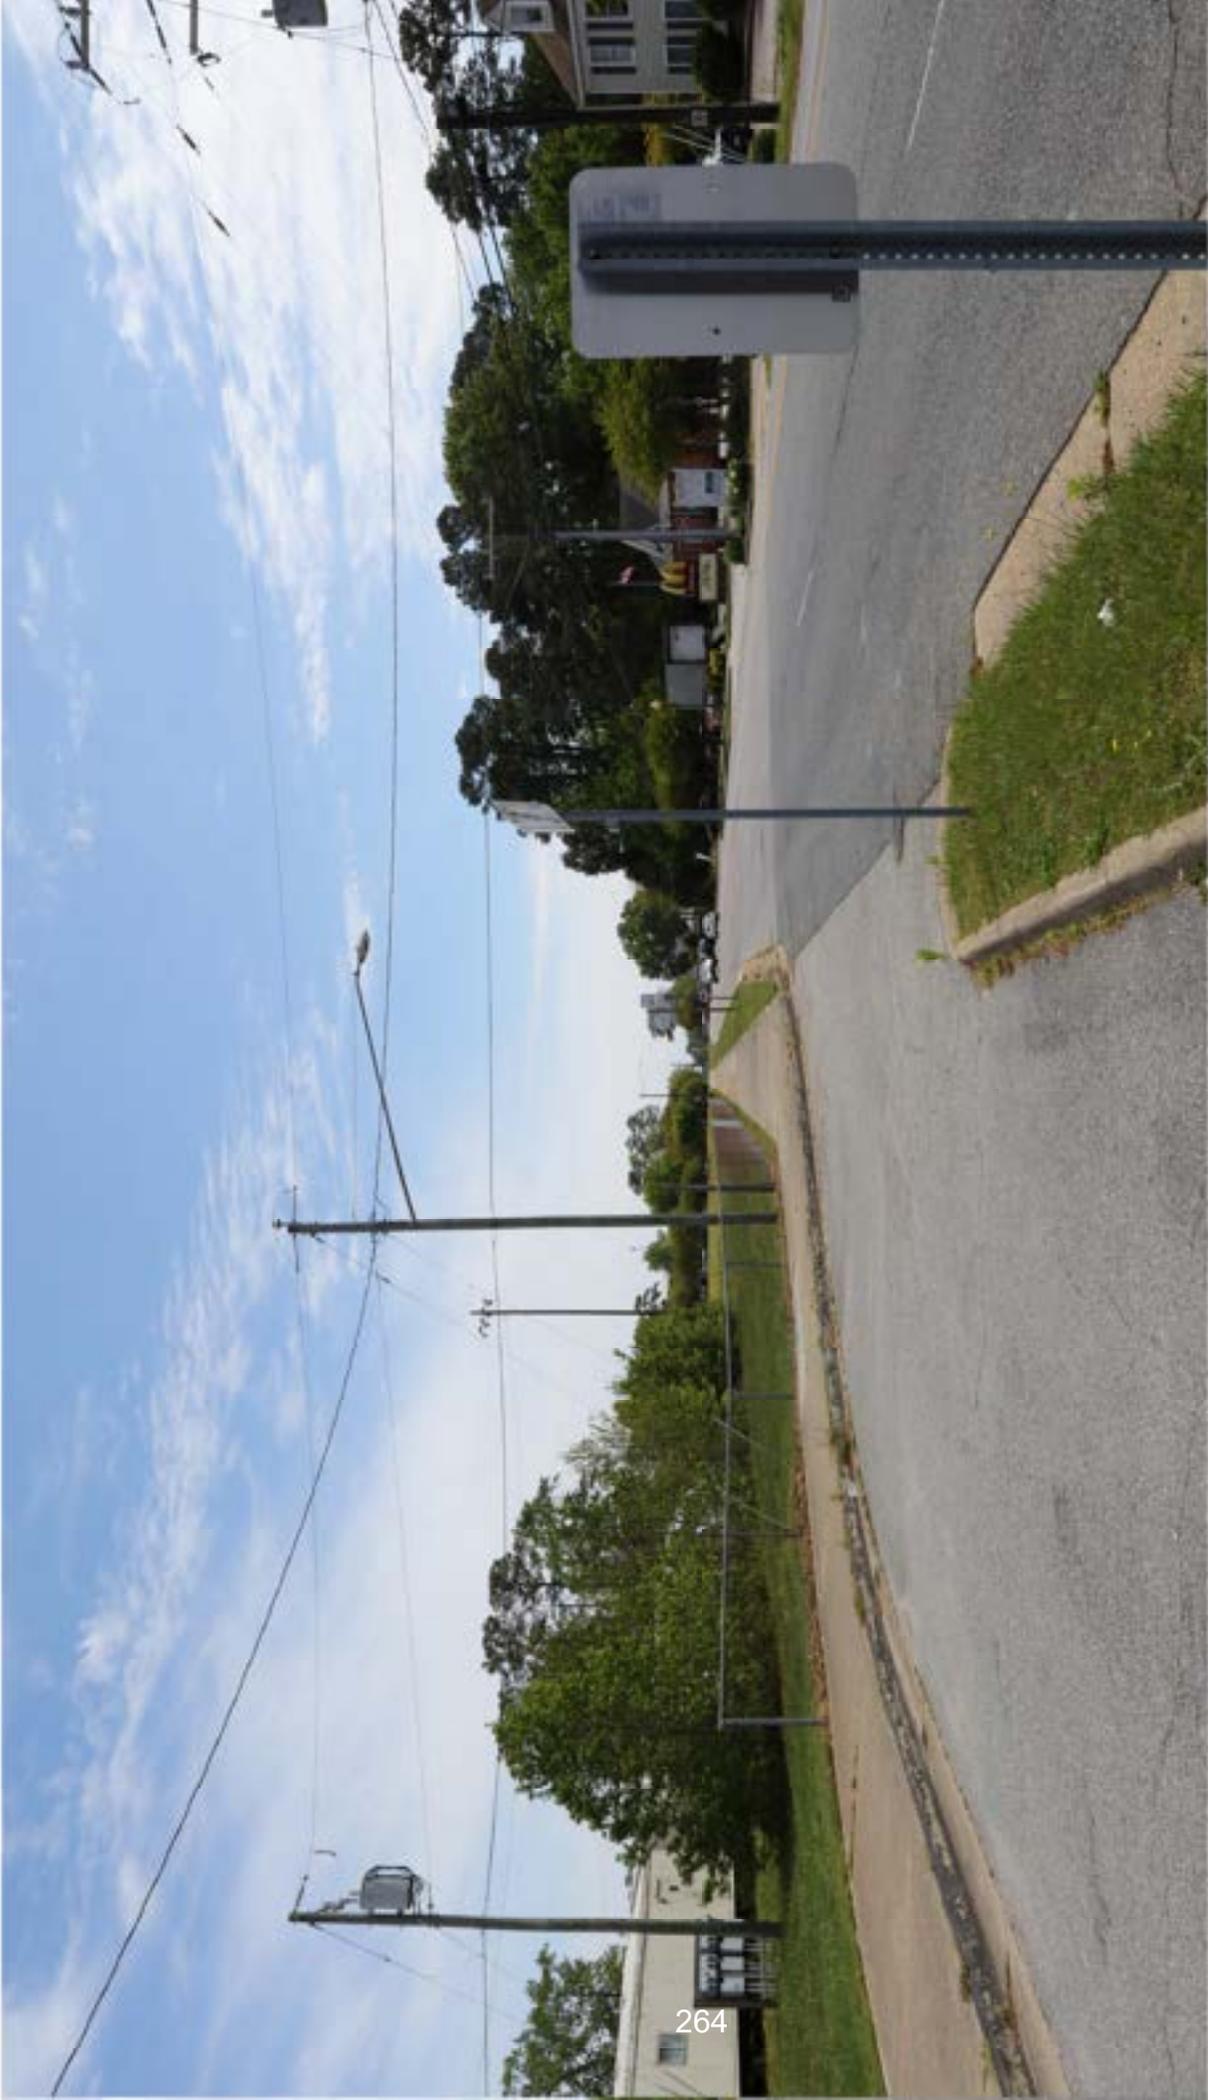
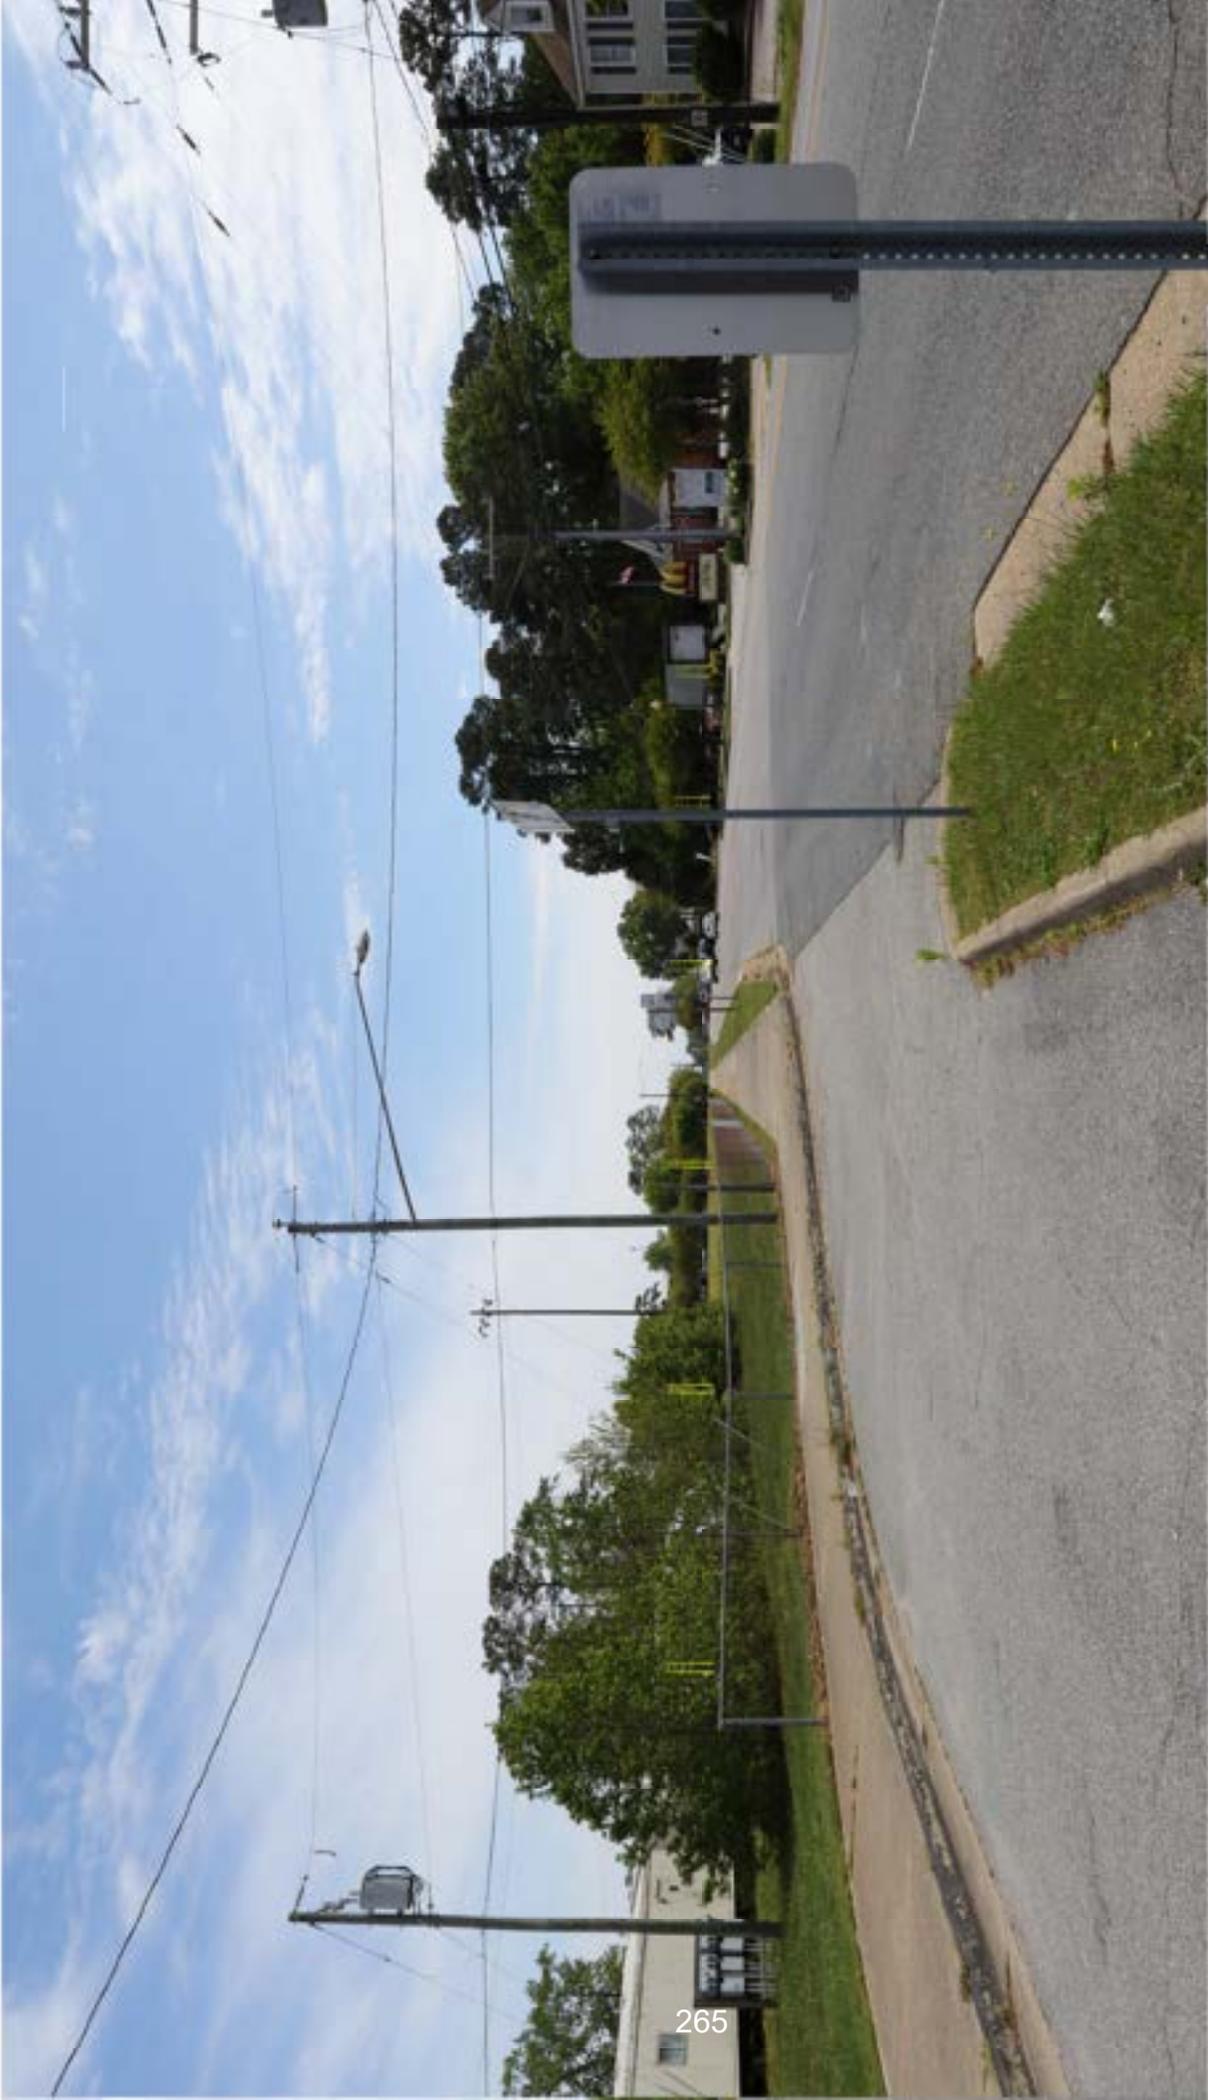
Viewpoint 6: Great Bridge School

Photo Simulations and diagrams represent approximate heights for electric transmission structures from the conceptual design used for the proposed project. These illustrations do not necessarily depict exact structure design or location.
