Application of Virginia Electric and Power Company for approval and certification of electric transmission facilities: Fentress-Yadkin 500 kV Line #588 Rebuild and New 500 kV Fentress-Yadkin Line #5005
Case No. PUR-2024-00105

ATTACHMENT I.A.1
PROJECT OVERVIEW MAP
 Fentress-Yadkin 500 KV Line #588 Rebuild and
 New 500 KV Fentress-Yadkin Line #5005
 City of Chesapeake, Virginia

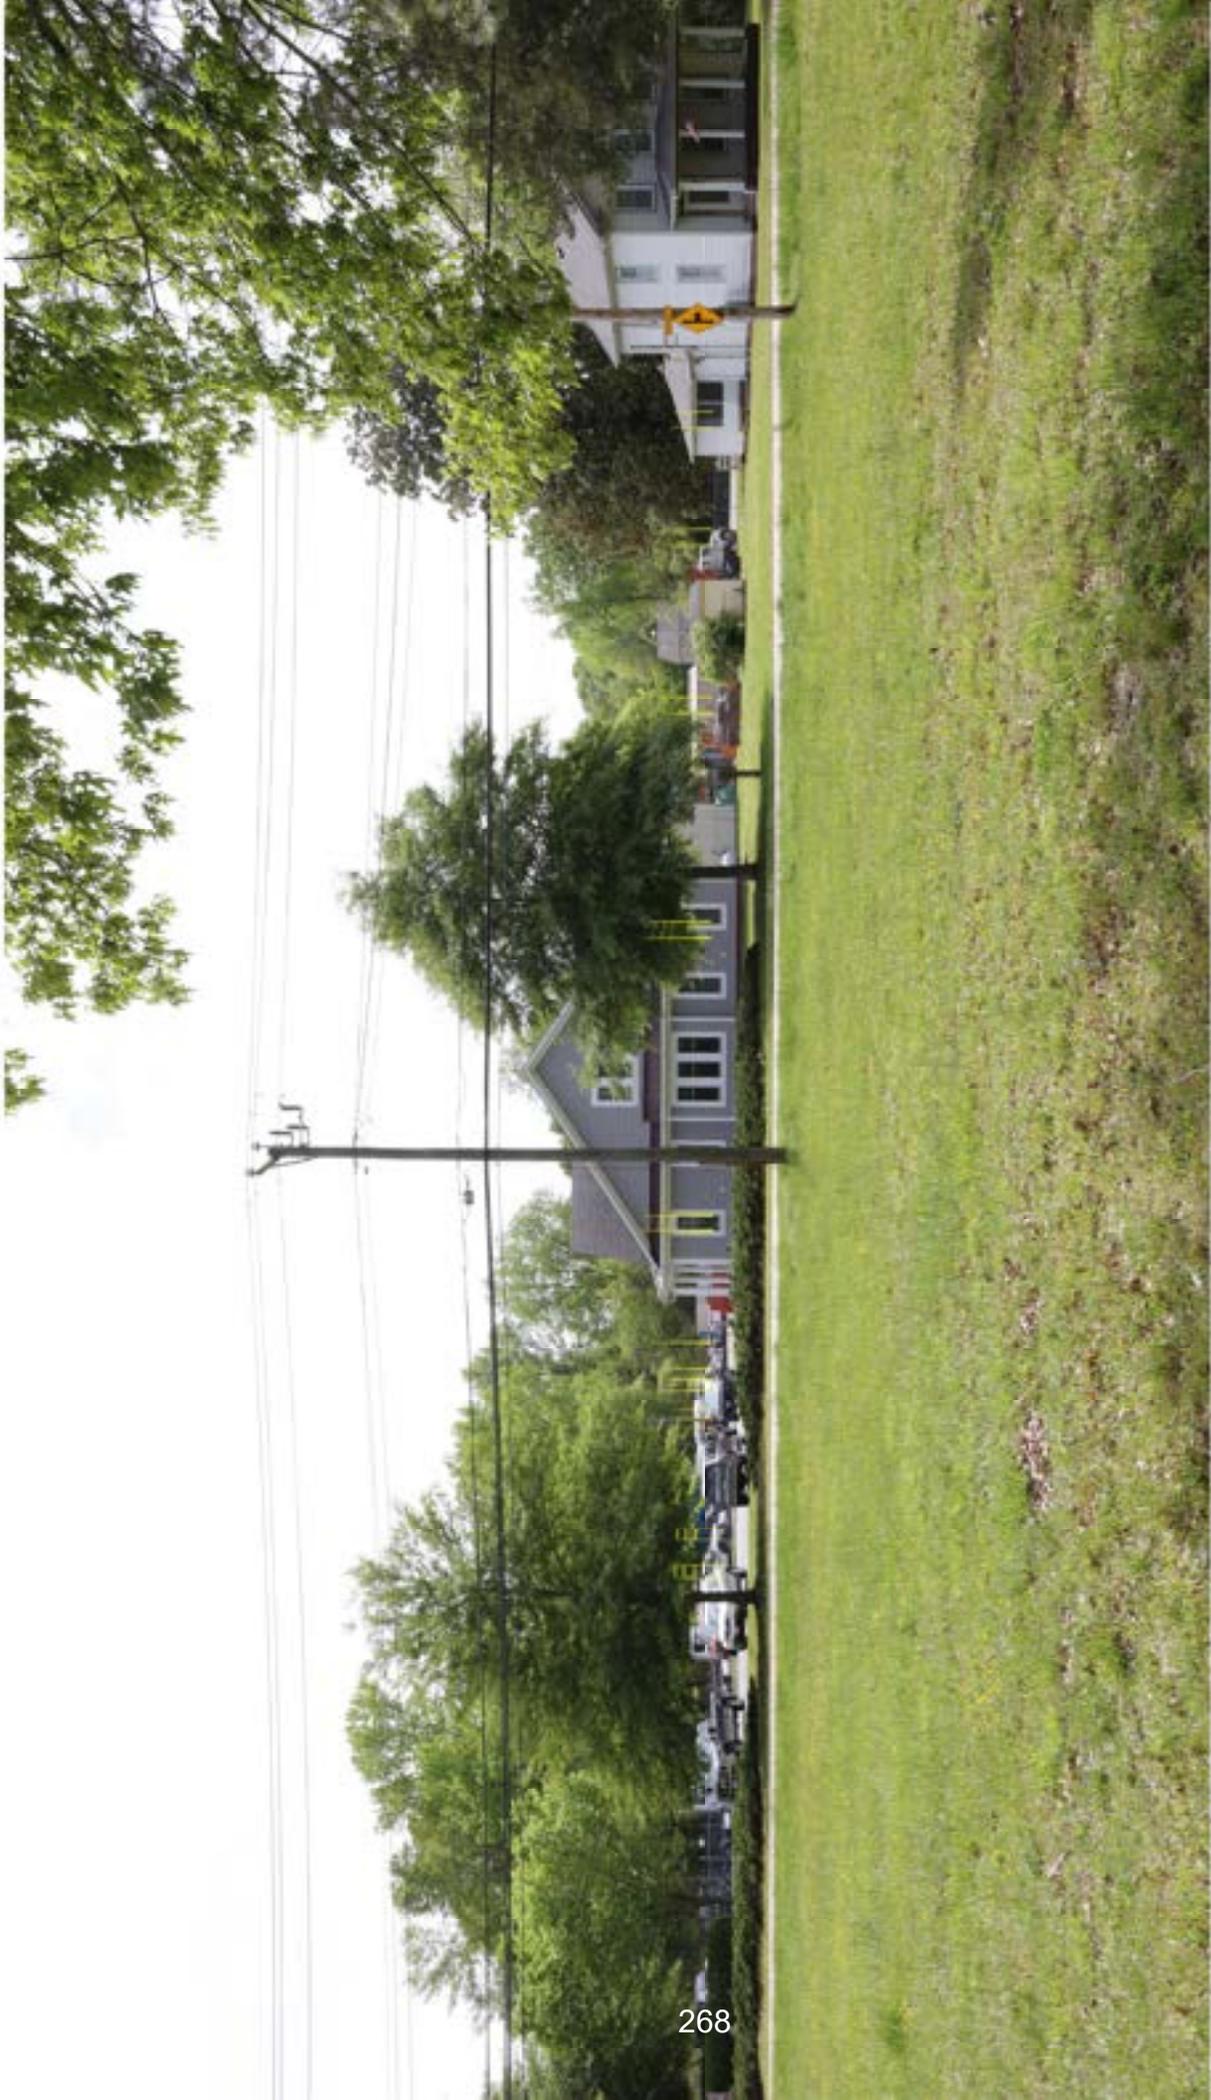
Viewpoint 7
Centerville-Fentress Historic District

**Viewpoint 7
 Centerville-Fentress Historic District**

Photo Simulations and diagrams represent approximate heights for electric transmission structures from the conceptual design used for the proposed project. These illustrations do not necessarily depict exact structure design or location.

Proposed View
 (Location of towers not visible are overlaid with yellow tower icons)

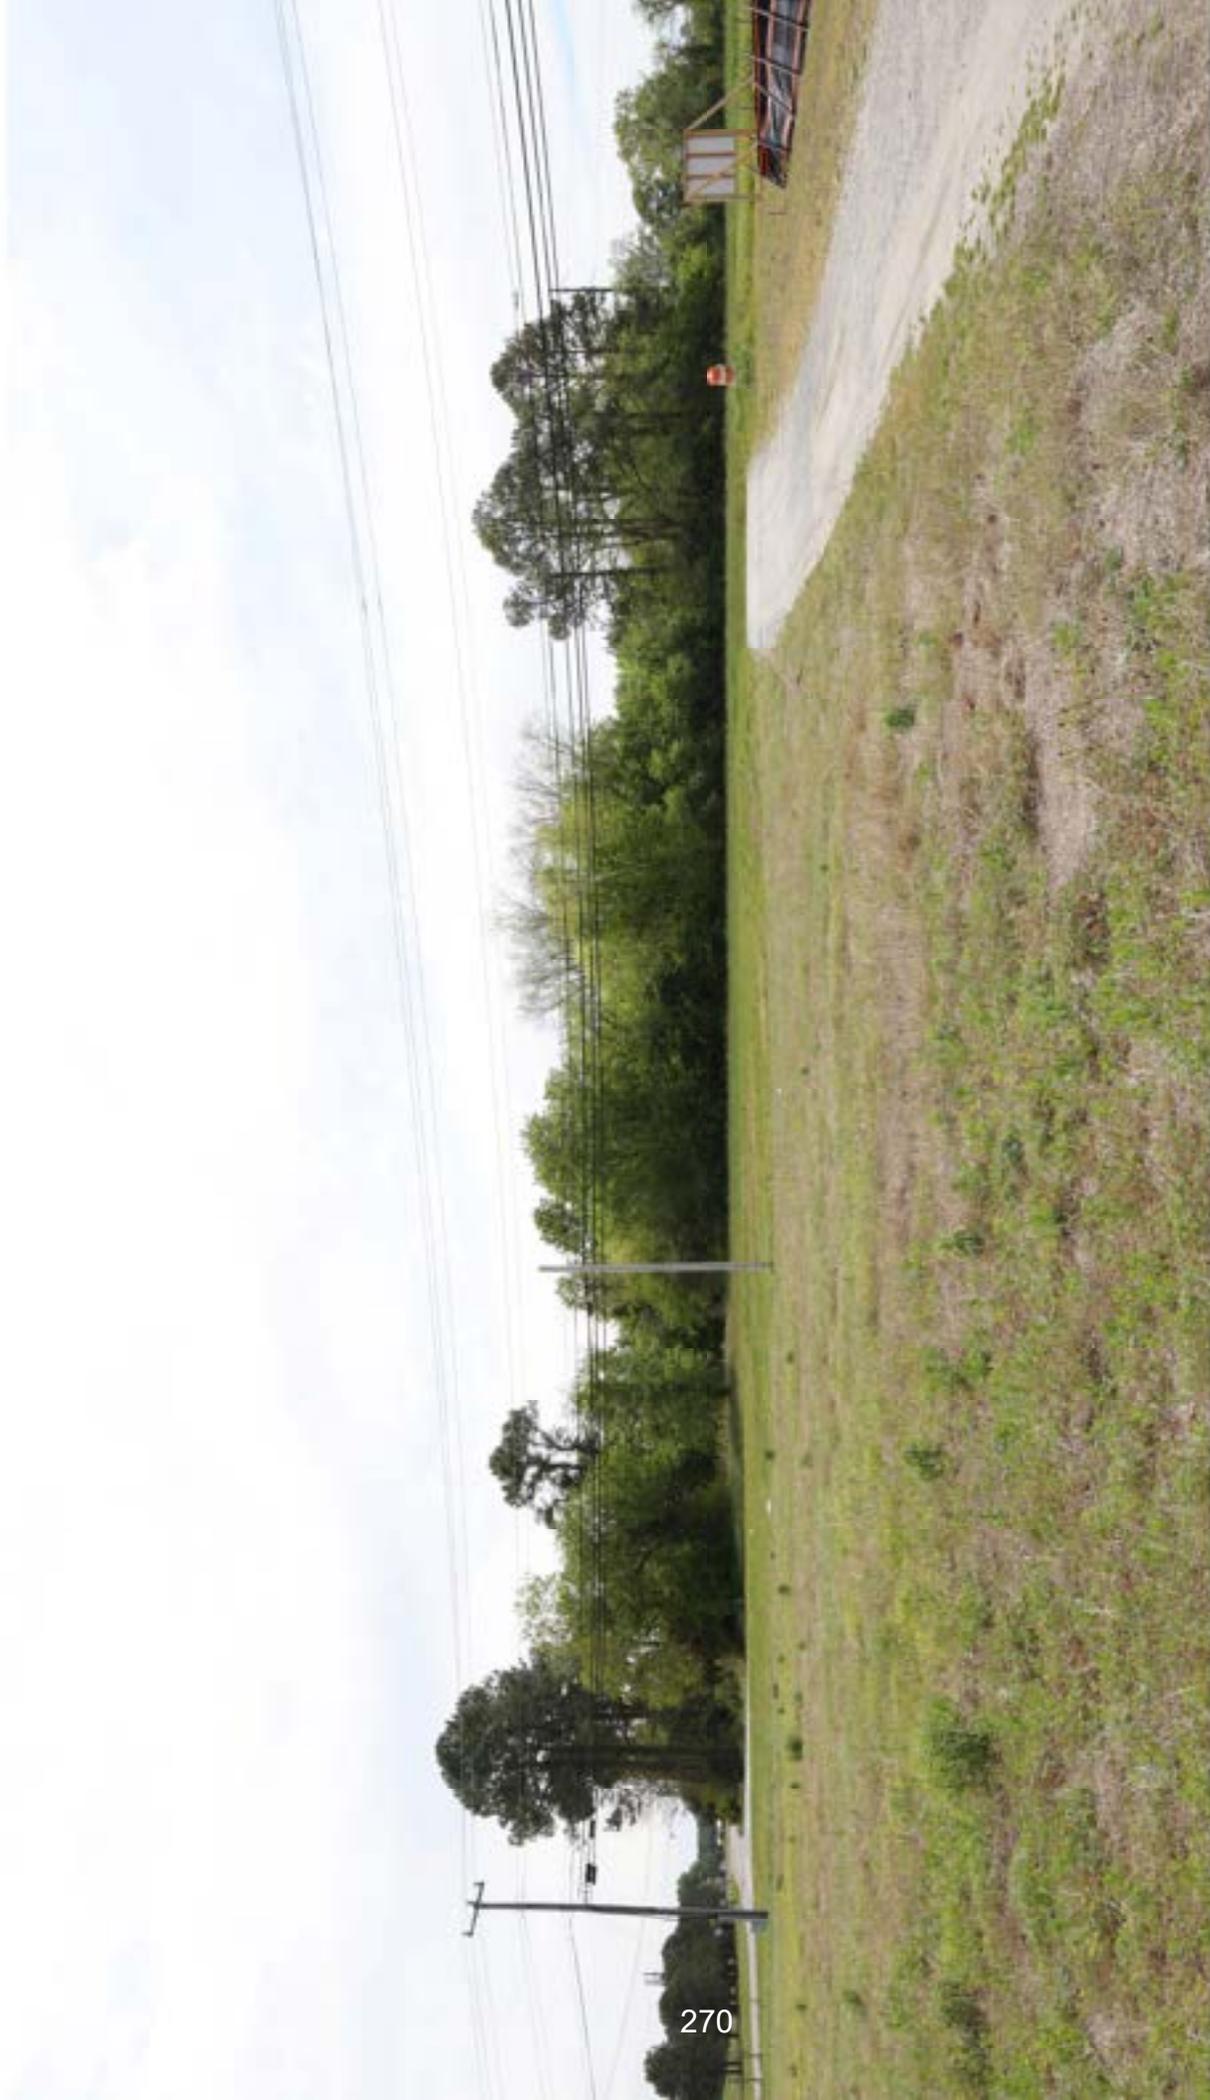
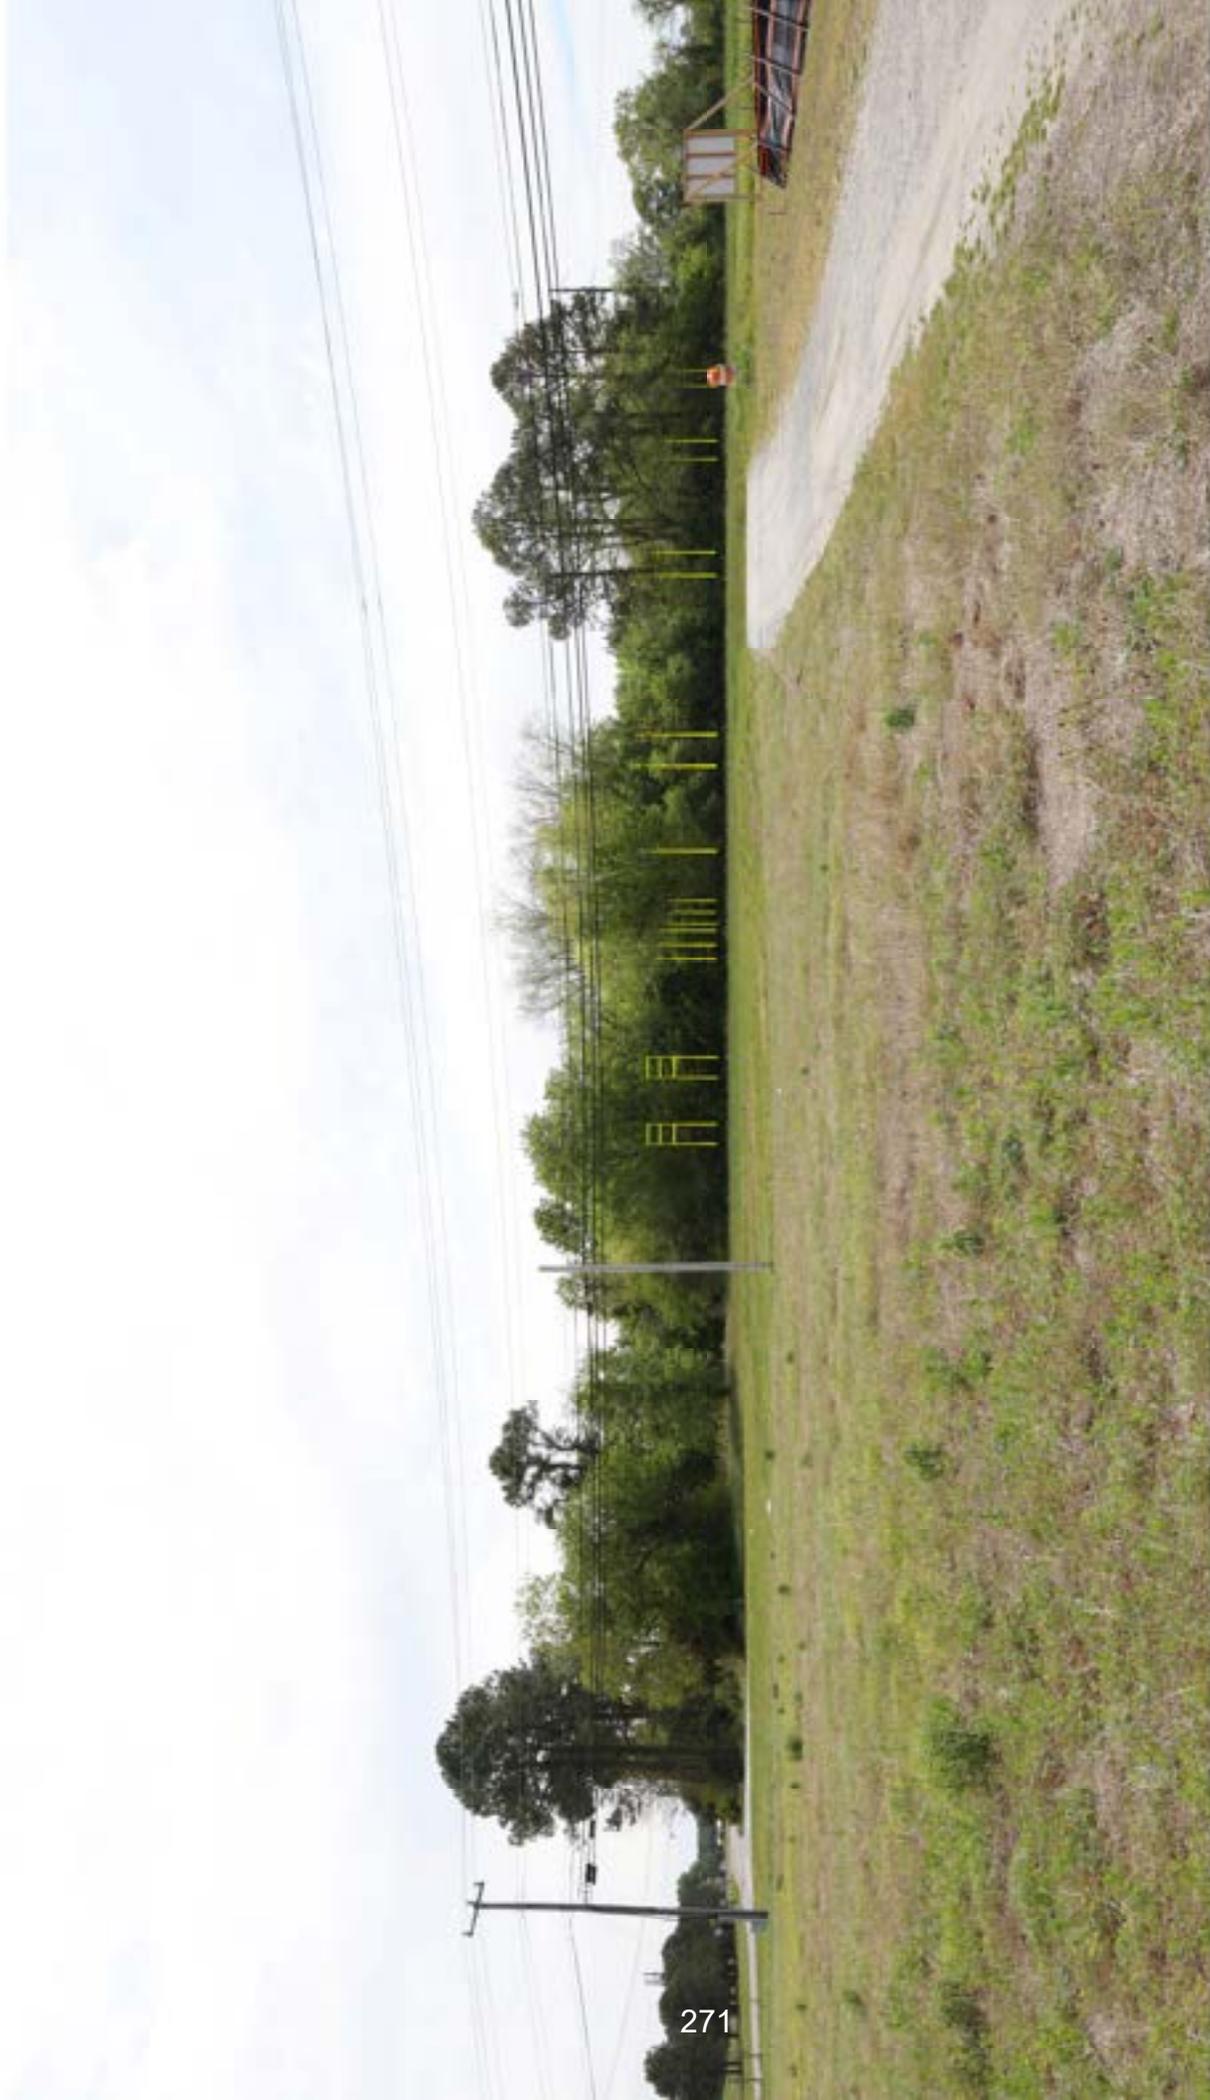
Viewpoint 8
Centerville-Fentress Historic District

Photo Simulations and diagrams represent approximate heights for electric transmission structures from the conceptual design used for the proposed project. These illustrations do not necessarily depict exact structure design or location.

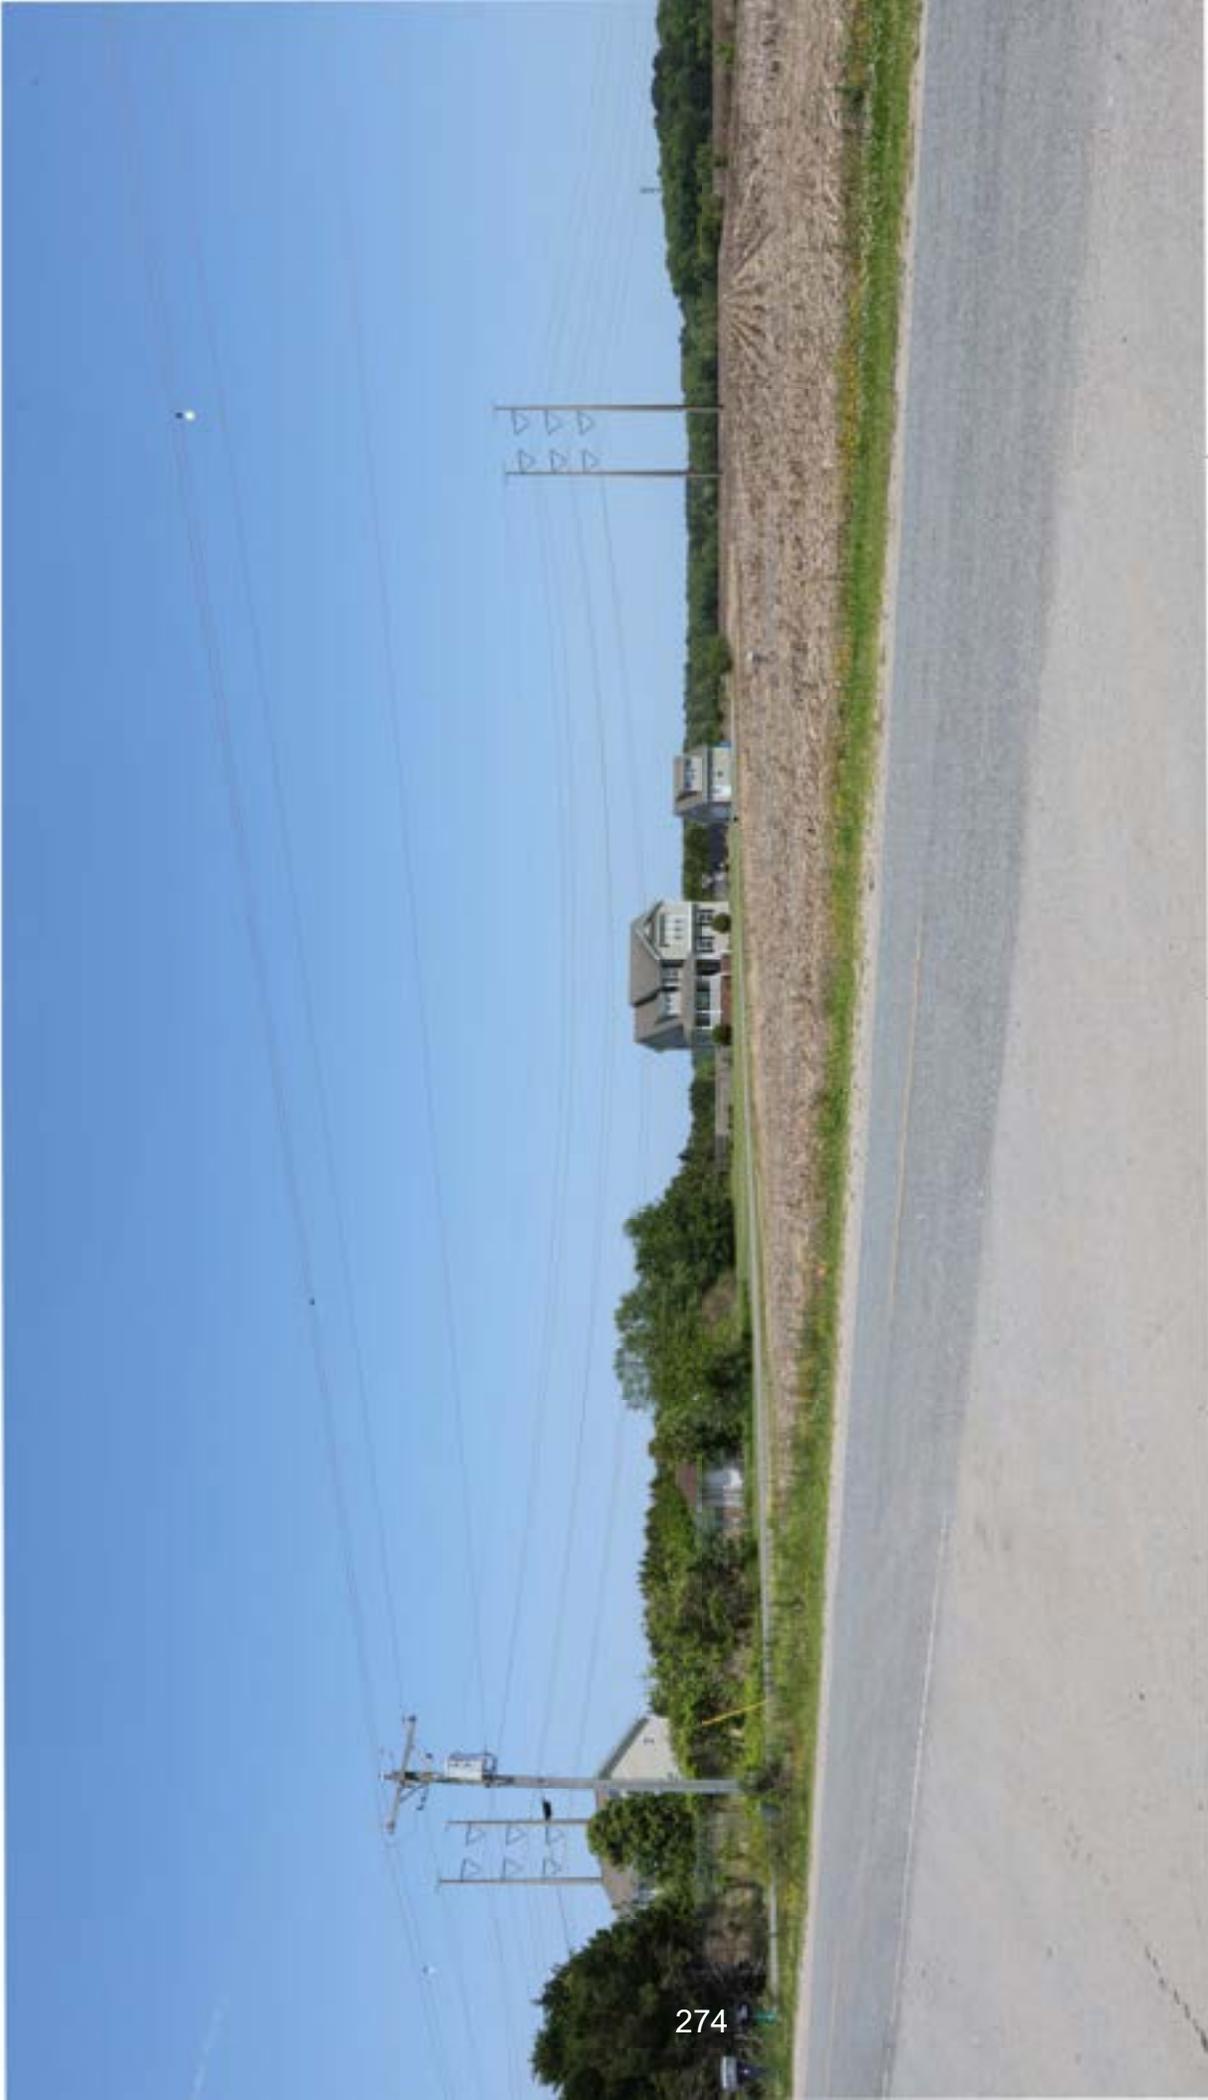
<p>Fentress-Yadkin 500kV Line #538 Rebuild & New 500kV Fentress-Yadkin Line #5005</p>	<p>Viewpoint 9A Herring Canal</p>	<p>Proposed View (Location of towers not visible are overlaid with yellow tower icon)</p>
<p>This simulation is designed for viewing on a computer monitor. To achieve the correct scale, the image should be increased or decreased in size until the scale above measures 4". When viewed with the eye at 31" from the screen the image will have the same scale as if the viewer were standing at the camera location.</p>

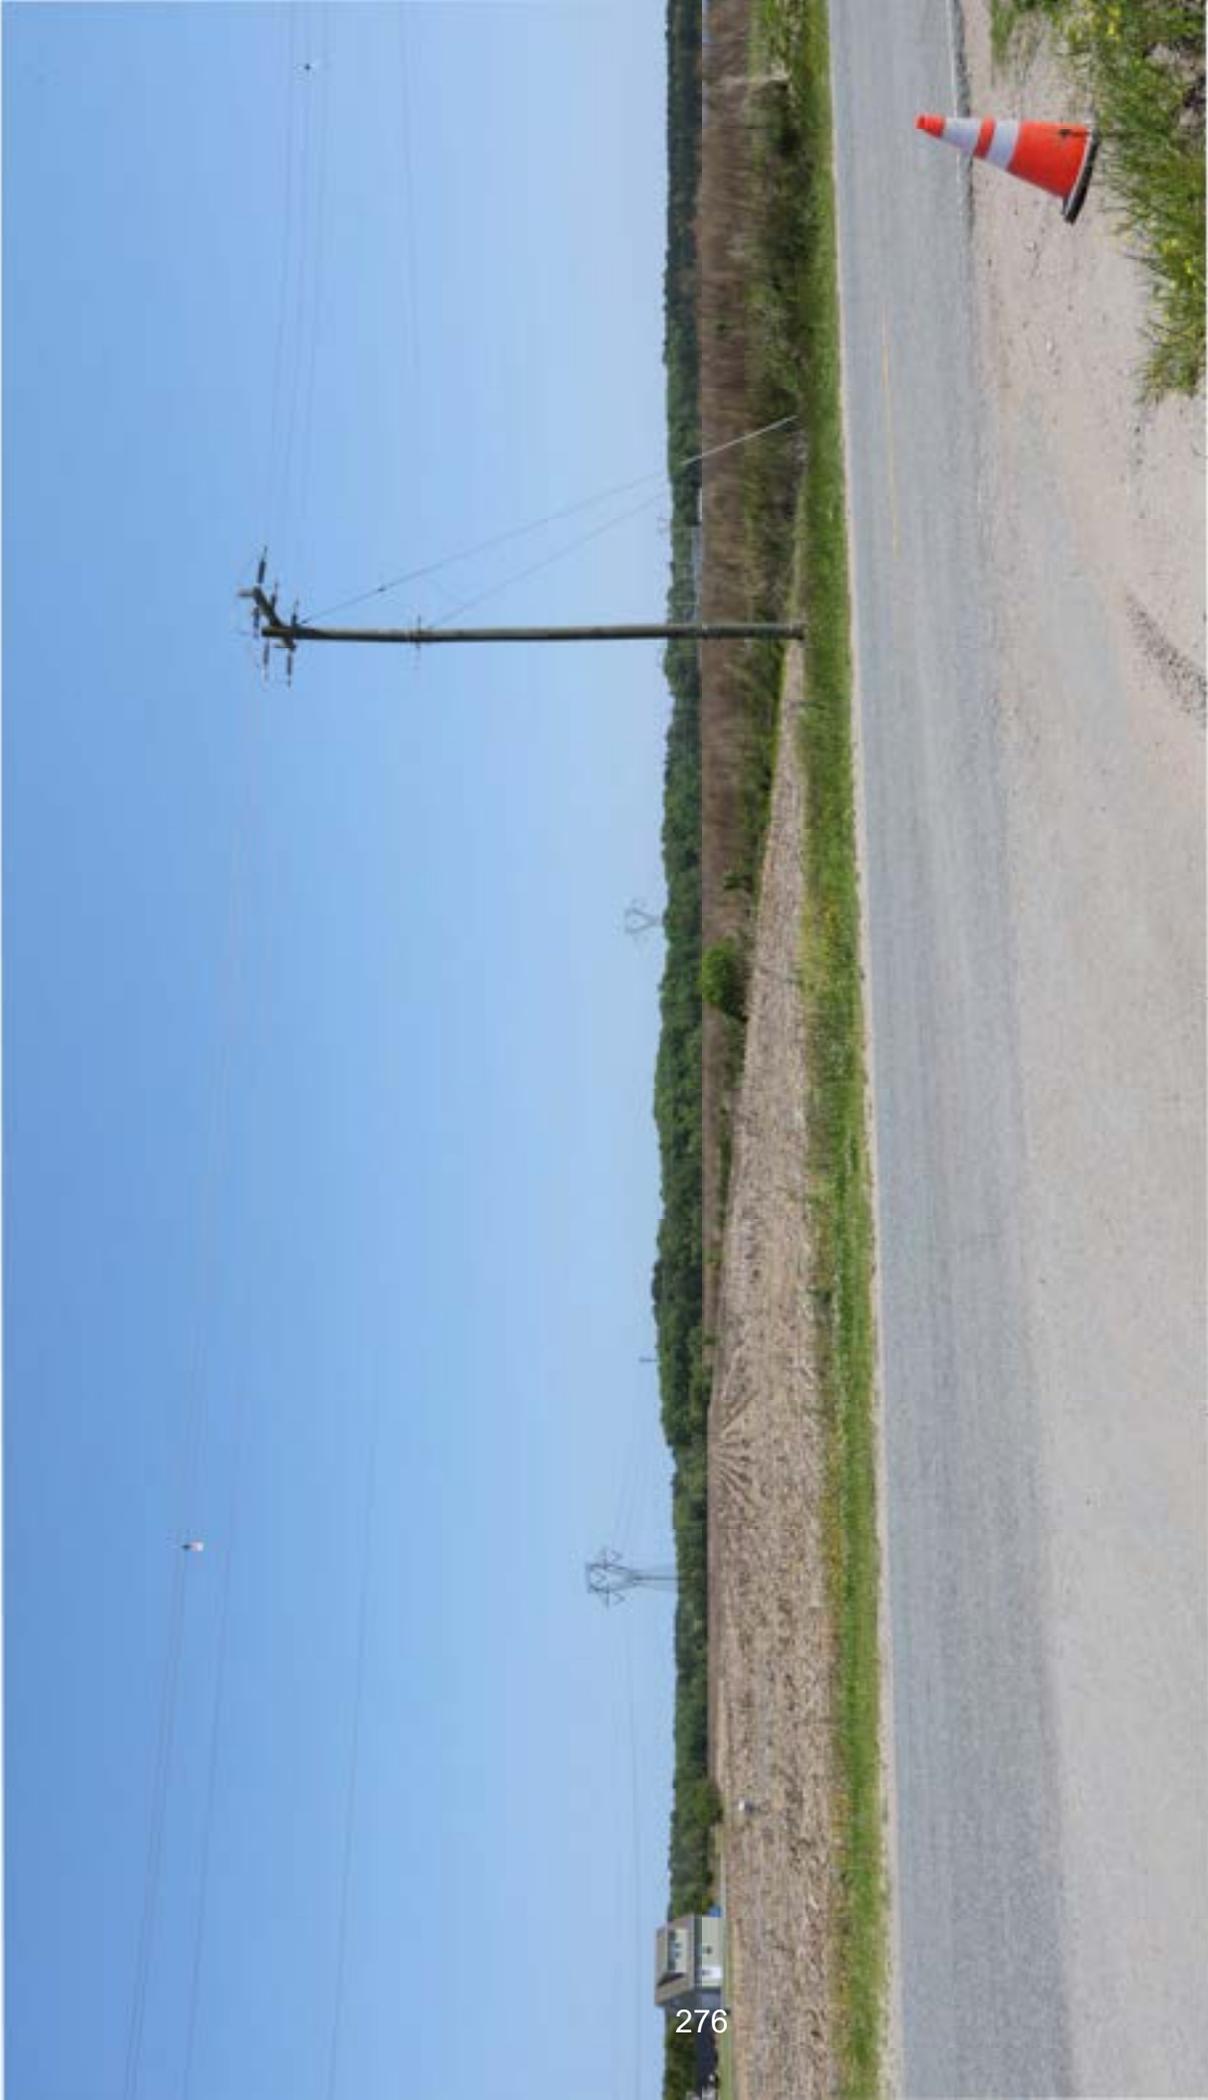
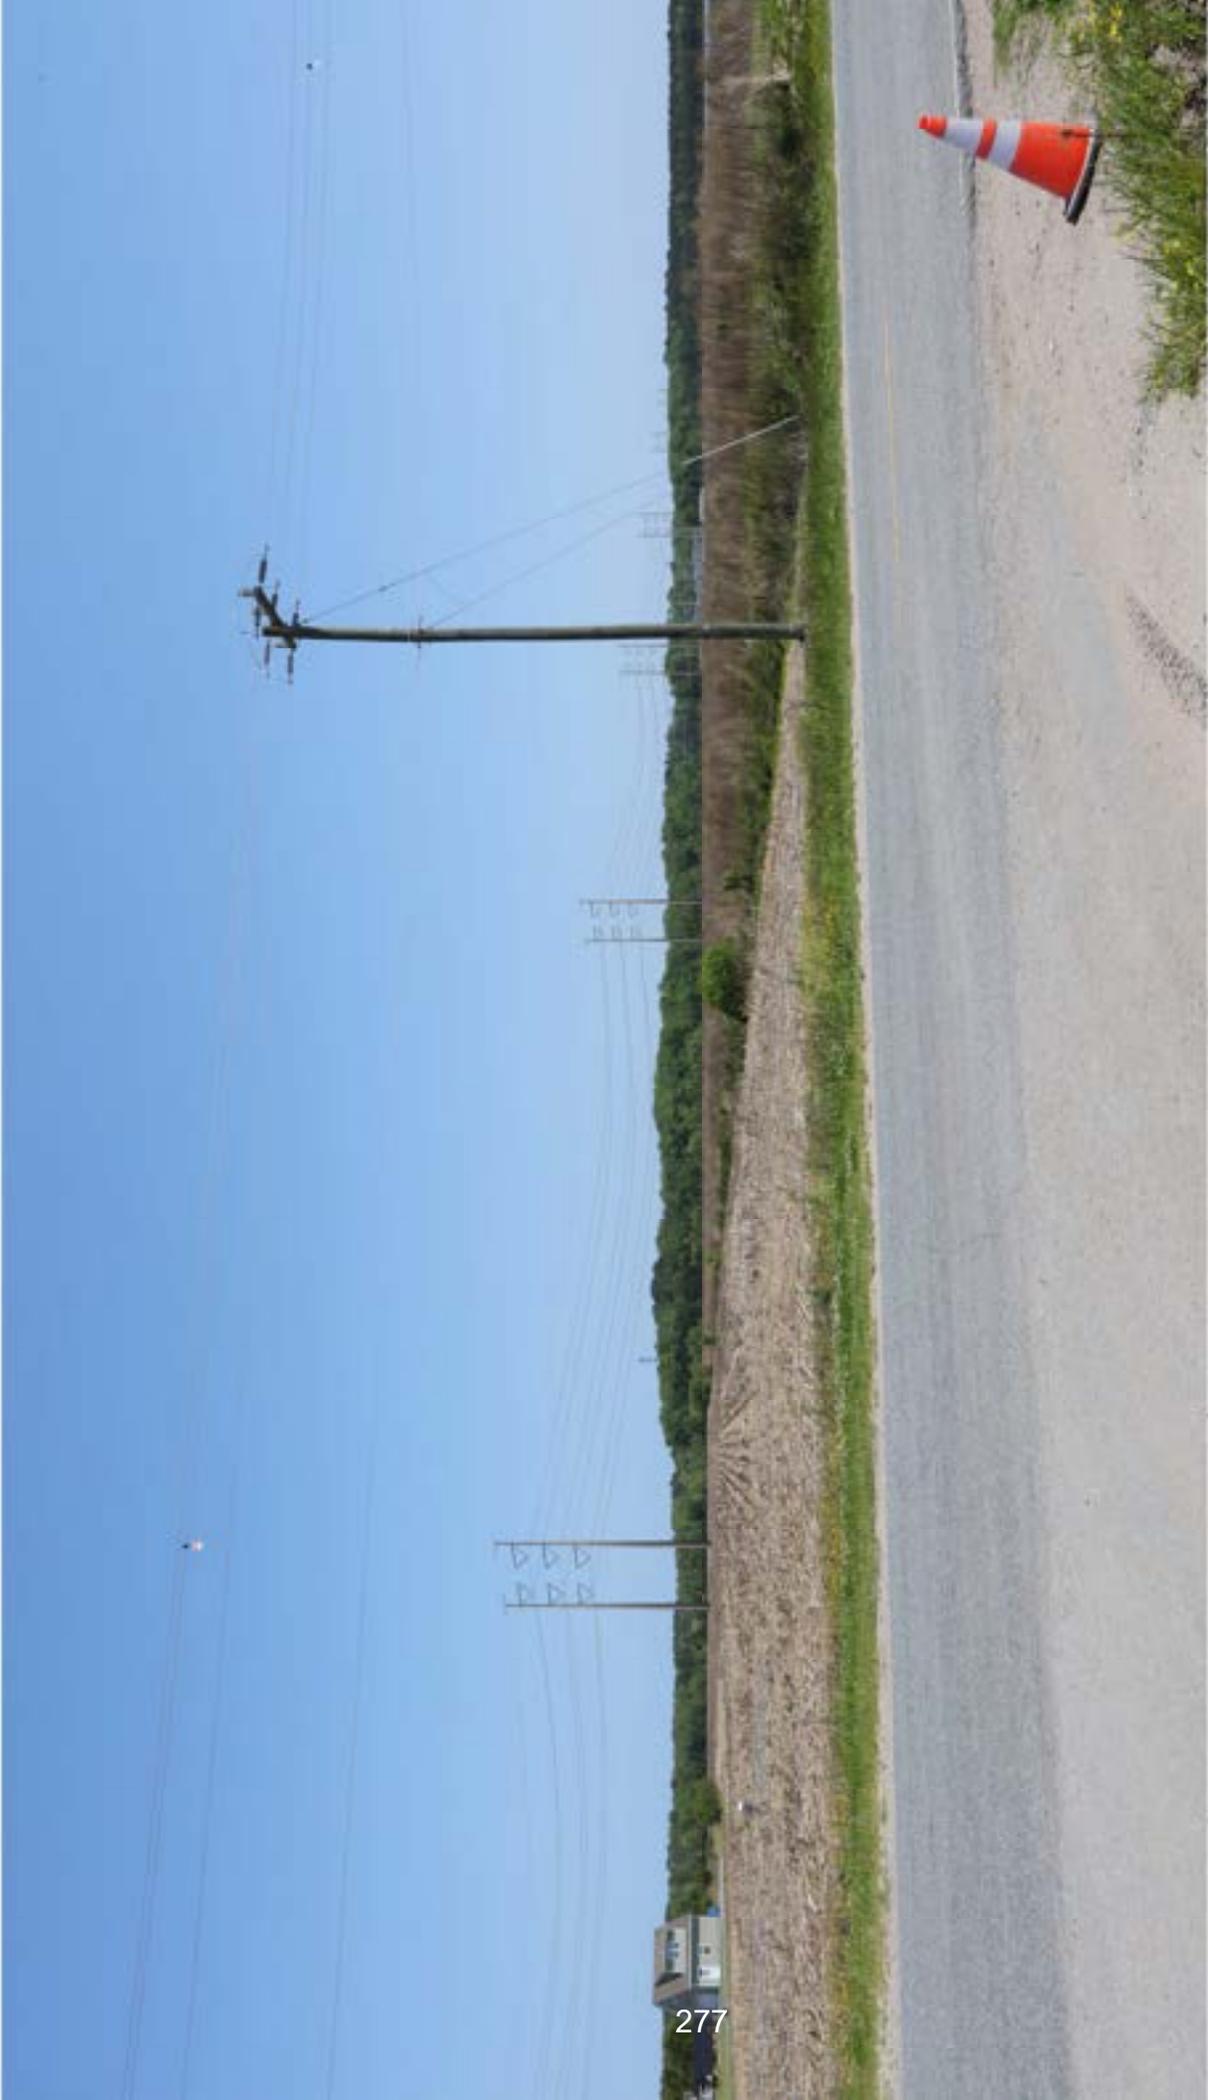
Viewpoint 9B Herring Canal

Photo Simulations and diagrams represent approximate heights for electric transmission structures from the conceptual design used for the proposed project. These illustrations do not necessarily depict exact structure design or location.

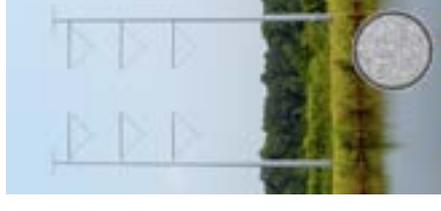
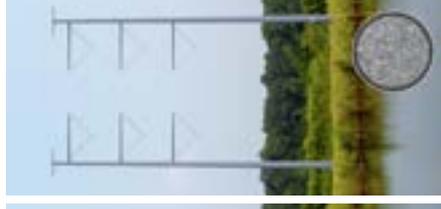
Corten

All structures and finish color depicted are for representation only.

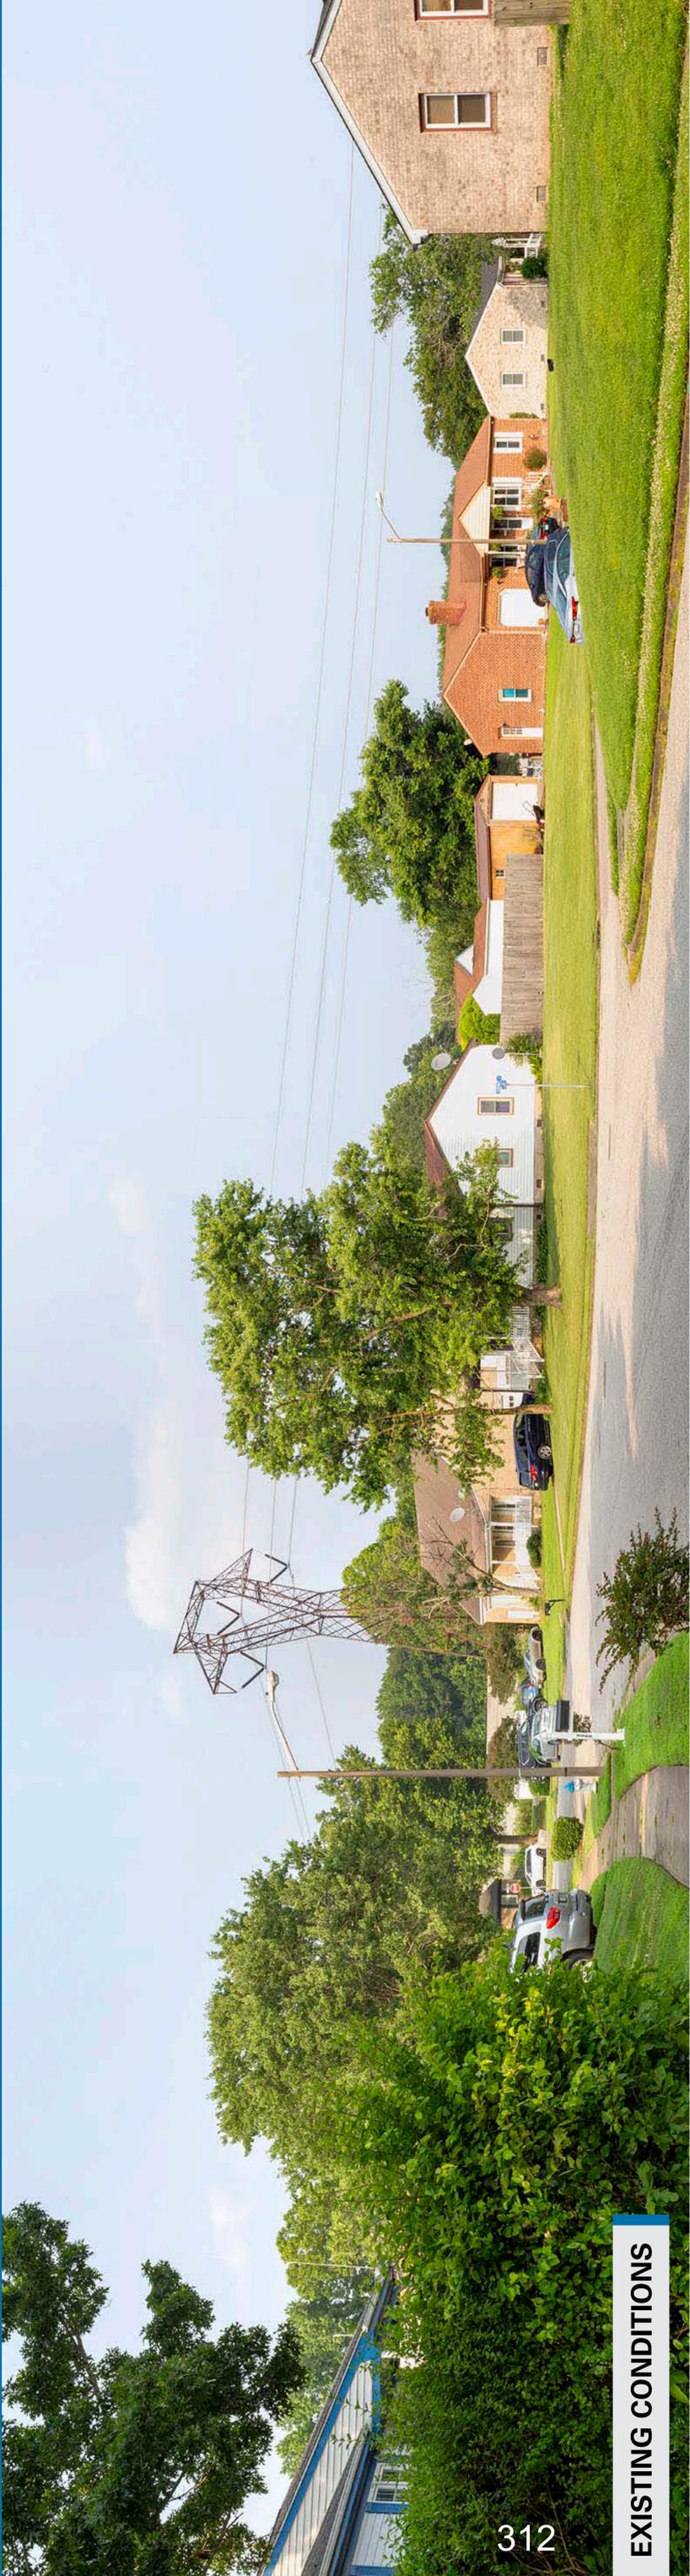
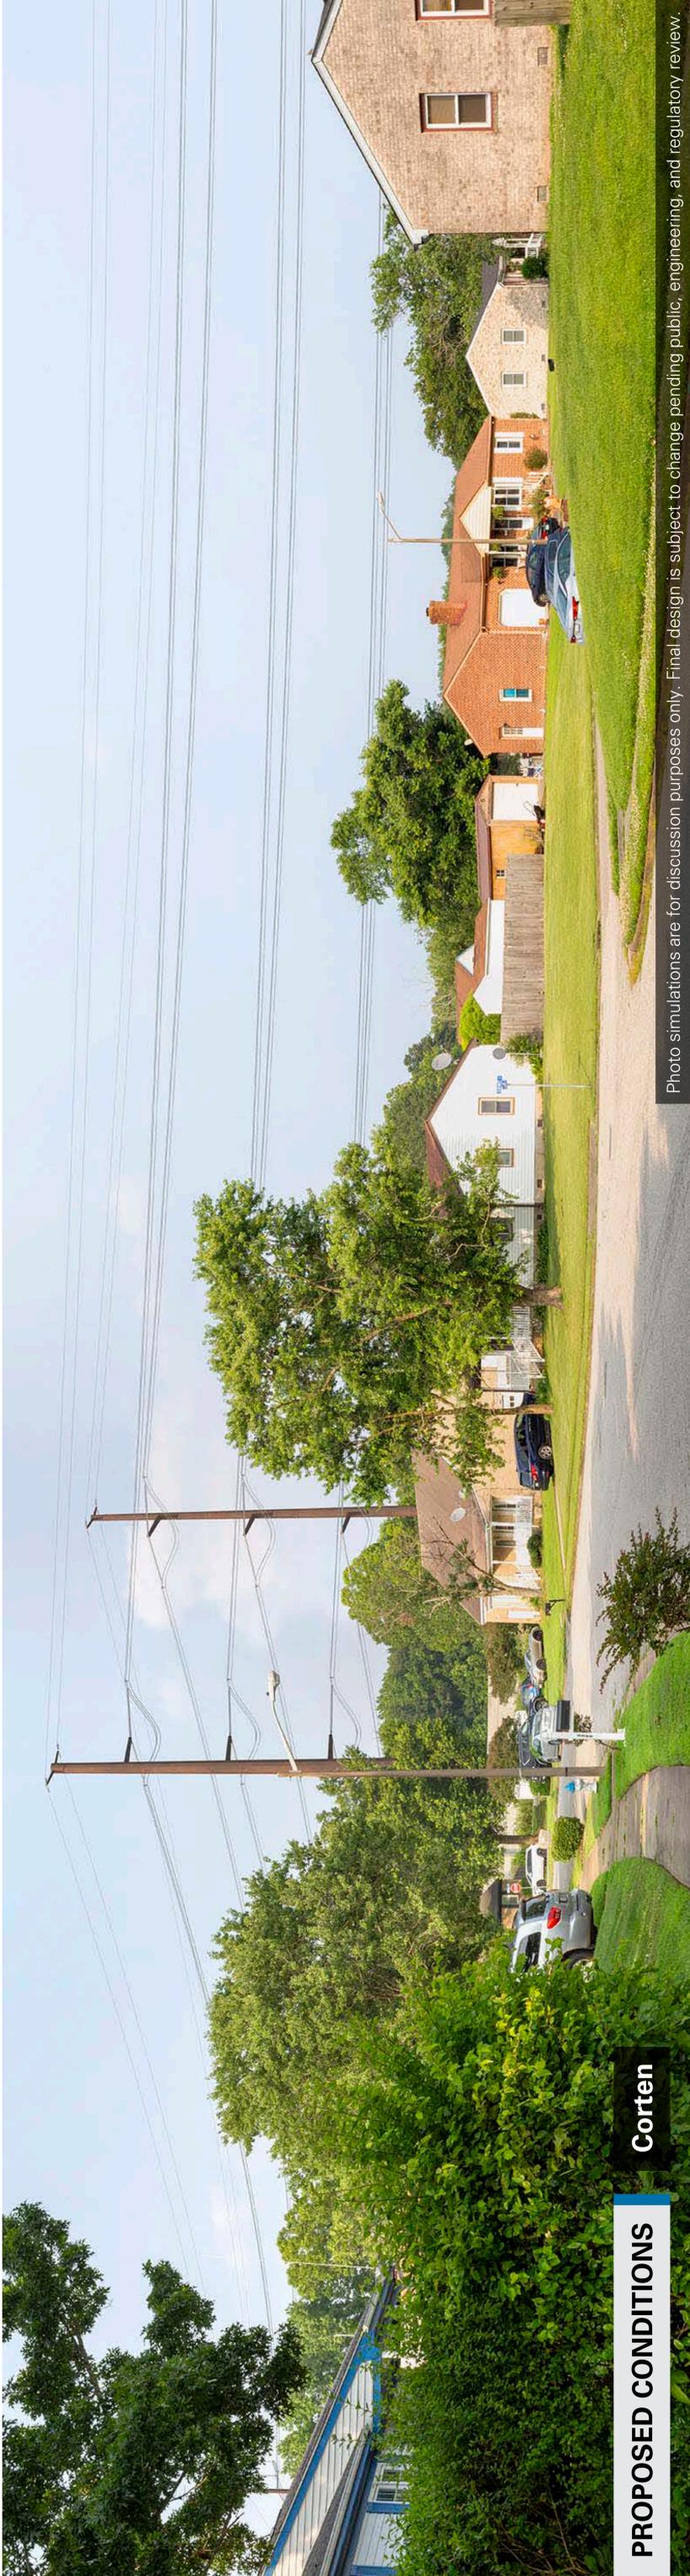
1 Viewpoint Location — Transmission Line

Date: 6/29/2023 Time: 4:55 pm Viewing Direction: East

EXISTING CONDITIONS

PROPOSED CONDITIONS

Corten

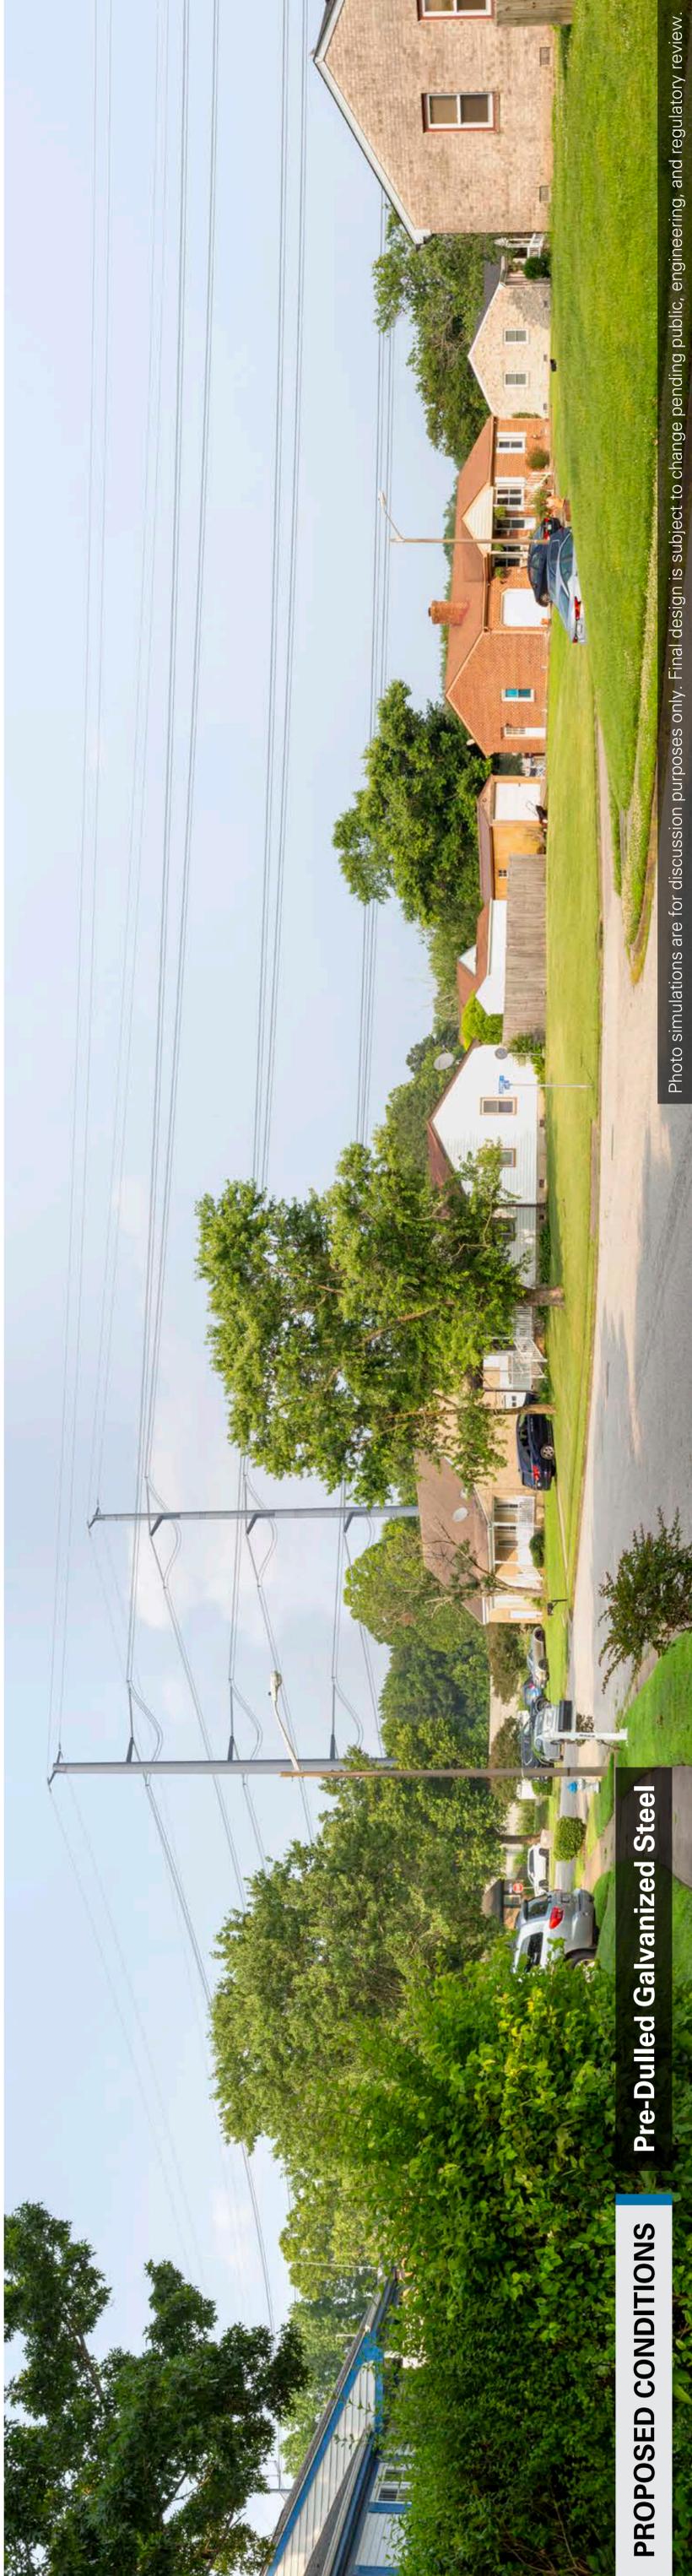
1 Viewpoint Location — Transmission Line

Date: 6/29/2023 Time: 4:55 pm Viewing Direction: East

EXISTING CONDITIONS

PROPOSED CONDITIONS

Pre-Dulled Galvanized Steel
