Application of Virginia Electric and Power Company for approval and certification of electric transmission facilities: Fentress-Yadkin 500 kV Line #588 Rebuild and New 500 kV Fentress-Yadkin Line #5005
Case No. PUR-2024-00105

ATTACHMENT I.A.1
PROJECT OVERVIEW MAP
 Fentress-Yadkin 500 KV Line #588 Rebuild and
 New 500 KV Fentress-Yadkin Line #5005
 City of Chesapeake, Virginia

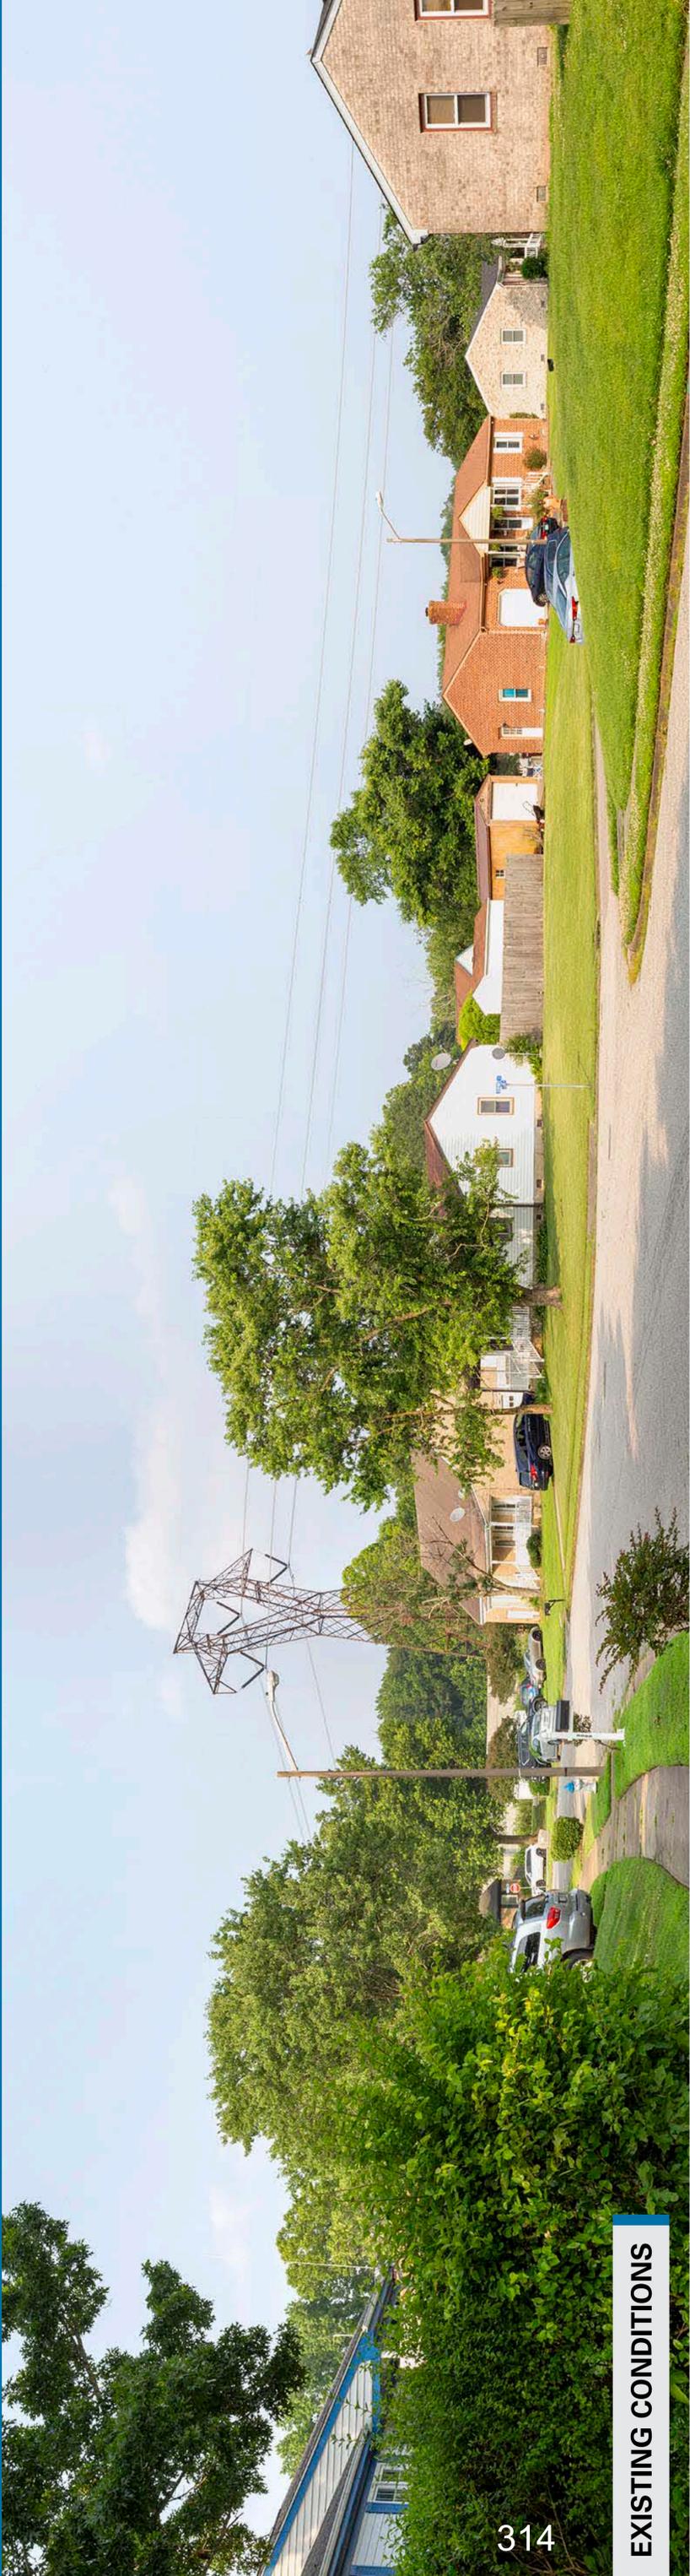
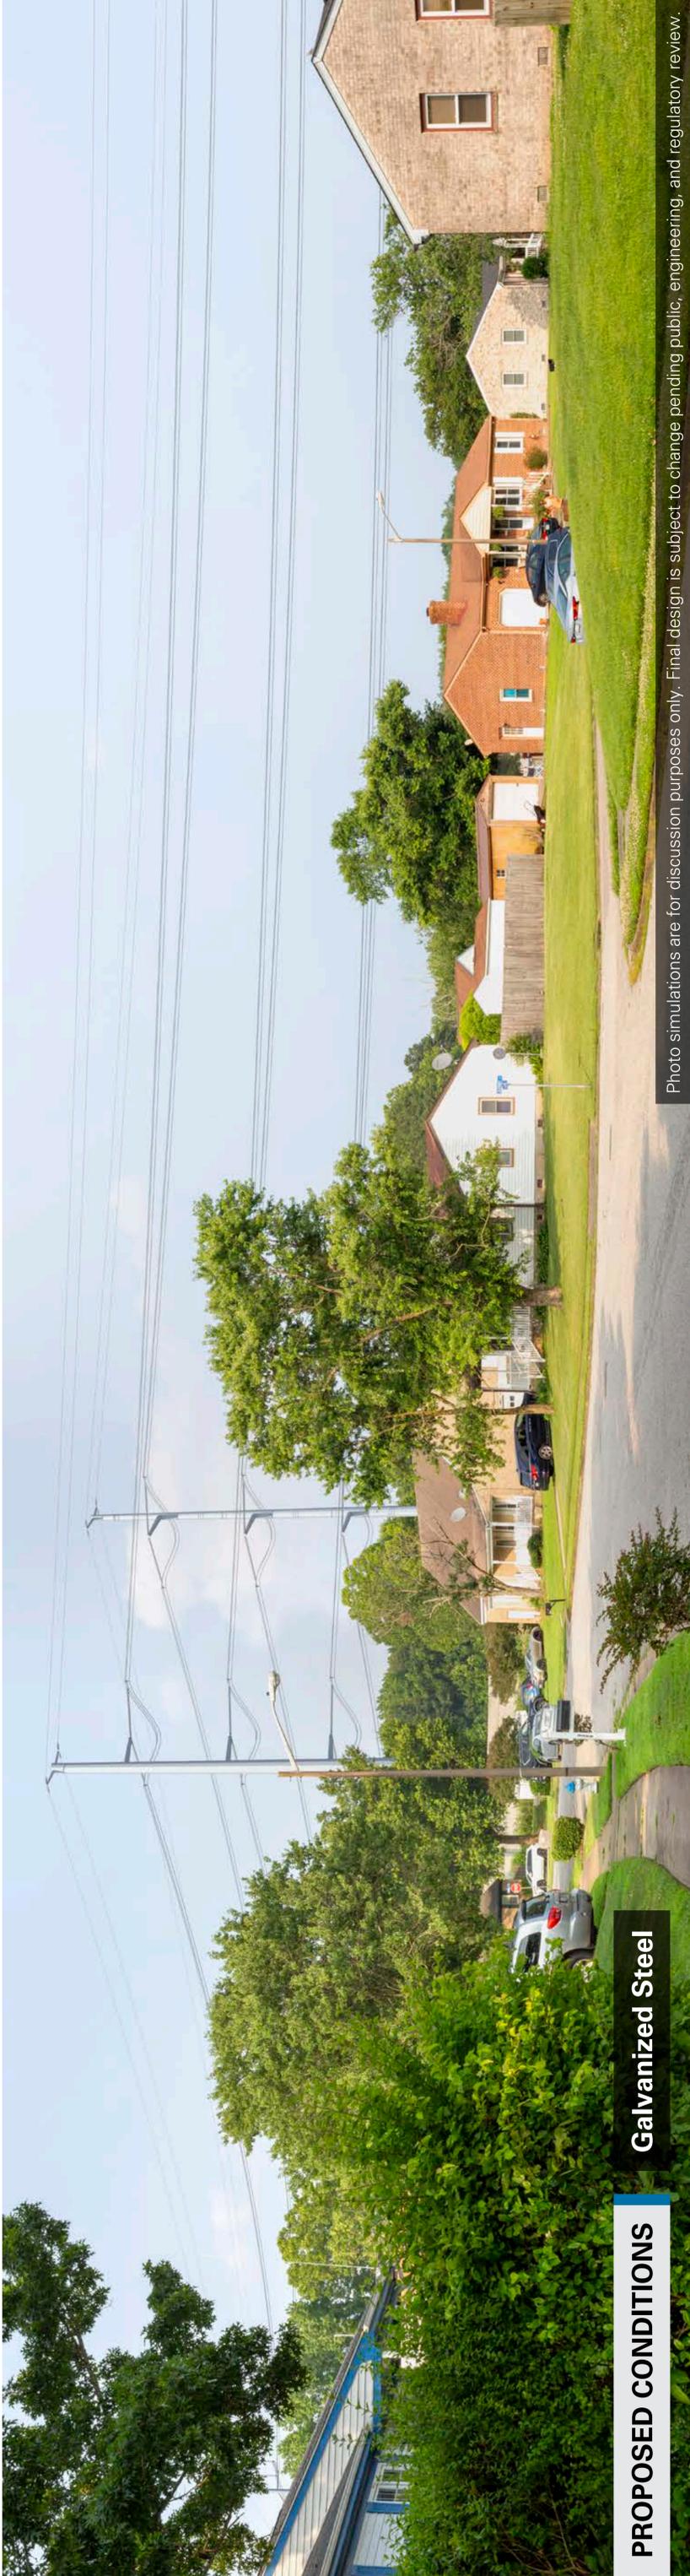
1 Viewpoint Location — Transmission Line

Date: 6/29/2023 Time: 4:55 pm Viewing Direction: East

EXISTING CONDITIONS

PROPOSED CONDITIONS

Galvanized Steel

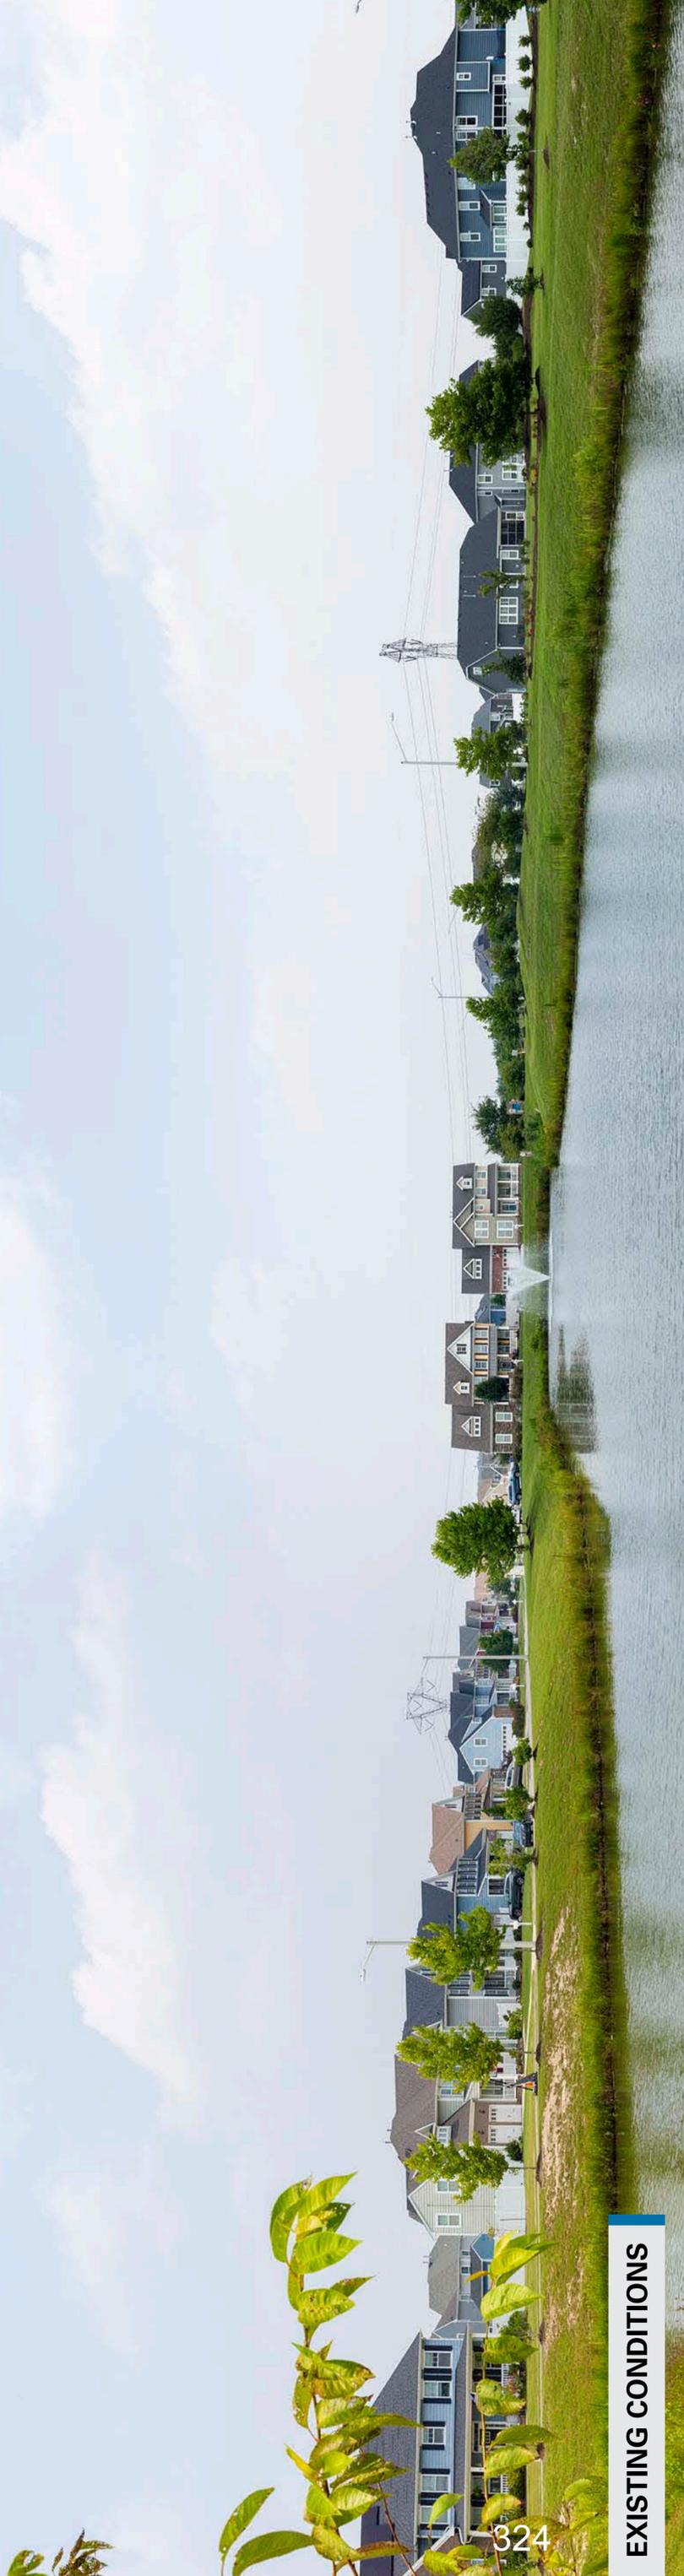
324

Date: 6/29/2023 Time: 12:17 pm Viewing Direction: North

5 Viewpoint Location — Transmission Line

EXISTING CONDITIONS

PROPOSED CONDITIONS

Corten

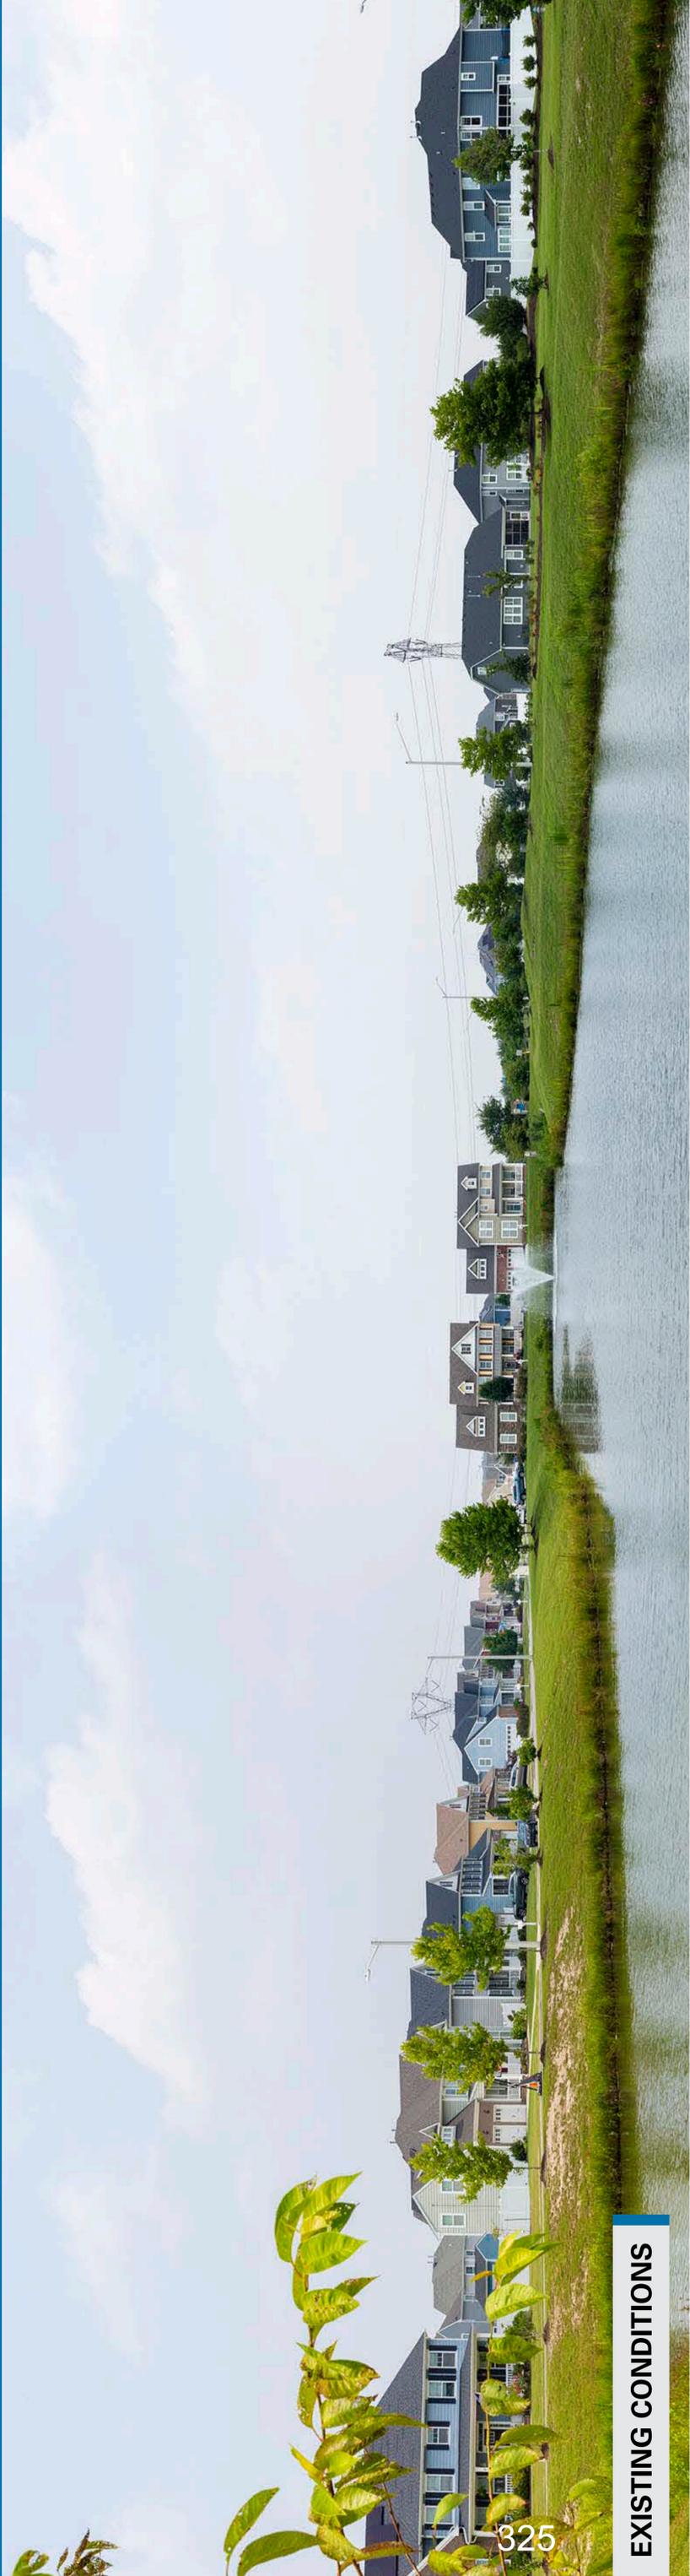
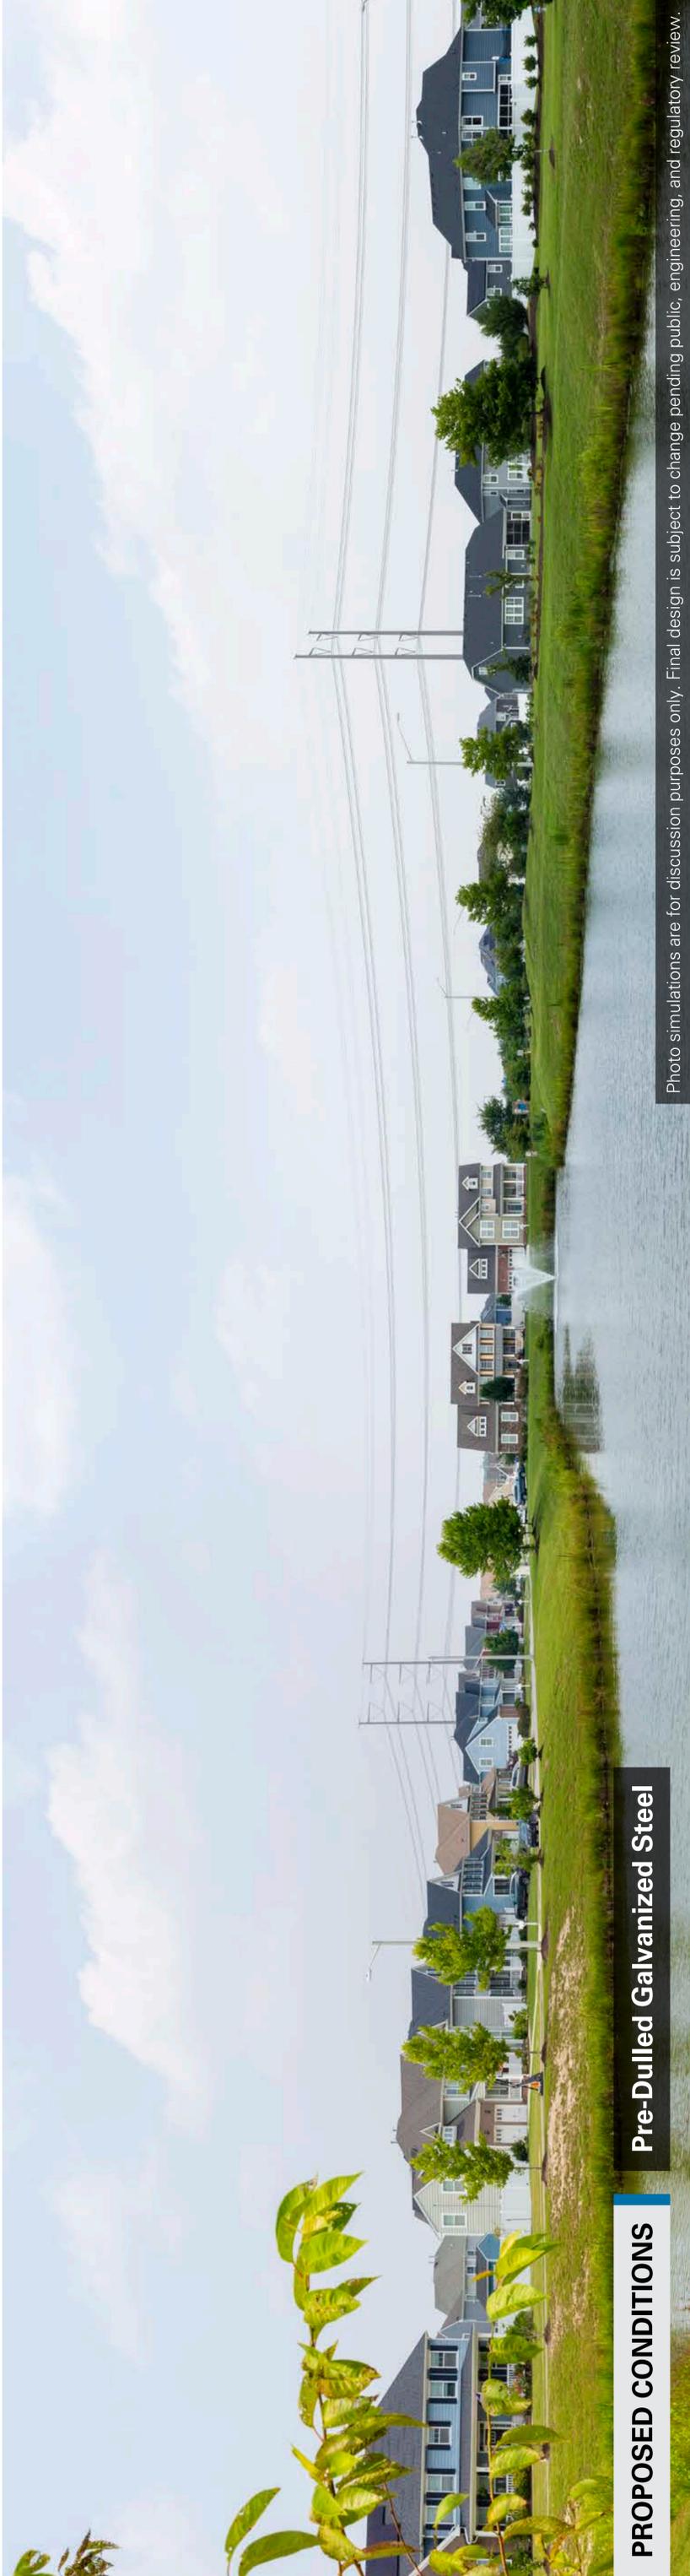
325

Date: 6/29/2023 Time: 12:17 pm Viewing Direction: North

5 Viewpoint Location — Transmission Line

EXISTING CONDITIONS

PROPOSED CONDITIONS

Pre-Dulled Galvanized Steel

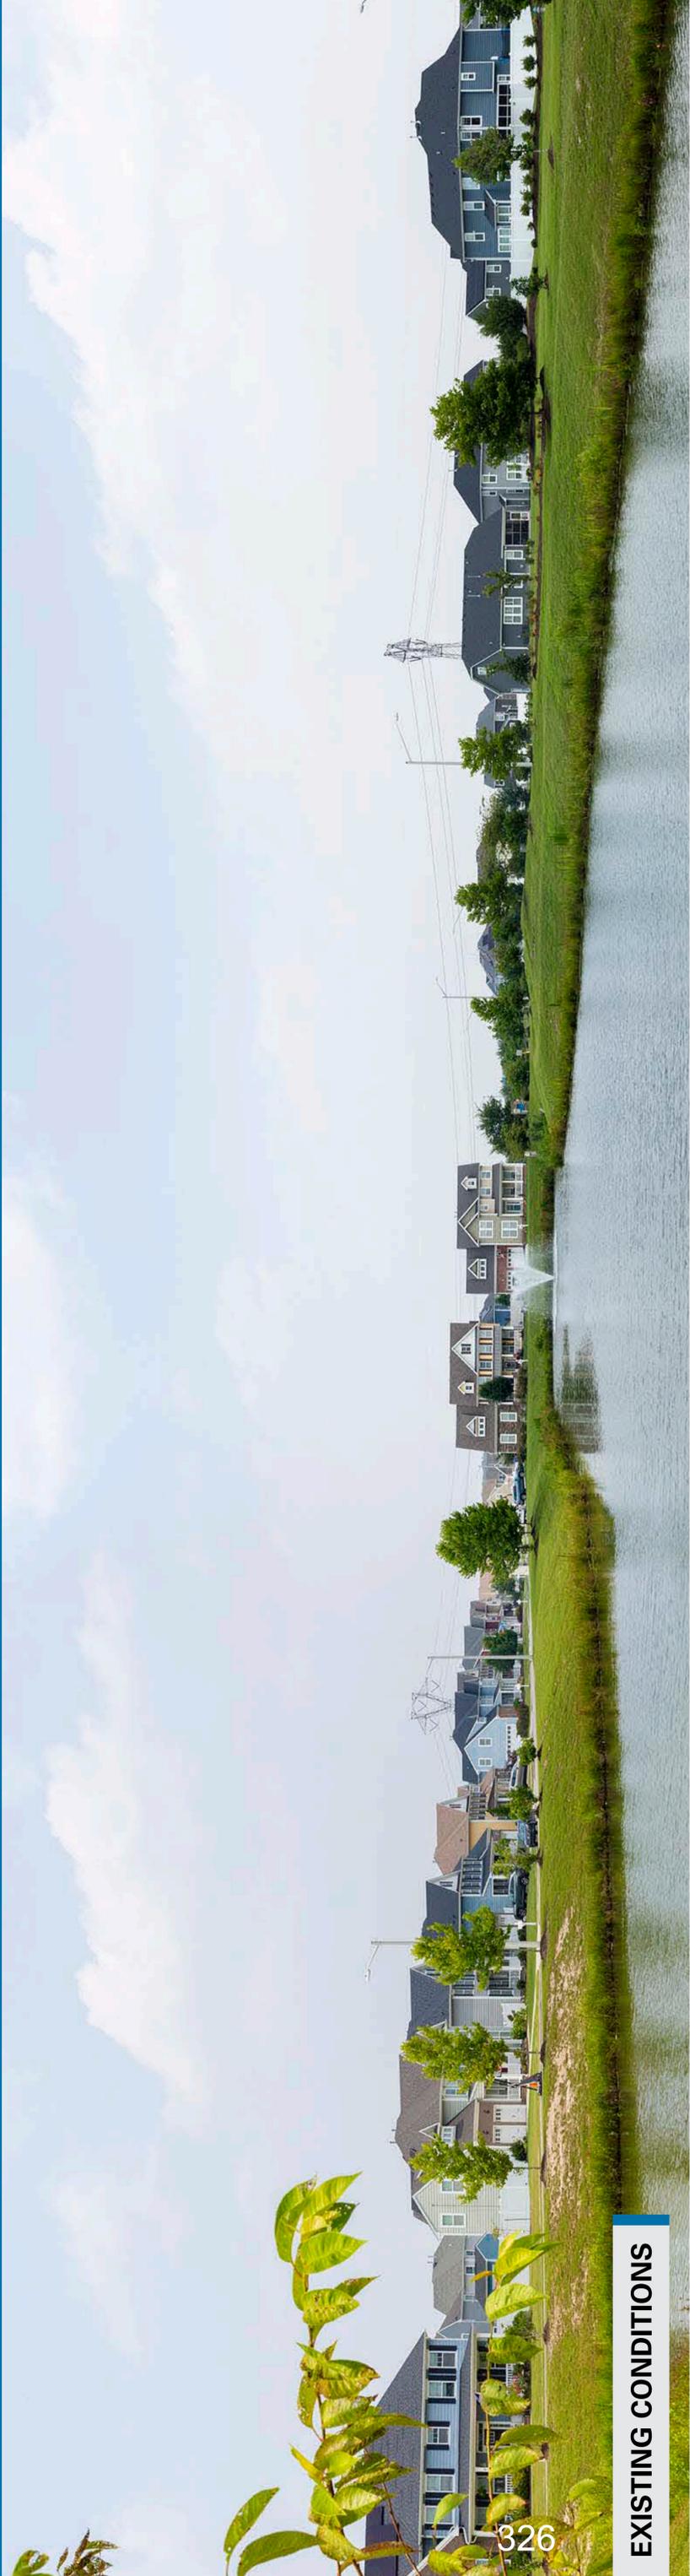
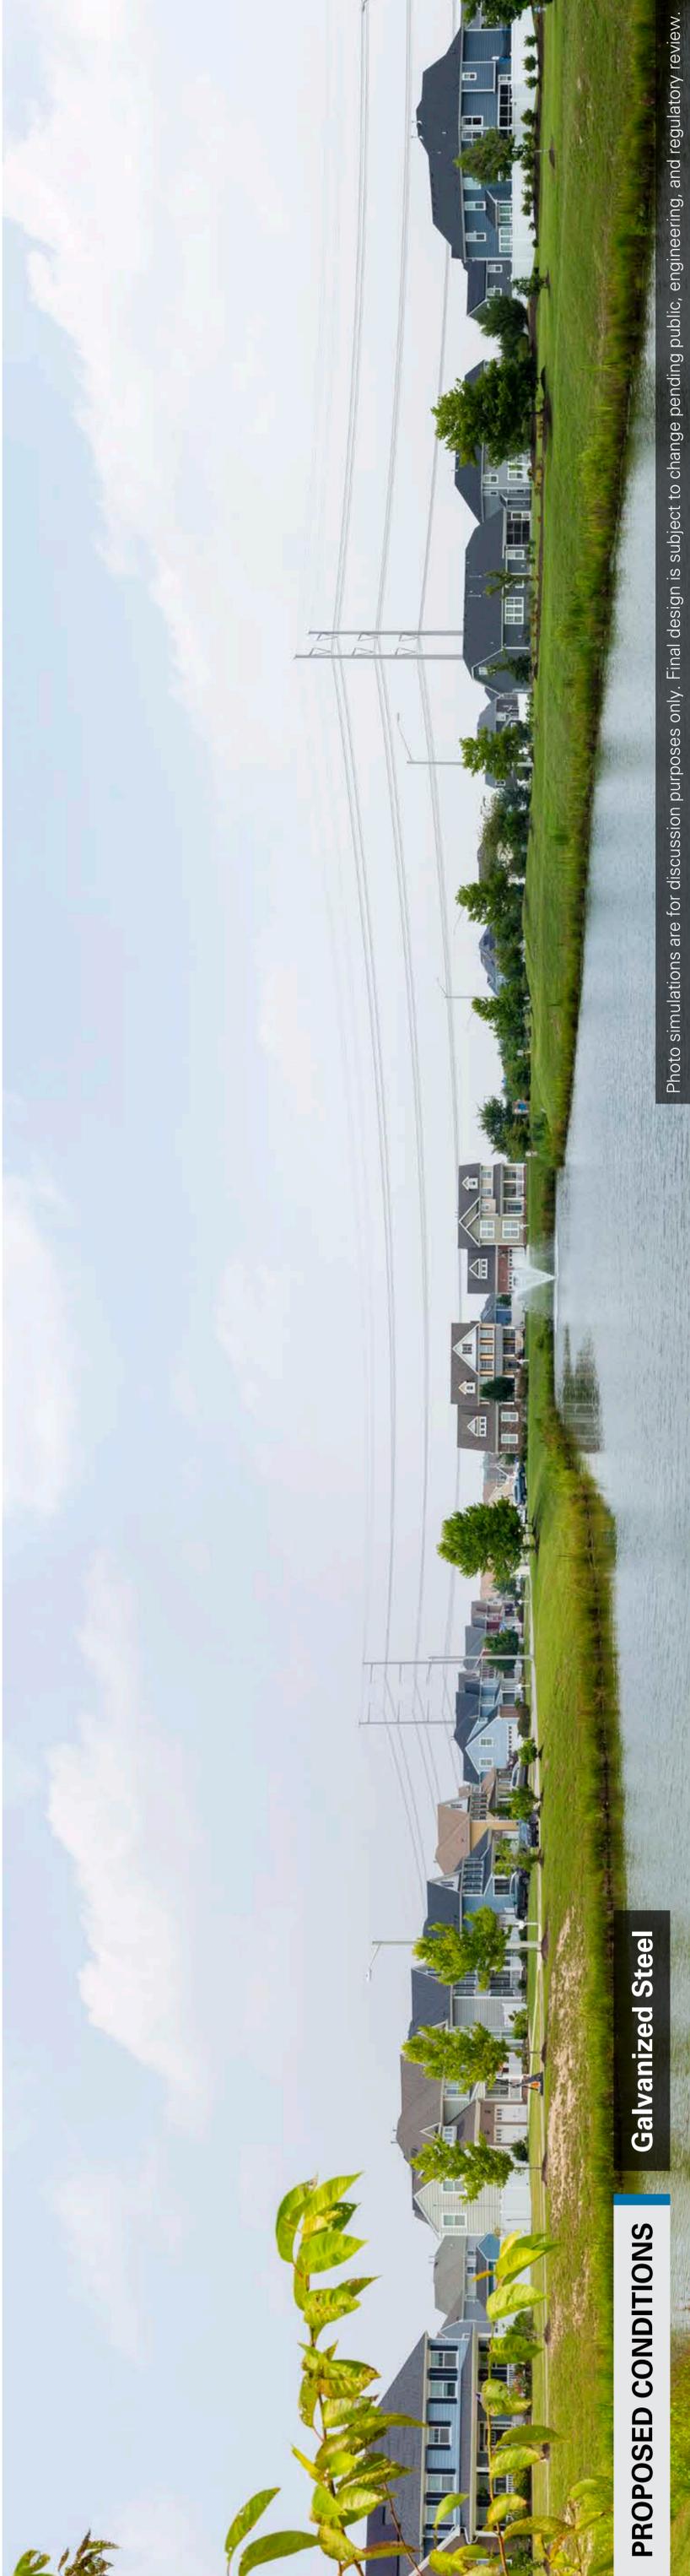
326

Date: 6/29/2023 Time: 12:17 pm Viewing Direction: North

5 Viewpoint Location — Transmission Line

EXISTING CONDITIONS

PROPOSED CONDITIONS

Galvanized Steel

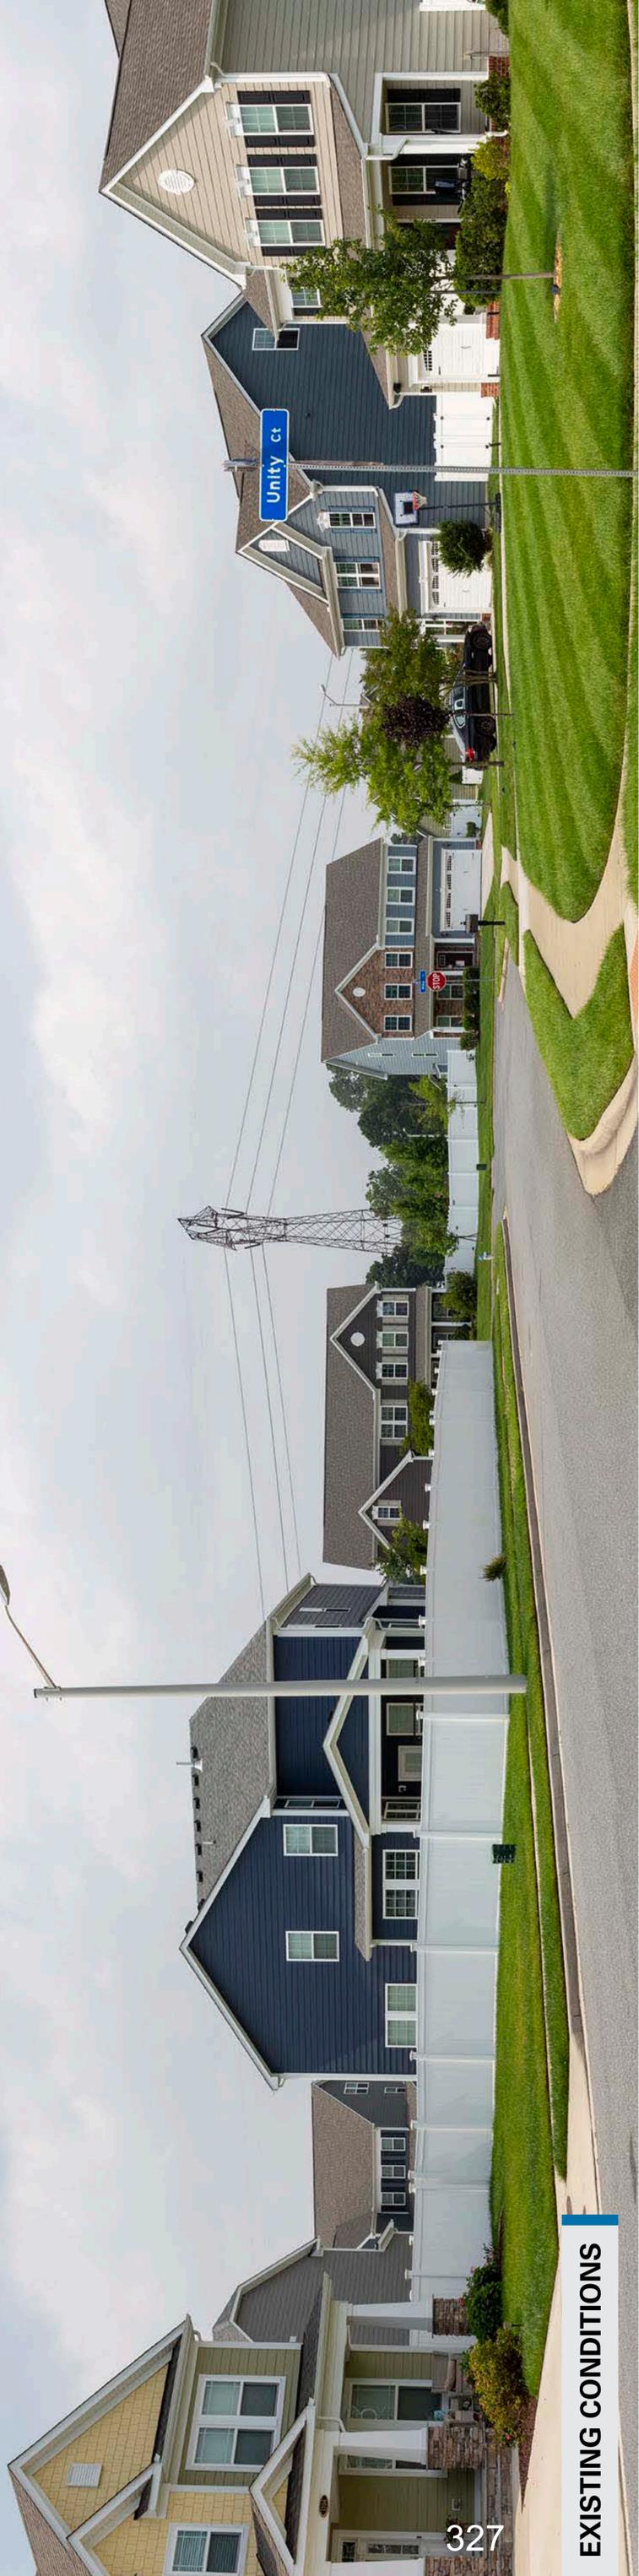
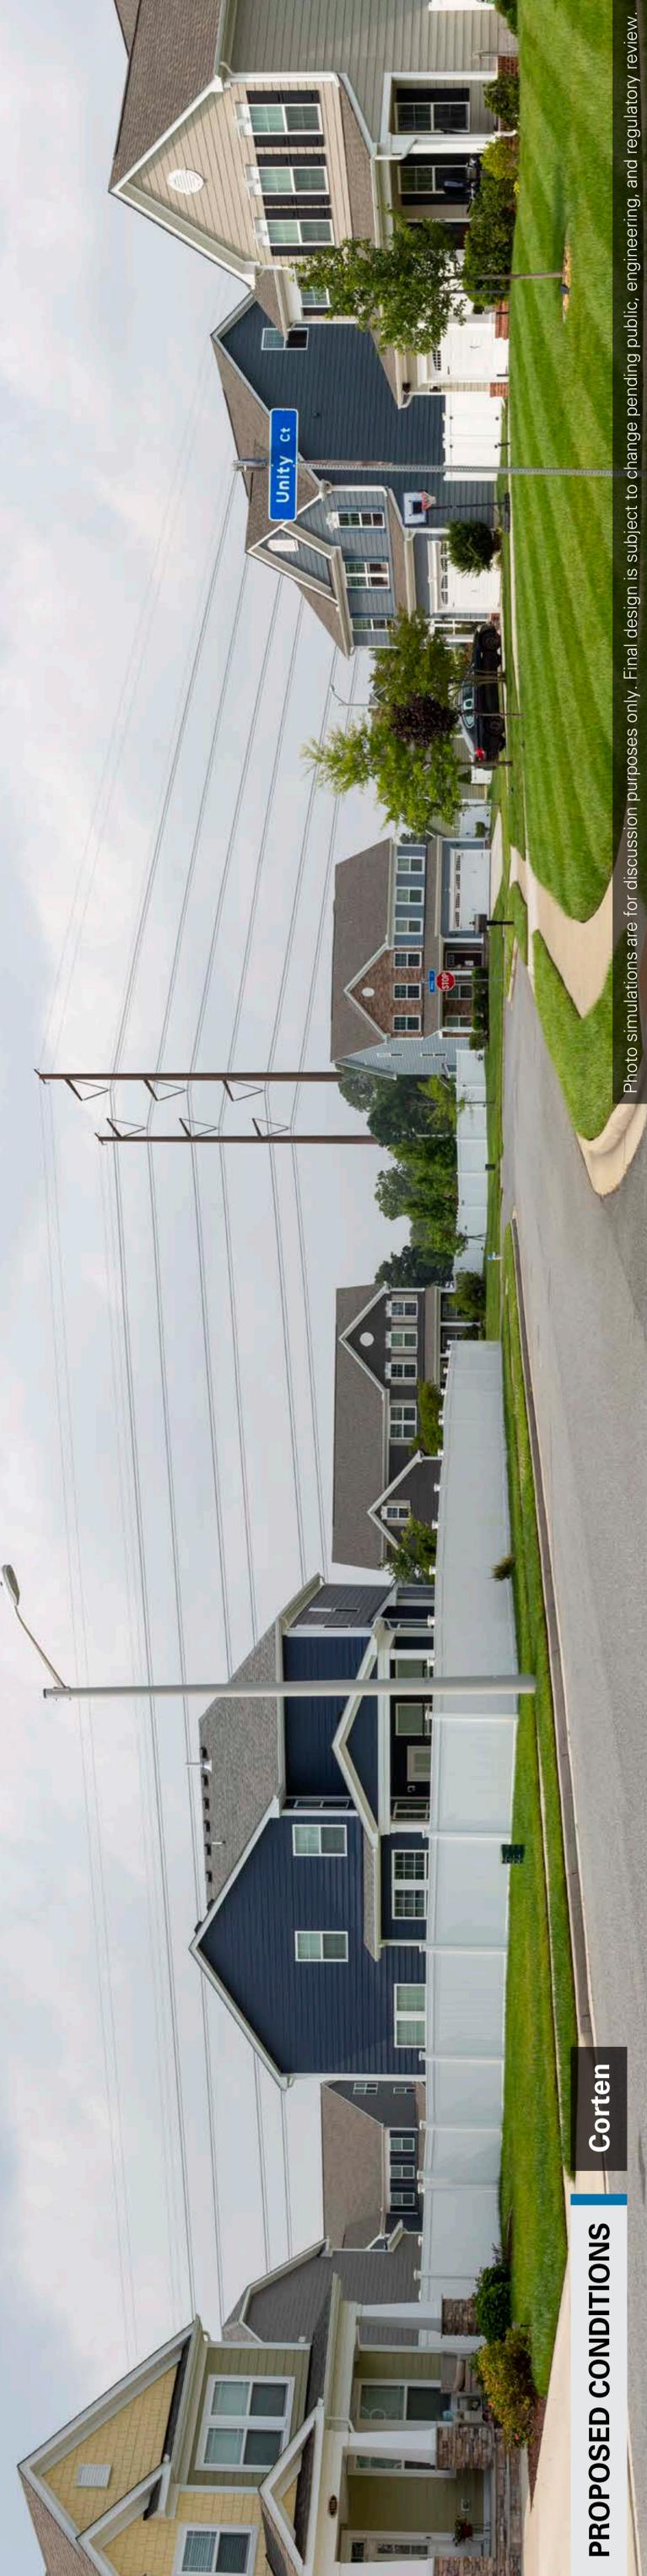
327

Date: 6/29/2023 Time: 2:10 pm Viewing Direction: North

6 Viewpoint Location — Transmission Line

EXISTING CONDITIONS

PROPOSED CONDITIONS

Corten

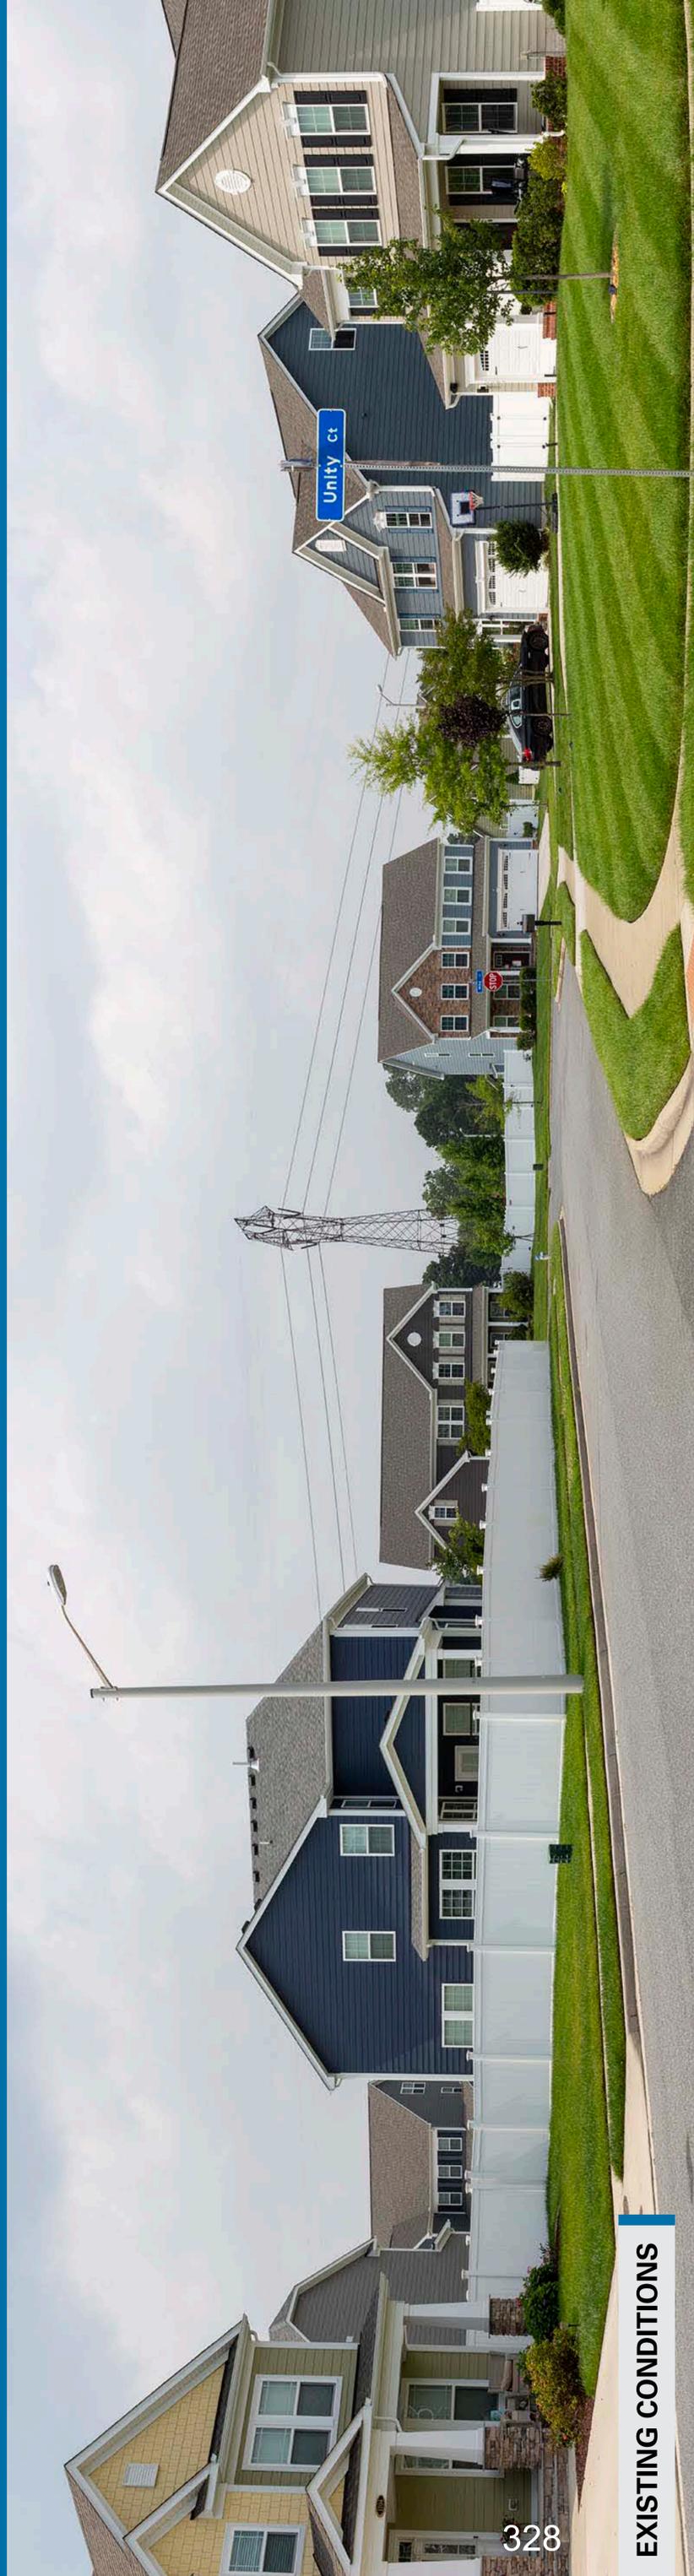
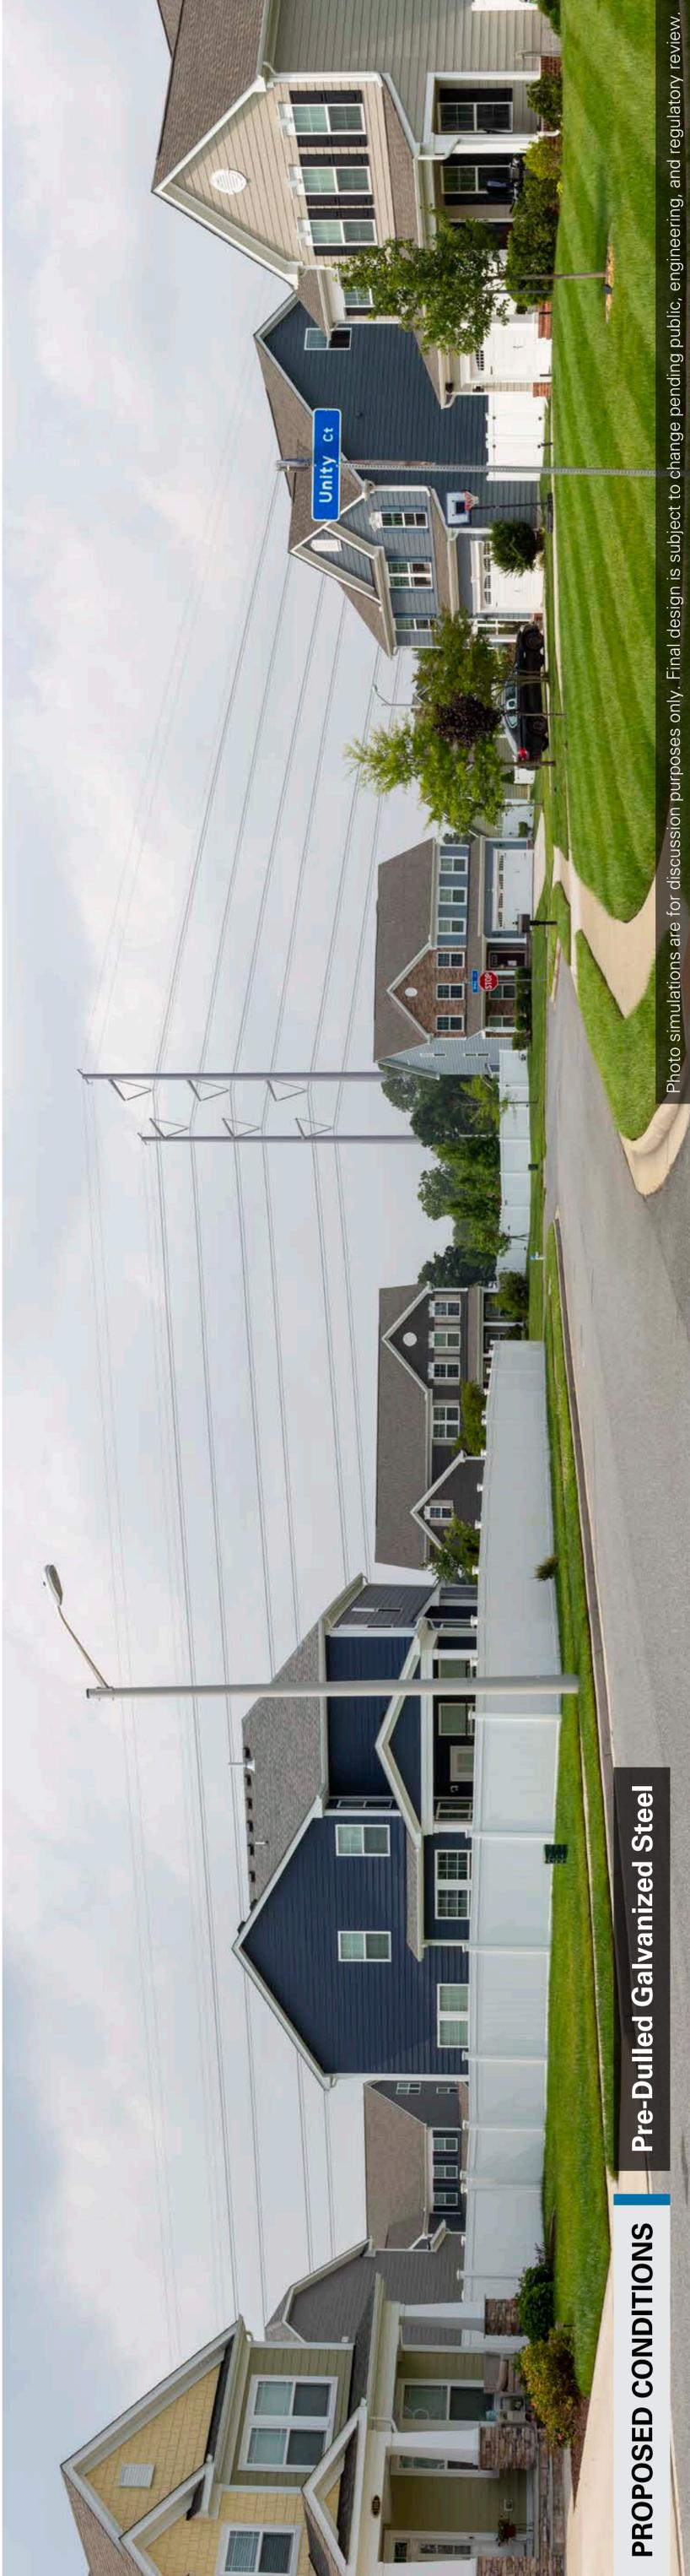
328

Date: 6/29/2023 Time: 2:10 pm Viewing Direction: North

6 Viewpoint Location — Transmission Line

EXISTING CONDITIONS

PROPOSED CONDITIONS

Pre-Dulled Galvanized Steel

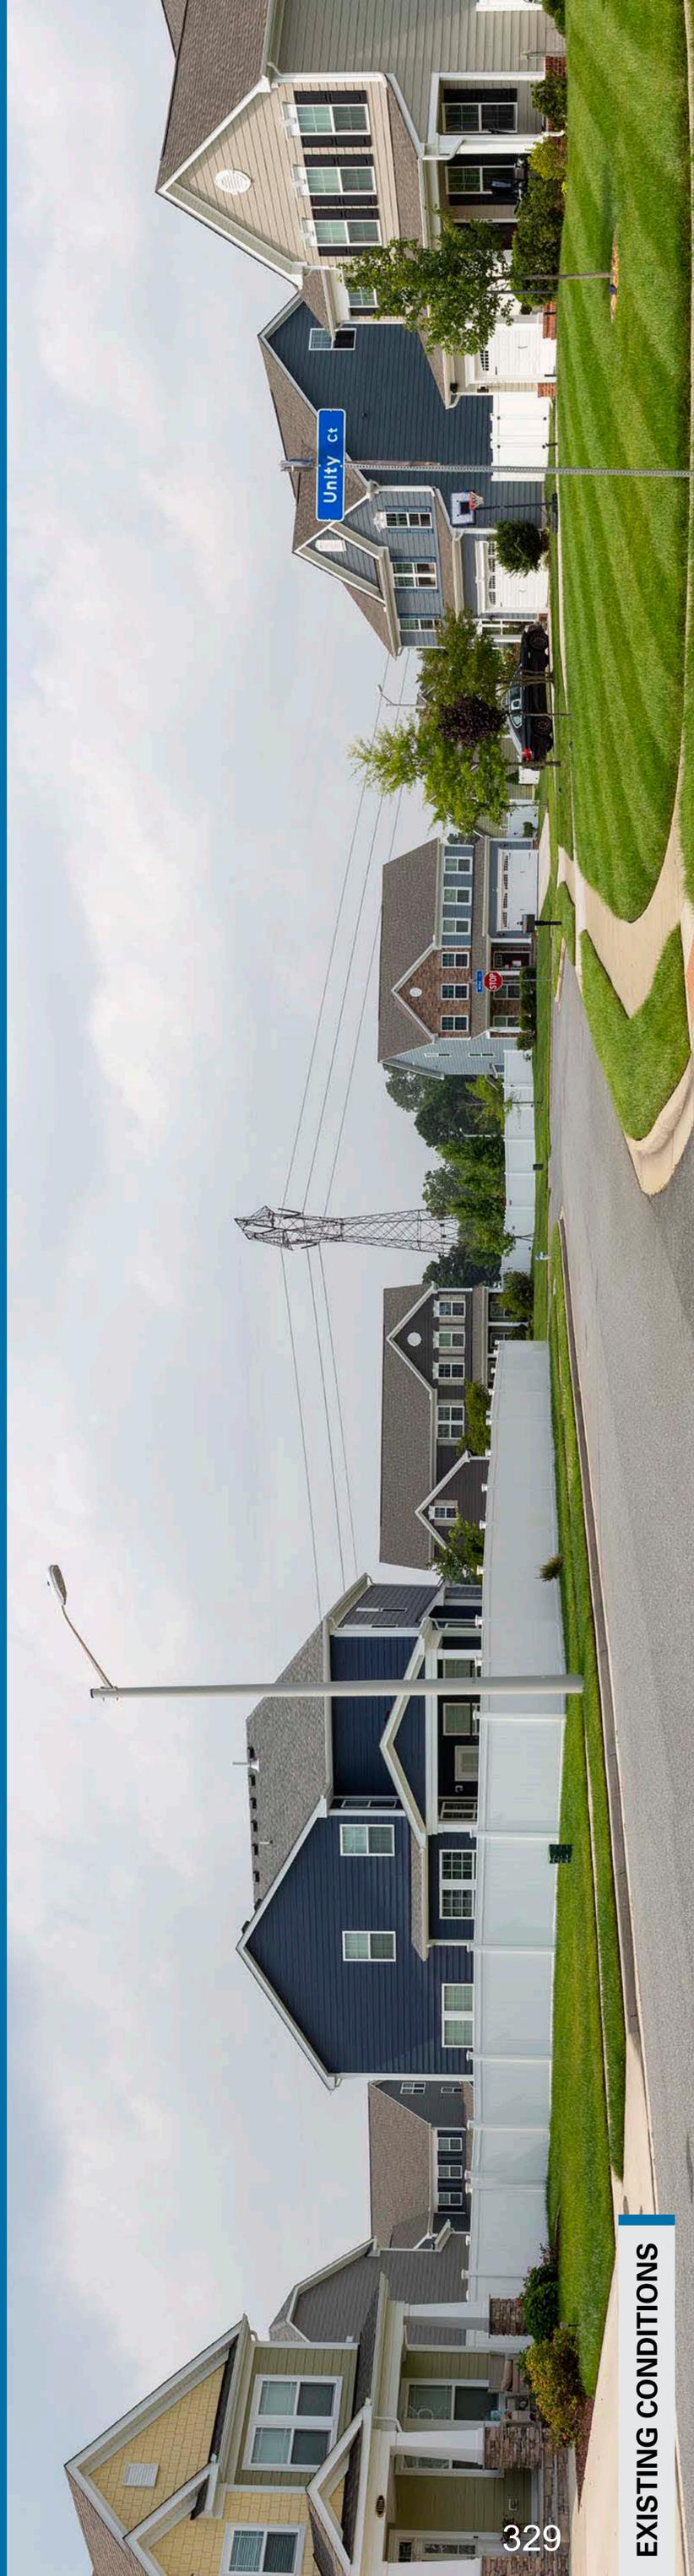
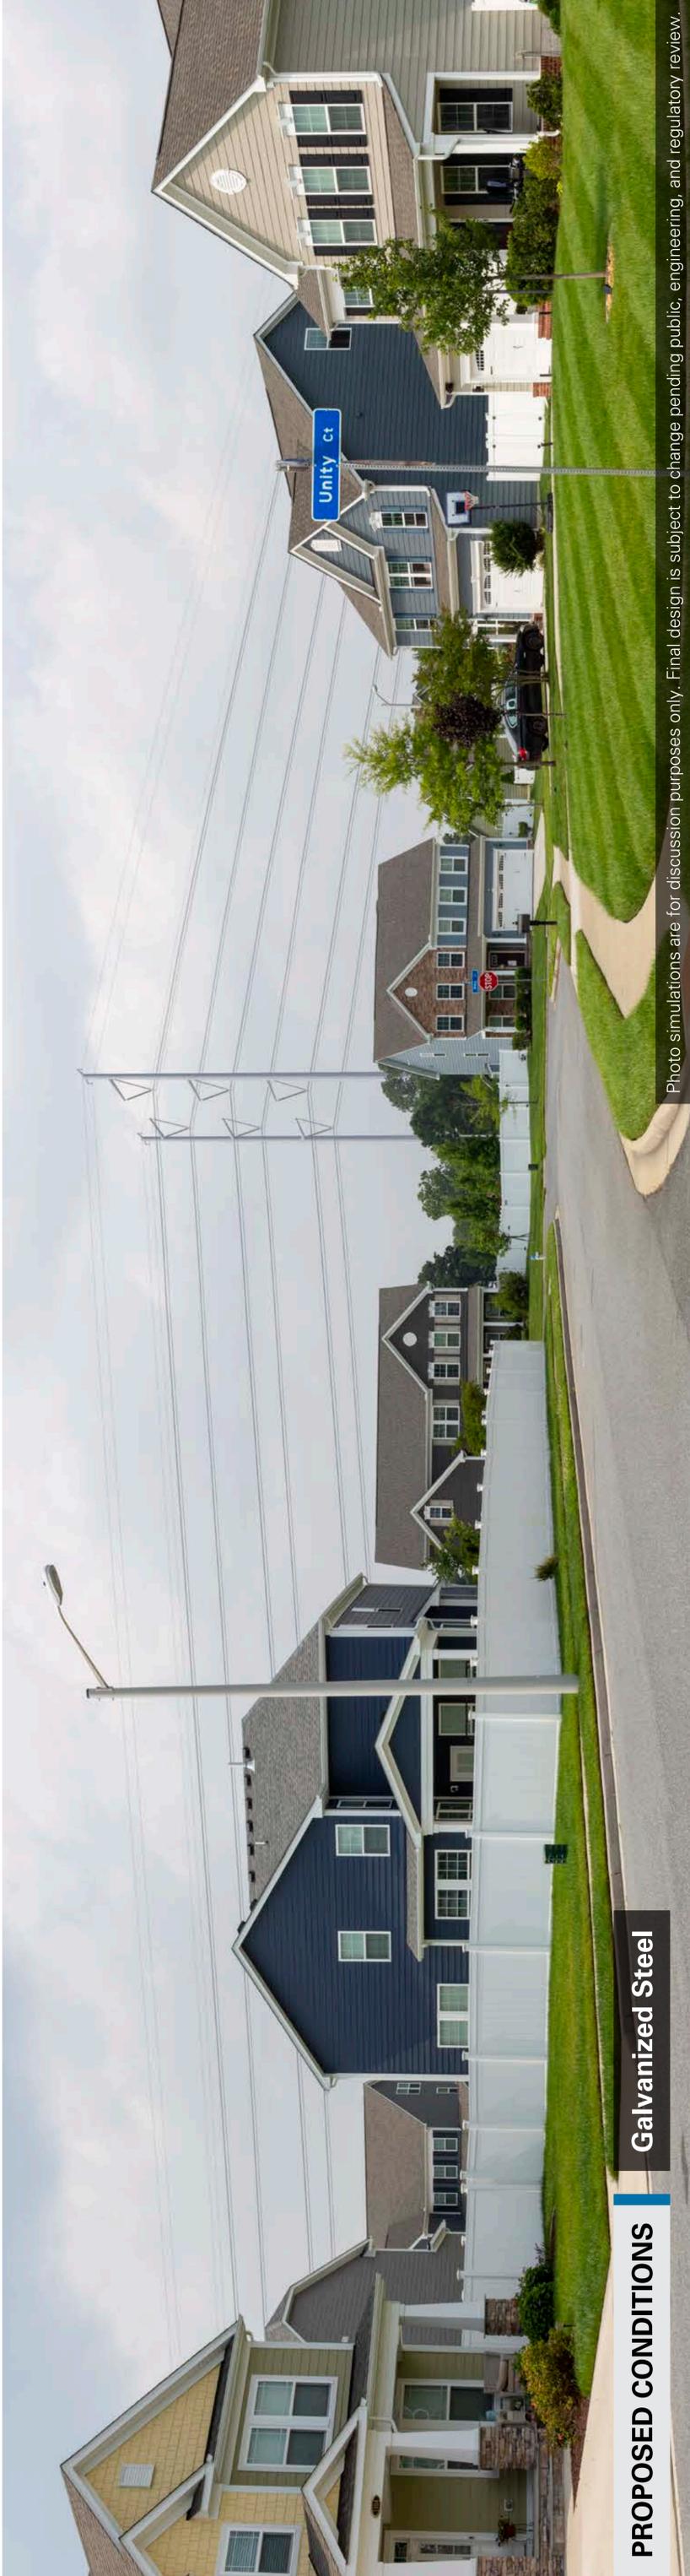
329

EXISTING CONDITIONS

PROPOSED CONDITIONS

Galvanized Steel
