Application of Virginia Electric and Power Company for approval and certification of electric transmission facilities: Fentress-Yadkin 500 kV Line #588 Rebuild and New 500 kV Fentress-Yadkin Line #5005
Case No. PUR-2024-00105

ATTACHMENT I.A.1
PROJECT OVERVIEW MAP
 Fentress-Yadkin 500 KV Line #588 Rebuild and
 New 500 KV Fentress-Yadkin Line #5005
 City of Chesapeake, Virginia

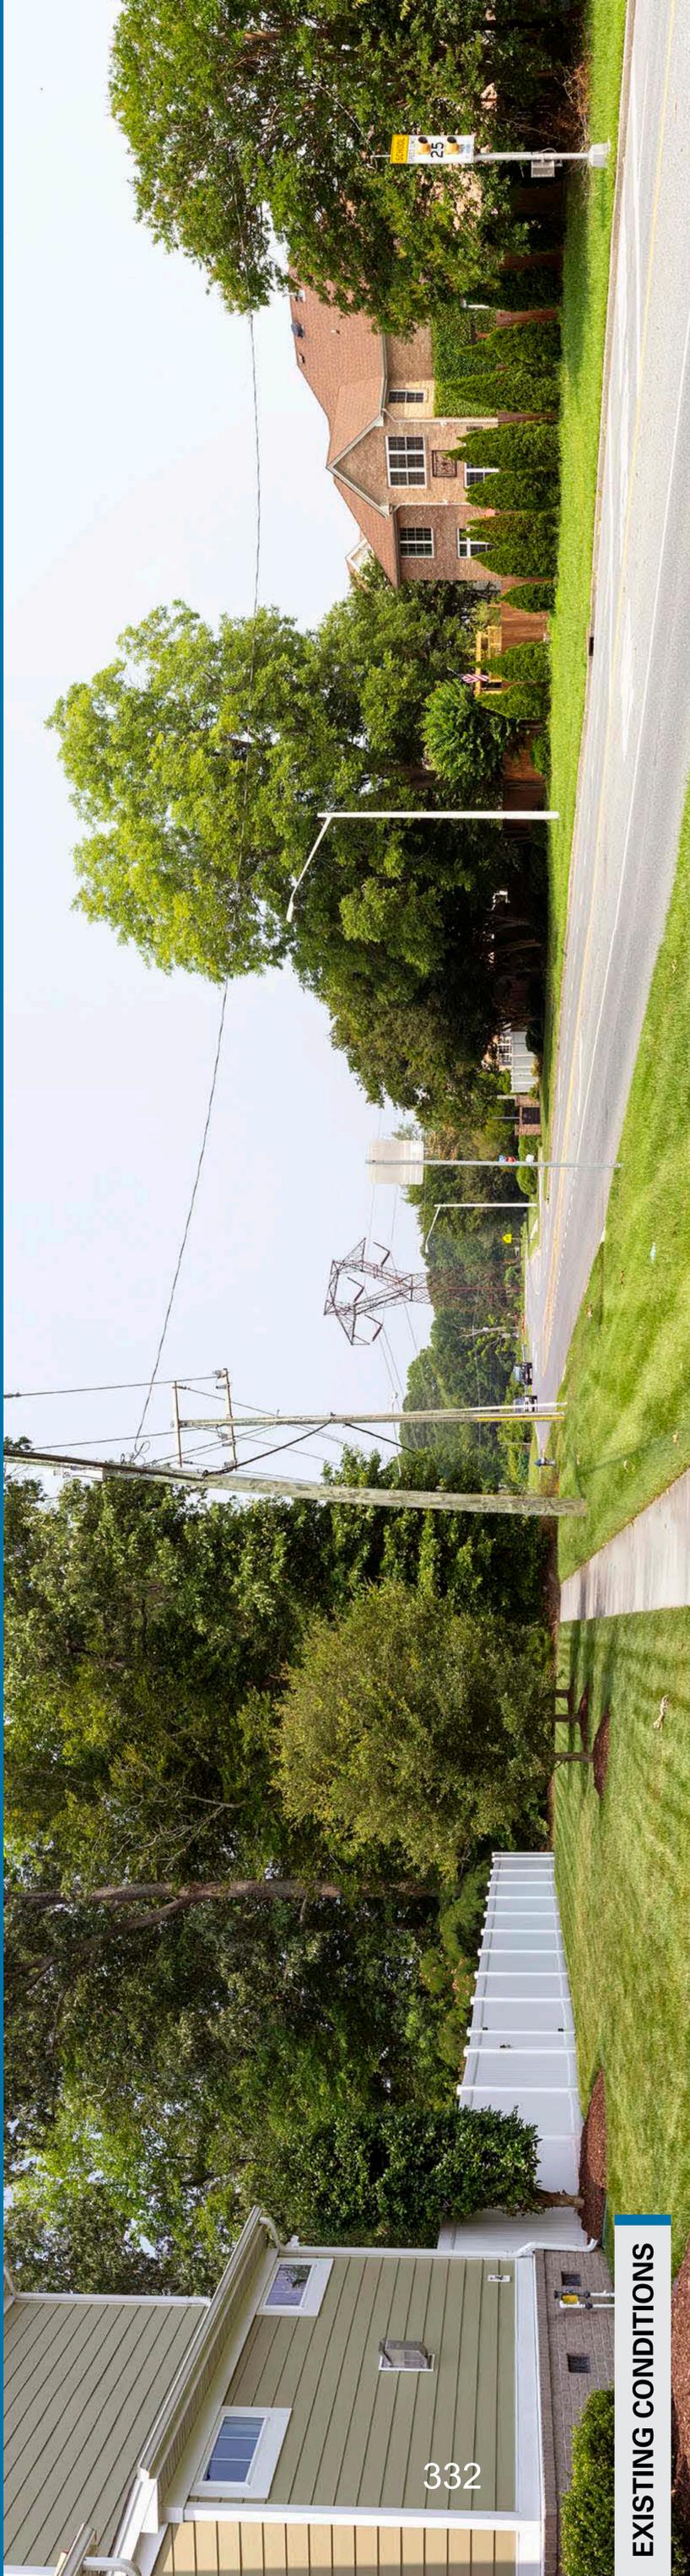
7 Viewpoint Location — Transmission Line

Date: 6/30/2023 Time: 10:14 am Viewing Direction: Northwest

EXISTING CONDITIONS

PROPOSED CONDITIONS

Galvanized Steel
