# HISTORY OF CONSTRUCTION

**Bremo Power Station CCR Surface Impoundment:  
East Ash Pond**

April 2018

Project No. 15-20347

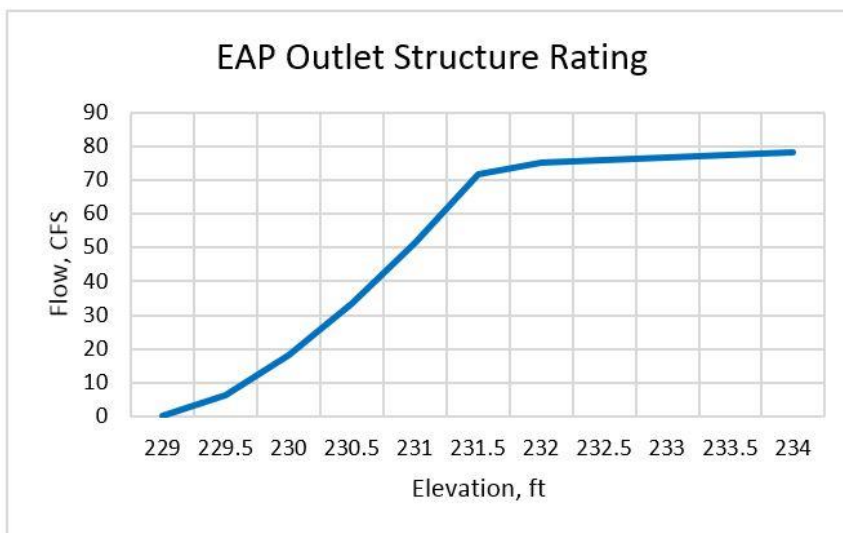
Figure 3: Riser Structure Rating

Prior to closure activities, the primary spillway, an intake tower and 24-inch diameter reinforced concrete pipe, regulated the pool elevation in the eastern portion of the EAP. The intake tower, in the eastern end of the impoundment area, is constructed of concrete and regulated by concrete stop logs. The current lowest stoplog elevation is approximately 229.0. A 24-inch diameter pipe extends from the structure under the EAP dike to a drainage channel and ultimately through a permitted outfall. As of mid-2017, the EAP has been dewatered for closure activities and the 24-inch diameter pipe has been temporarily plugged to satisfy discharge permit requirements. Surface water and pore water within the EAP are pumped to the on-site CSWTS for treatment and discharge. There is no auxiliary spillway. The primary spillway capacity table and curve are shown in Figure 3 below. The analysis of the spillway capacity is included in Appendix B of the Inflow Design Flood Control System Plan.

Elevation, ft	Structure Rating, CFS
229	0.00
229.5	6.42
230	18.15
230.5	33.34
231	51.34
231.5	71.74
232	75.10
232.5	75.90
233	76.70
233.5	77.40
234	78.20
