**2016 Annual
Landfill Inspection Report**

**SCE&G
Cope Station
Class III Landfill**

**Cope, SC
County of Orangeburg**

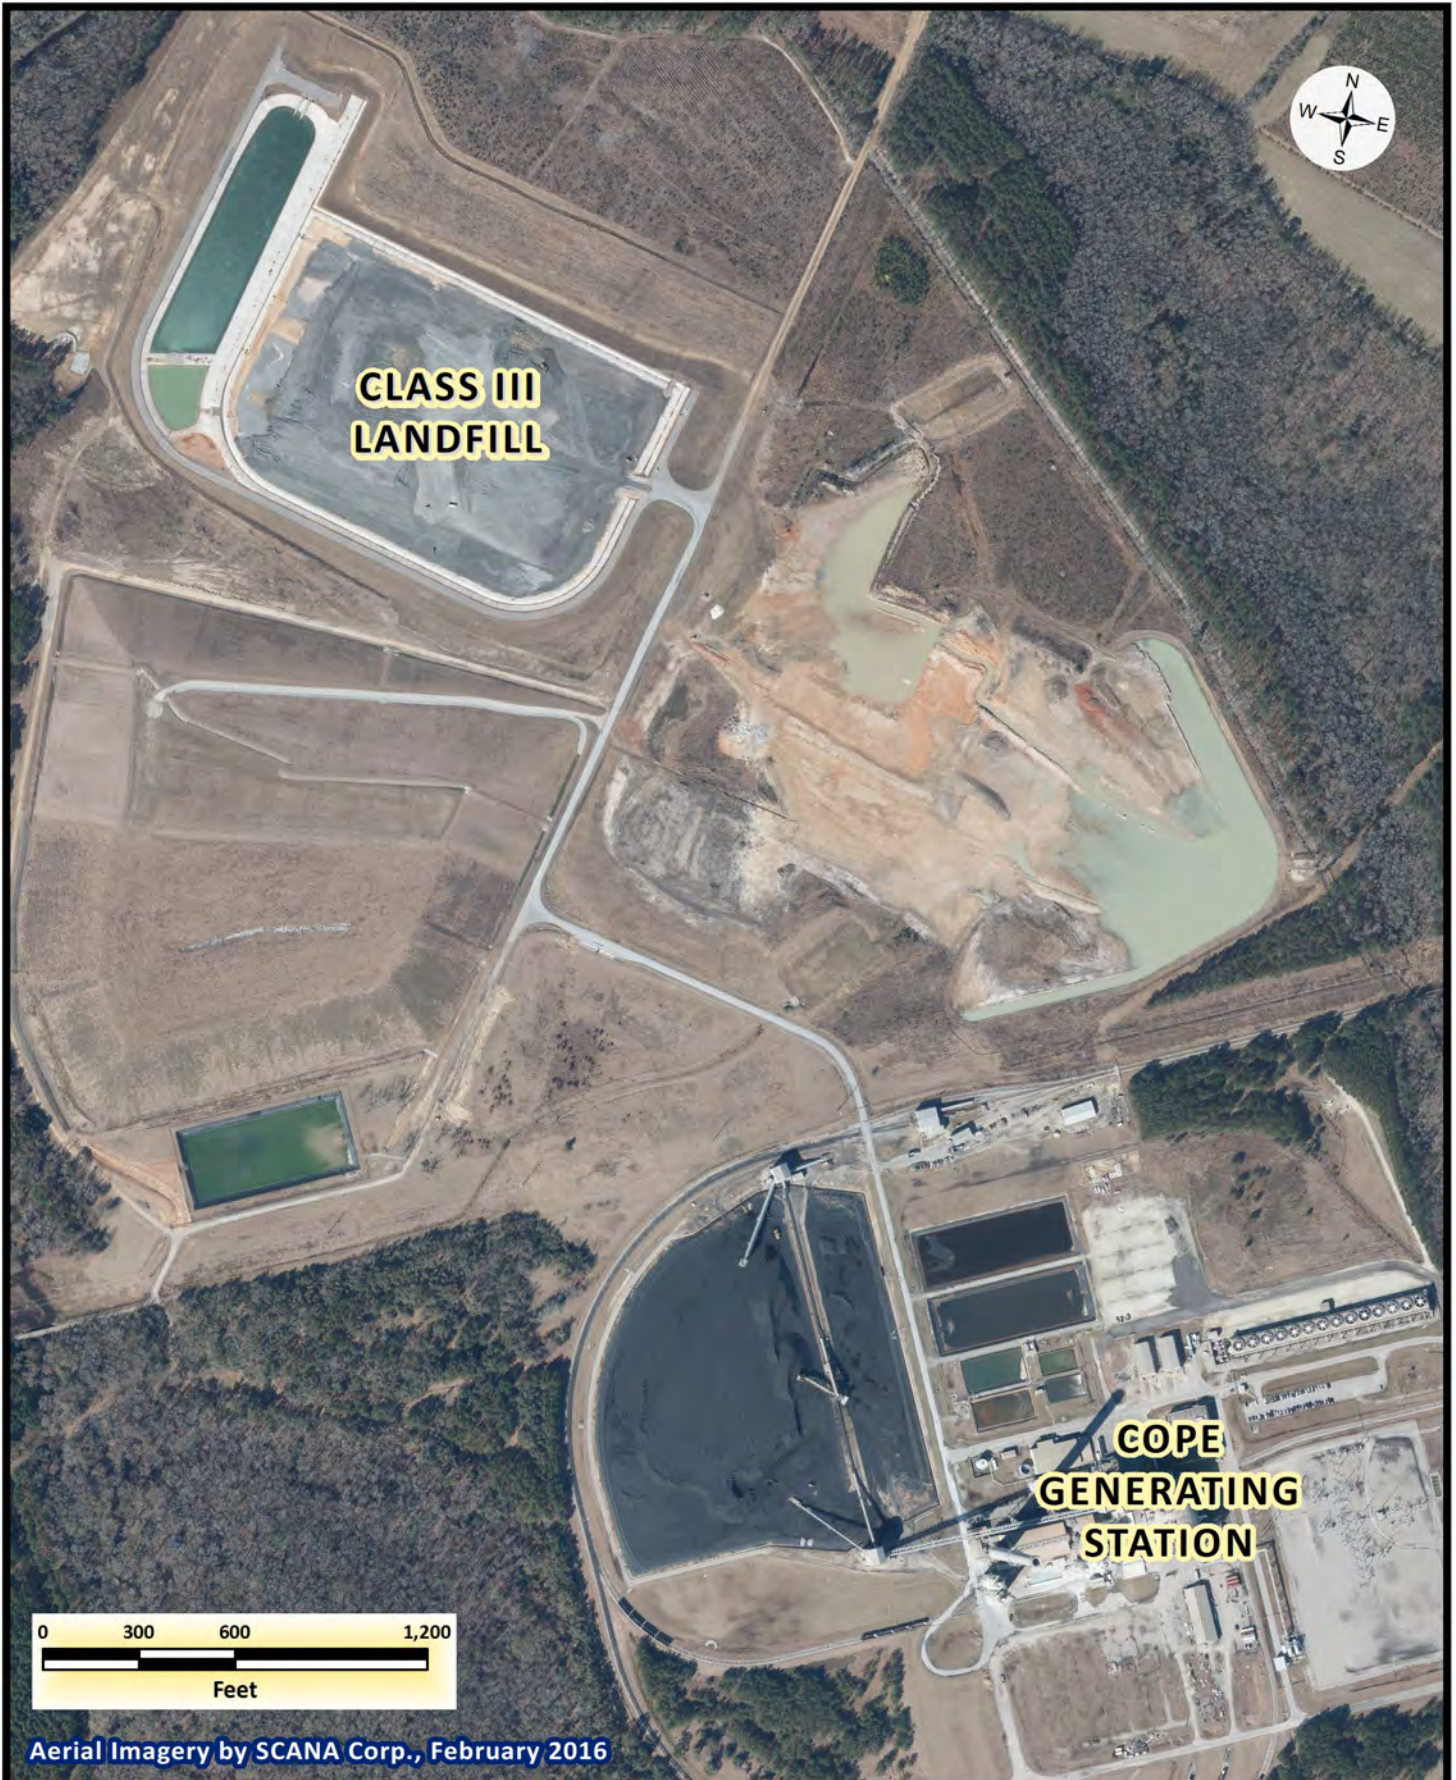
**Figure 1 – Site Location
Cope Station Landfill**

Aerial Imagery by SCANA Corp., February 2016

The landfill is located at the Cope Generating Station in Orangeburg County. The Cope Generating Station is approximately 13 miles southwest the City of Orangeburg, SC. Figure 1 – Site Location Figure, shows the location of the landfill relative to the power plant. The date of the aerial imagery is February 2016. The Class III landfill is permitted by the South Carolina Department of Health and Environmental Control (SCDHEC) under Permit No. 383320-1601.
