**2018 Annual
Landfill Inspection Report**

**SCE&G
Cope Station
Class III Landfill**

**Cope, SC
County of Orangeburg**

January 17, 2019

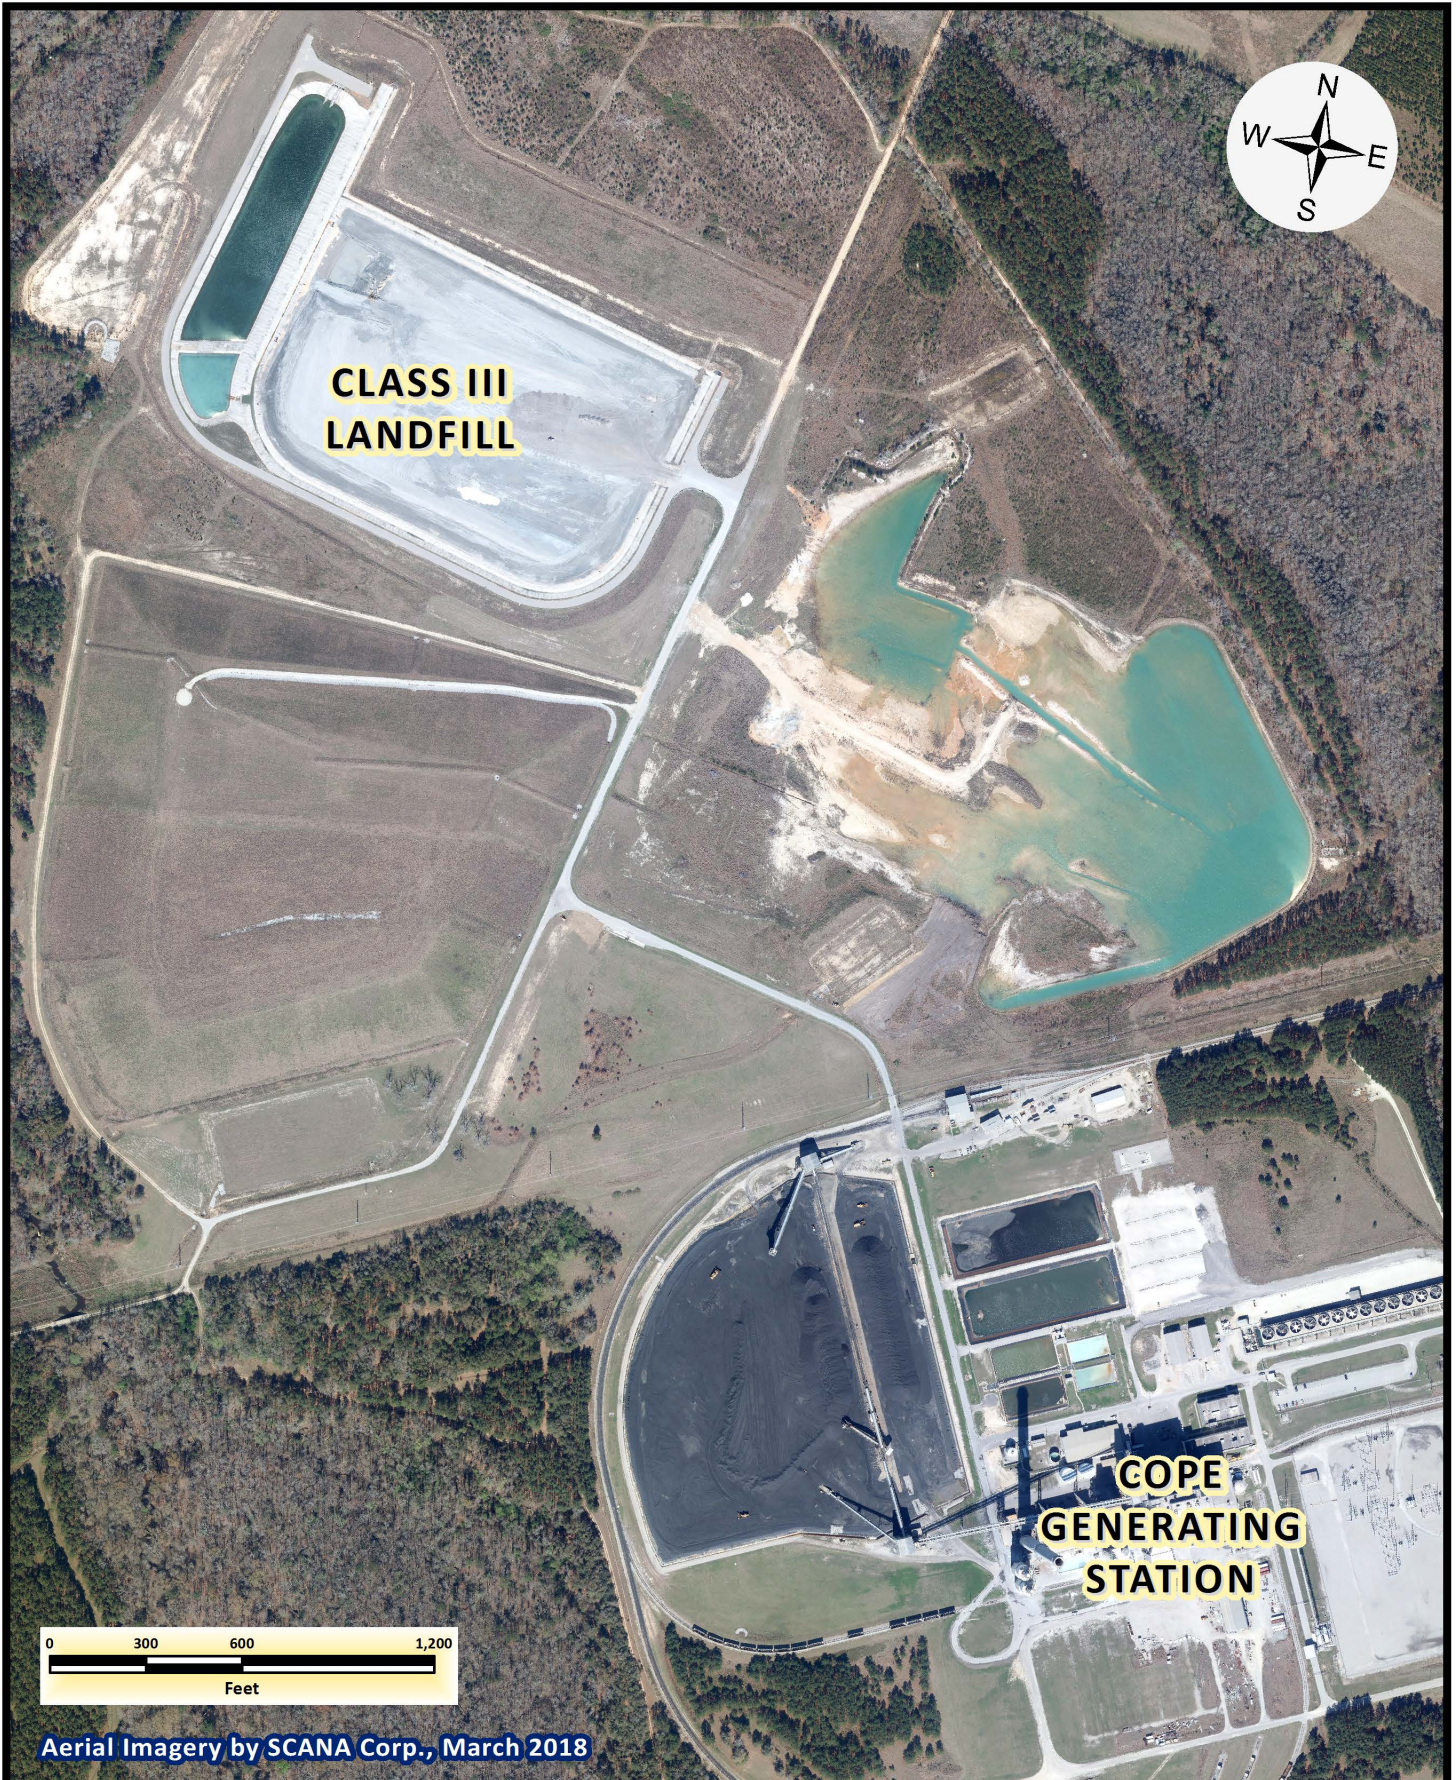
**Figure 1 – Site Location
Cope Station Landfill**

Aerial Imagery by SCANA Corp., March 2018

The landfill is located at the Cope Generating Station in Orangeburg County. The Cope Generating Station is approximately 13 miles southwest of the City of Orangeburg, SC. Figure 1
