**2019 Annual
Landfill Inspection Report**

**Dominion Energy
South Carolina
Wateree Station
Class III Landfill**

**Eastover, SC
County of Richland**

January 18, 2020

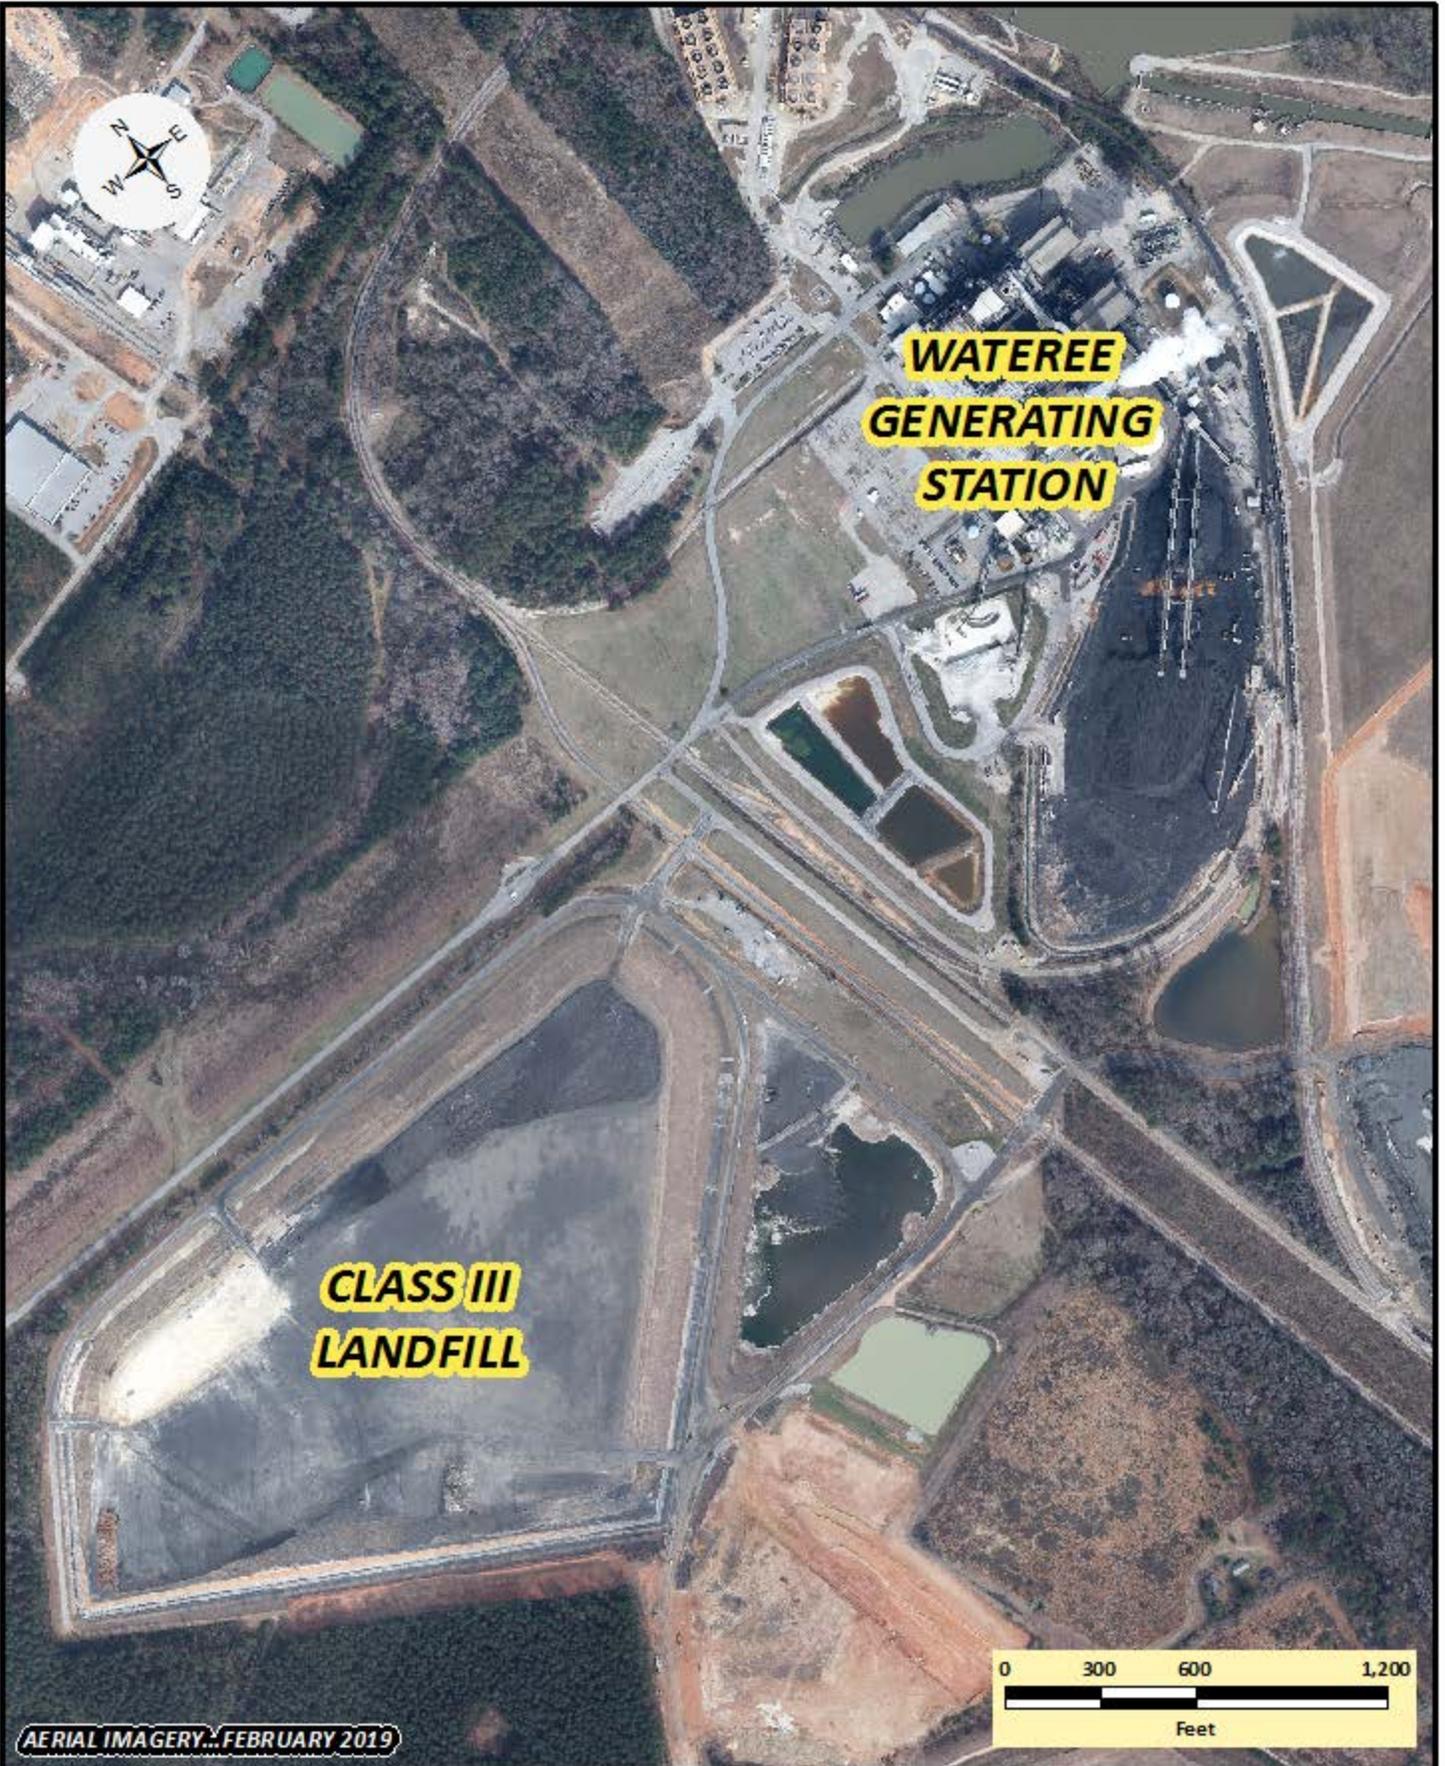
**FIGURE 1 - SITE LOCATION
Wateree Station Landfill**

of the City of Eastover, SC. Figure 1 – Site Location, shows the location of the landfill relative to the power plant. The date of the aerial imagery is February 2019. The Class III landfill is permitted by the South Carolina Department of Health and Environmental Quality (SCDHEC) under Permit No. 403320-1601.
